DRY GAS SEAL INSPECTION REPORT

PROJECT: **SAMPLE**

COMPRESSOR: **Mitsubishi**

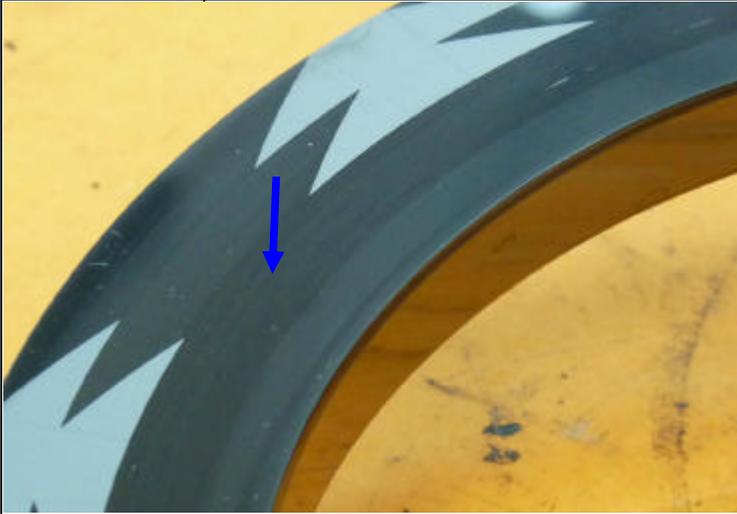
PICTURE 3

Axial movement of the carrier felt normal.
Faint contact marking is visible on the polished surface of the mating ring. (See pic 3).
Faint contact marking is visible on the polished surface of the primary ring. (See pic 6).
Wear marking is visible on the surface of the carrier where the balance diameter polymer ring seals. (See pic 7).

Picture 3 shows a close up on the inboard mating ring, faint contact marking is visible on the polished surface of the inboard mating ring. An attempt made to remove the marking by polishing was successful without affecting the groove depth. This component requires relapping, repolishing & regrooving.

MATING RINGS			ACQUISITION No:		
INBOARD MATING RING	SILICON CARBIDE	YES	CLEAN RELAP REGROOVE AND REUSE	N.A.	FAINT CONTACT MARKING
OUTBOARD MATING RING	SILICON CARBIDE	YES	CLEAN RELAP REGROOVE AND REUSE	N.A.	WEARING MARK AND LIGHT BAND DISTORTED

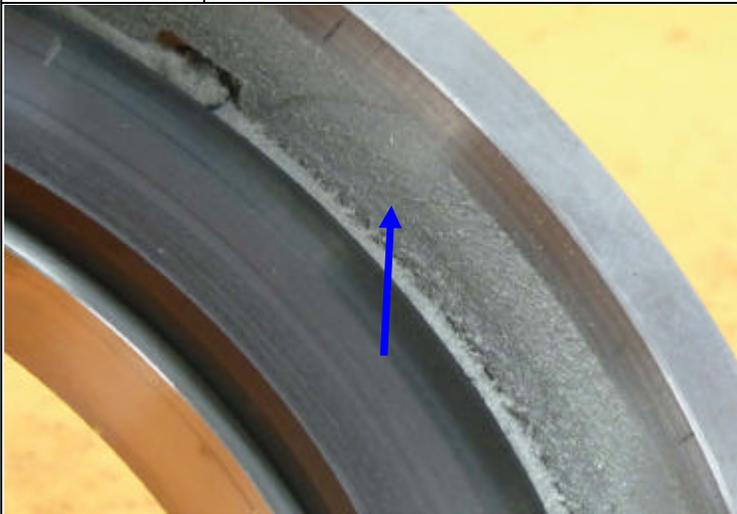
PICTURE 4

Picture 4 shows the inboard retainer assembly. Fibre like particles (suspected to be the material for the seal gas filter) build up at the ID of the inboard retainer clip. Samples were collected for analysis test if required.

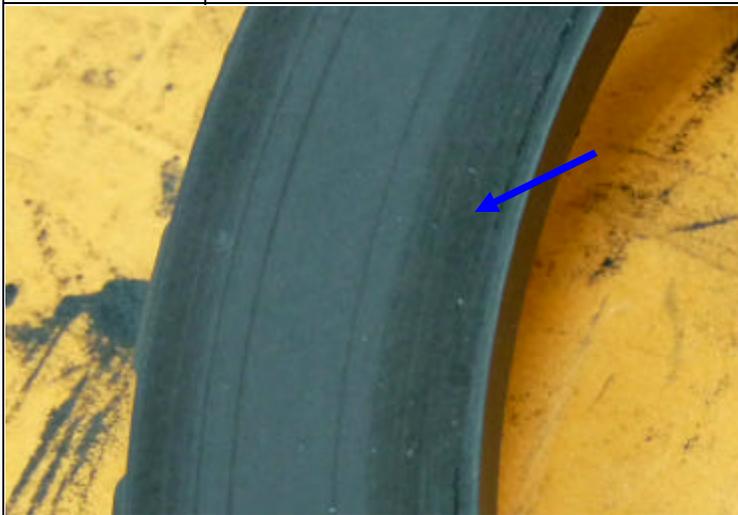
PICTURE 6

Picture 6 shows a close up of faint contact marking is visible on the polished surface of the inboard primary ring. An attempt made to remove the marking by polishing was not successful without affecting the tolerance. **This component requires replacing.**

PRIMARY RINGS			ACQUISITION No:		
INBOARD PRIMARY RING	28G F1682 004 9028	YES	UNABLE TO KEEP WITHIN CALIBRATION REPLACE	N.A.	FAINT CONTACT MARKING; UNDERSIZED
OUTBOARD PRIMARY RING	28G F1682 004 9028	YES	UNABLE TO KEEP WITHIN CALIBRATION REPLACE	N.A.	FAINT CONTACT MARKING; UNDERSIZED

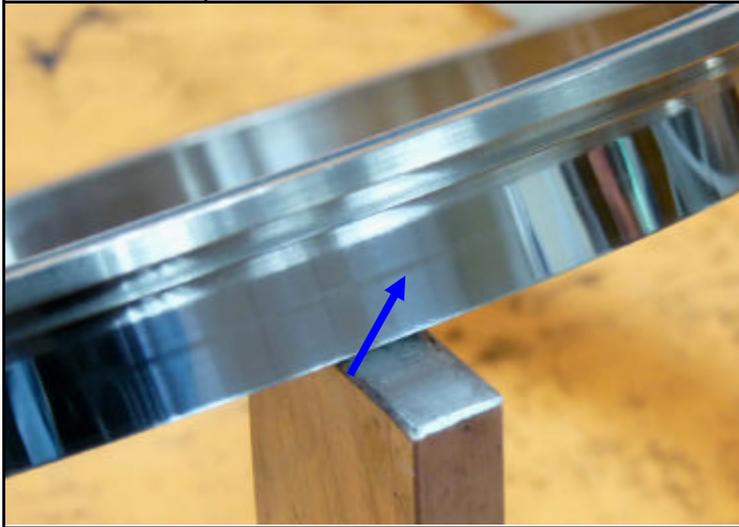
PICTURE 7

Picture 7 shows after cleaning of the inboard carrier, wear marking is visible on the surface of the inboard carrier where the balance diameter polymer ring seals. This component can be requires recoating.

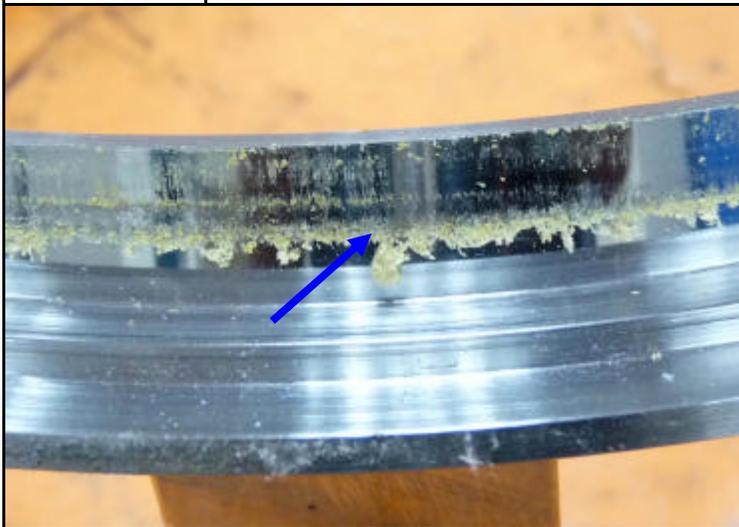
PICTURE 8

Picture 8 shows before cleaning of the inboard carrier, yellow color flakes (suspected to be the product) build up at the surface of the inboard carrier where the balance diameter polymer ring seals. Samples were collected for analysis test if required.

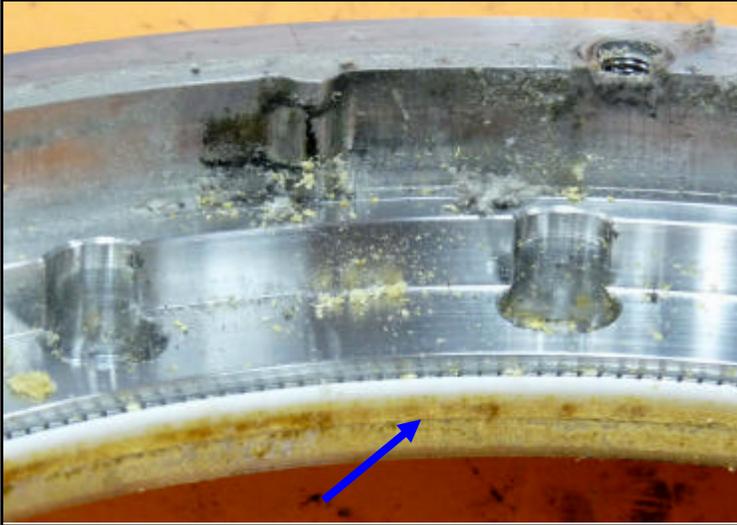
PICTURE 9

Picture 9 shows yellow color flakes (suspected to be the product) build up at the inboard retainer balance diameter polymer ring. Samples were collected for analysis test if required.

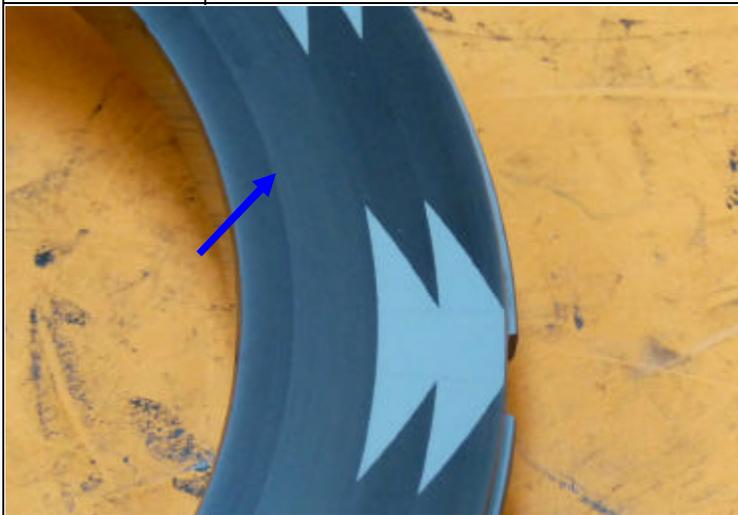
PICTURE 12

Axial movement of the carrier felt normal.
Wearing mark is visible at the inner surface of the mating ring. (See pic 12).
Faint contact marking is visible on the polished surface of the primary ring. (See pic 15).
Wear marking is visible on the surface of the carrier where the balance diameter polymer ring seals. (See pic 16).

Picture 12 shows the outboard mating ring, wearing mark is visible at the inner surface and calibration was checked and showed that the light band had distorted. An attempt made to restore the light band by polishing was not successful without affecting the groove depth. This component requires relapping, repolishing & regrooving.

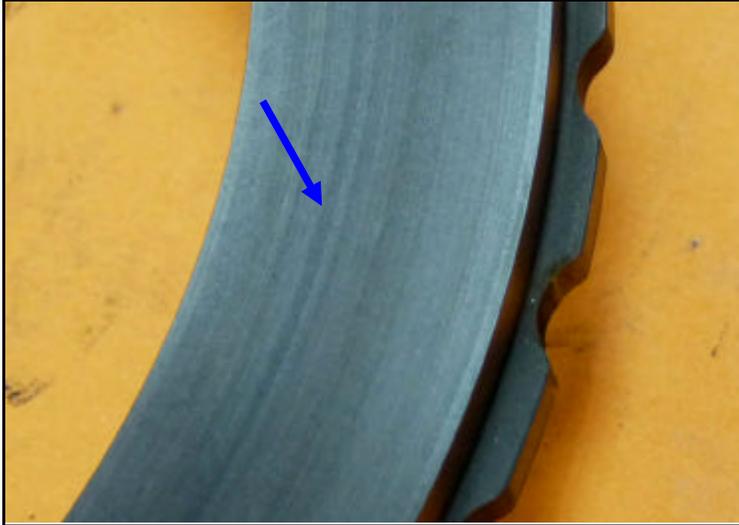
PICTURE 15

Picture 15 shows a close up of faint contact marking is visible on the polished surface of the outboard primary ring. An attempt made to remove the marking by polishing was not successful without affecting the tolerance. **This component requires replacing.**

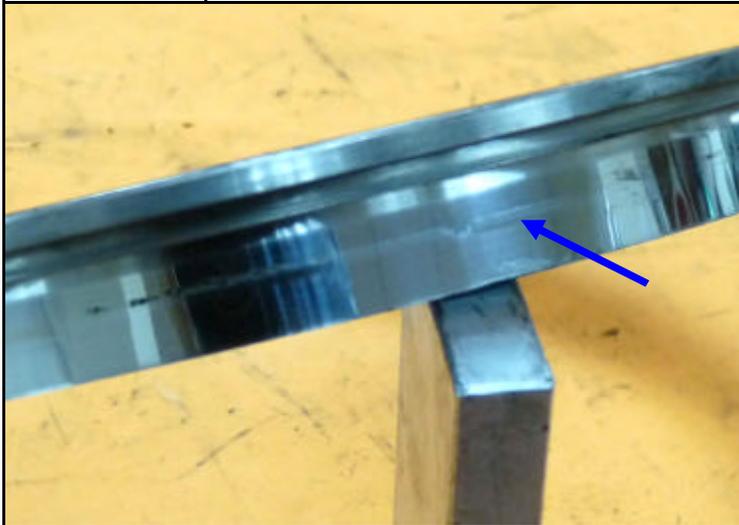
PICTURE 16

Picture 16 shows wear marking is visible on the surface of the outboard carrier where the balance diameter polymer ring seals. This component can be requires recoating

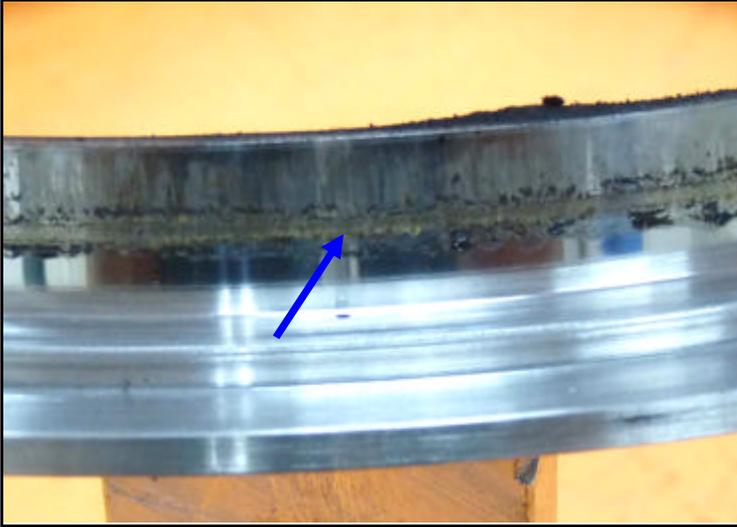
PICTURE 17

Picture 17 shows a close up of hydrocarbon contaminants build up at the surface of the outboard carrier where the balance diameter polymer ring seals.

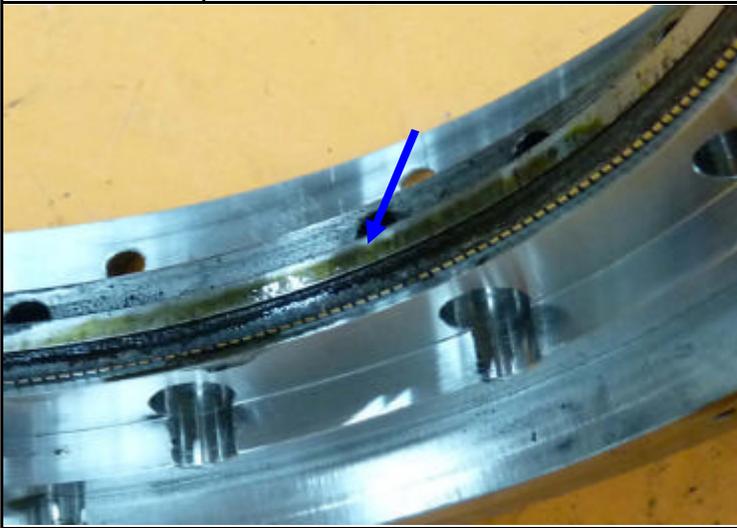
PICTURE 18

Picture 18 shows a close up of wet hydrocarbon contaminants (suspected to be mixture of hydrocarbon & bearing lube oil) is visible at the outboard retainer balance diameter polymer ring.

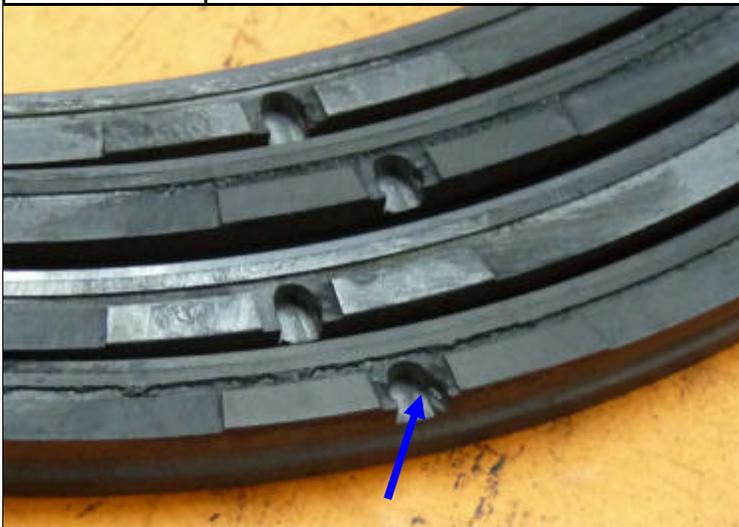
PICTURE 20

Both the inboard & outboard bushing segments anti-rotation slot elongated. (See pics 20,21).
Sleeve sealing surface worn. (See pic 22).

Picture 20 shows the inboard bushing segments anti-rotation slot elongated. **This component requires replacing.**

INBOARD BUSHING SEGMENT	S/90660 7082	YES	REPLACE	ANTI-ROTATION SLOT ELONGATED
OUTBOARD BUSHING SEGMENT	S/90660 7082	YES	REPLACE	ANTI-ROTATION SLOT ELONGATED

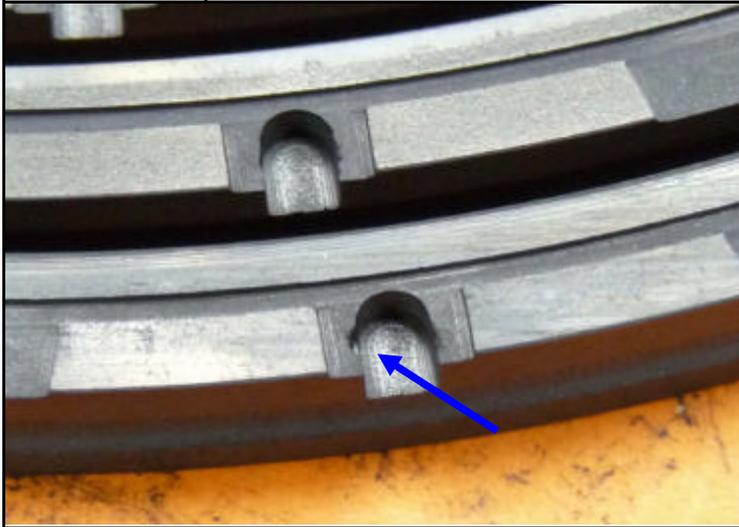
PICTURE 21

Picture 21 shows the outboard bushing segments anti-rotation slot elongated. This component requires replacing.

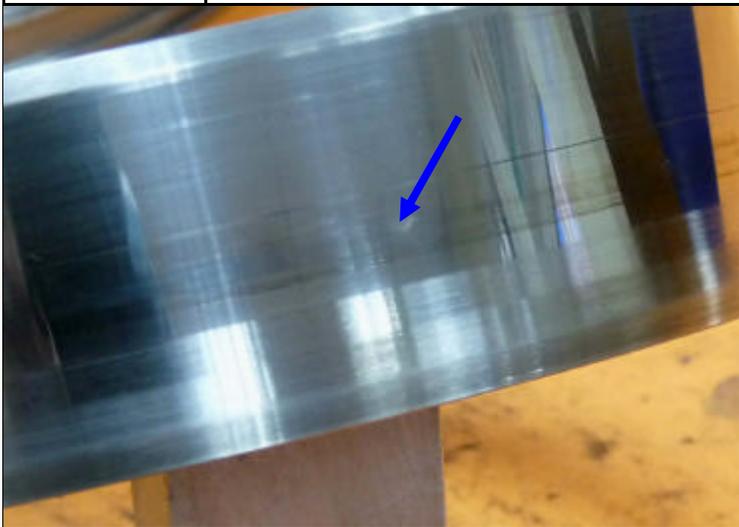
PICTURE 22

Picture 22 shows locking sleeve sealing diameter with wearing marks. This component requires recoating.

SLEEVE	PLG M1600 001 6864	YES	RECOAT AND REUSE	SEALING SURFACE WORN
ADAPTOR	PSG F1682 033 0620	YES	CLEAN AND REUSE	GOOD CONDITION
COLLAR	CLG F1682 014 0620	YES	CLEAN AND REUSE	GOOD CONDITION
SPLIT THRUST RING	TRG F1682 004 0620	YES	CLEAN AND REUSE	GOOD CONDITION
THRUST RING	TRG F1682 005 0620	YES	CLEAN AND REUSE	GOOD CONDITION
INSTALLATION PLATE INNER	IPG M1600 002 0530	YES	CLEAN AND REUSE	GOOD CONDITION
INSTALLATION PLATE OUTER	IPG M1600 001 0530	YES	CLEAN AND REUSE	GOOD CONDITION
BUSHING HOUSING	HSG M1600 001 0620	YES	CLEAN AND REUSE	GOOD CONDITION
CLAMP PLATE	PSG M1600 001 0620	YES	CLEAN AND REUSE	GOOD CONDITION
THRUST PLATE	PDG M1600 001 0620	YES	CLEAN AND REUSE	GOOD CONDITION
