關島 cabras 電廠#2 機
汽機大修報告

服務機關：台灣電力公司電力修護處

CABRAS # 1 STEAM TURBINE OVERHAUL FINAL REPORT 2016

關島 cabras 電廠#2 機汽機大修預定工期 45 天 2016 年 2 月 22 日開始大修至 4 月 6 日。大修主要工作內容為，高低壓開蓋大修、高壓轉子第一、四、七級動葉片更換、低壓轉子#22 級 TE&GE 端動葉片更換。大修開蓋後發現中壓第一級(#10 級)動葉片似乎遭異物撞擊而損傷，廠方決定一同更換。另汽機主閥全部拆卸檢修。MSV&RSV 之 SEAT 及 DISC 接觸狀況都不好，此次大修將 MSV&RSV 做了研磨。MSV&RSV 之彈簧也予以更換。#1CV、#5CV 彈簧也予以更換希望能改善閥之開關控制。N1 汽封運轉中有洩漏蒸汽之情形，檢修中發現止回閥未開，因此拆卸檢修後將止回閥打開，並作記號確保止回閥在開的位置。汽機之汽封更換了七級包括 IP5、IP10 之 SEAL STRIP，HP7、HP8、IP6、IP8、IP9 之 Packing ring。低壓外缸之安全膜片也做了更換。大修過程中因葉片拆解後量測才製造，第 1、10 級葉片至 3 月 18 日才到廠，最後 L-0 至 3 月 30 日到廠，經全力趕工使原本預定四月六日啟動日期延期至四月 16 日才啟動並聯，比重新修訂工期提前 3 天完工。

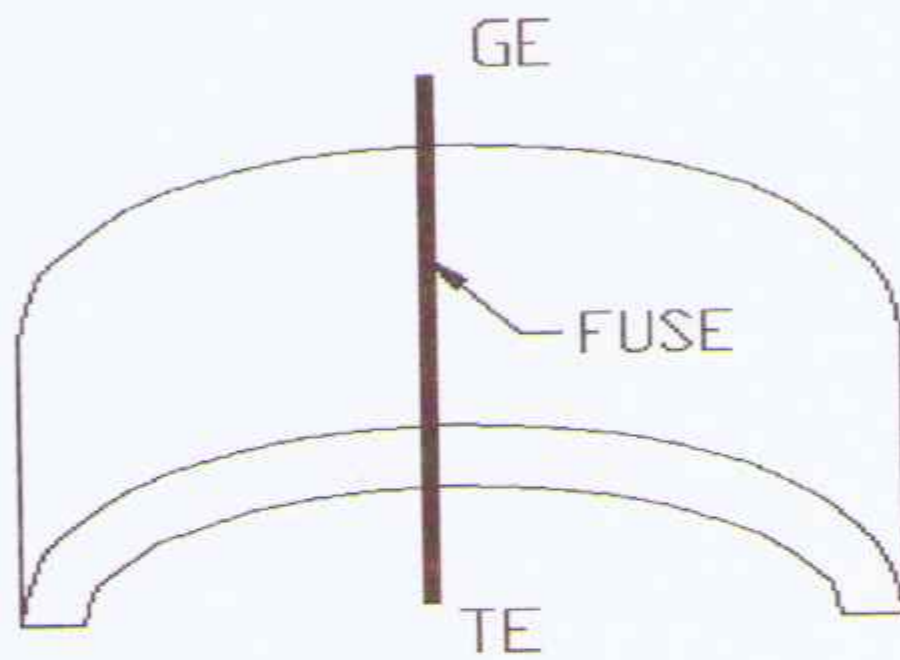
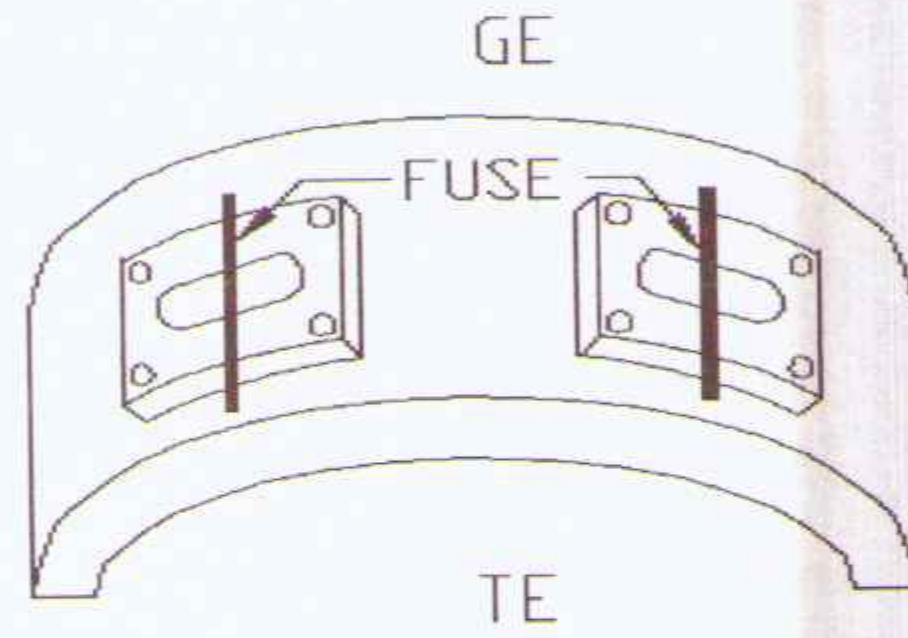
Brg Pinch Check

Brg NO	SIM Width	Mea Point		FUUSE Thick	PINCH	DESIGN	Note
1		TOP	TE	0.80	0.02	0.05-	
			GE	0.80	0.00	0.125	
2	= x0.7	LEFT	TE	0.80	0.02	0.05-	
			GE	0.80	0.00	0.125	
		RIGHT	TE	0.80	0.00	0.05-	
			GE	0.80	0.02	0.125	
3	= x0.7	LEFT	TE	0.80	00.2	0.05-	
			GE	0.80	0.02	0.125	
		RIGHT	TE	0.80	0.02	0.05-	
			GE	0.80	0.02	0.125

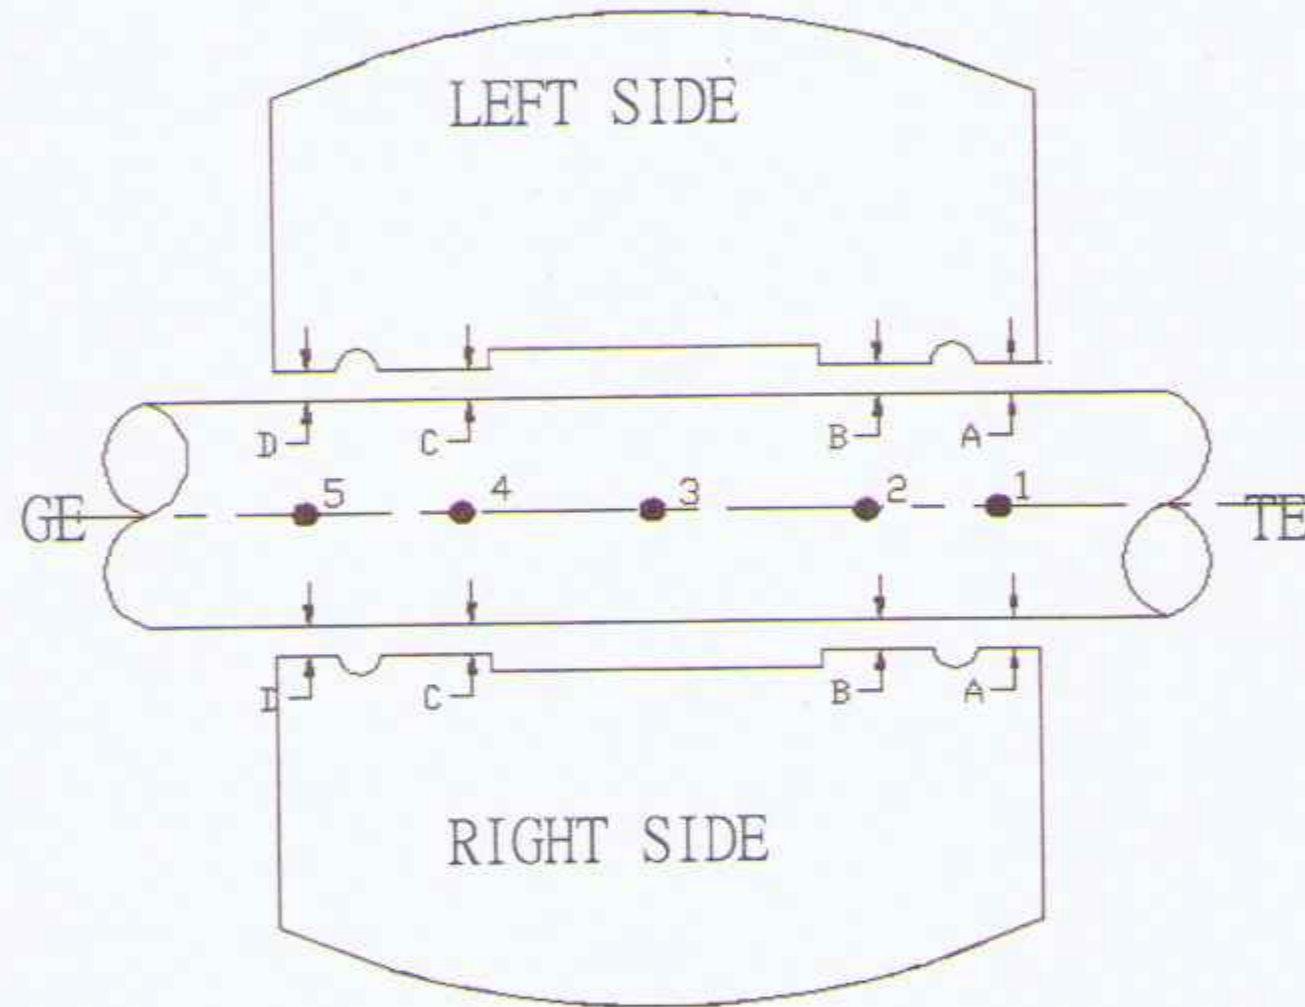
#1、2、3Brg Clearance&Parallel Check

A		B		C		D	
	left	right	left	right	left	right	left	right
NO.1	0.20	0.16	0.20	0.18	0.22	0.19	0.25	0.20
NO.2	0.40	0.45	0.40	0.45	0.42	0.39	0.45	0.35
NO.3	0.35	0.20	0.30	0.20	0.38	0.23	0.40	0.25

#1	#2	#3
Design	0.31~0.37	0.51~0.61	0.43~0.56
As found	0.45	0.69	0.65
As left	0.48	0.71	0.68

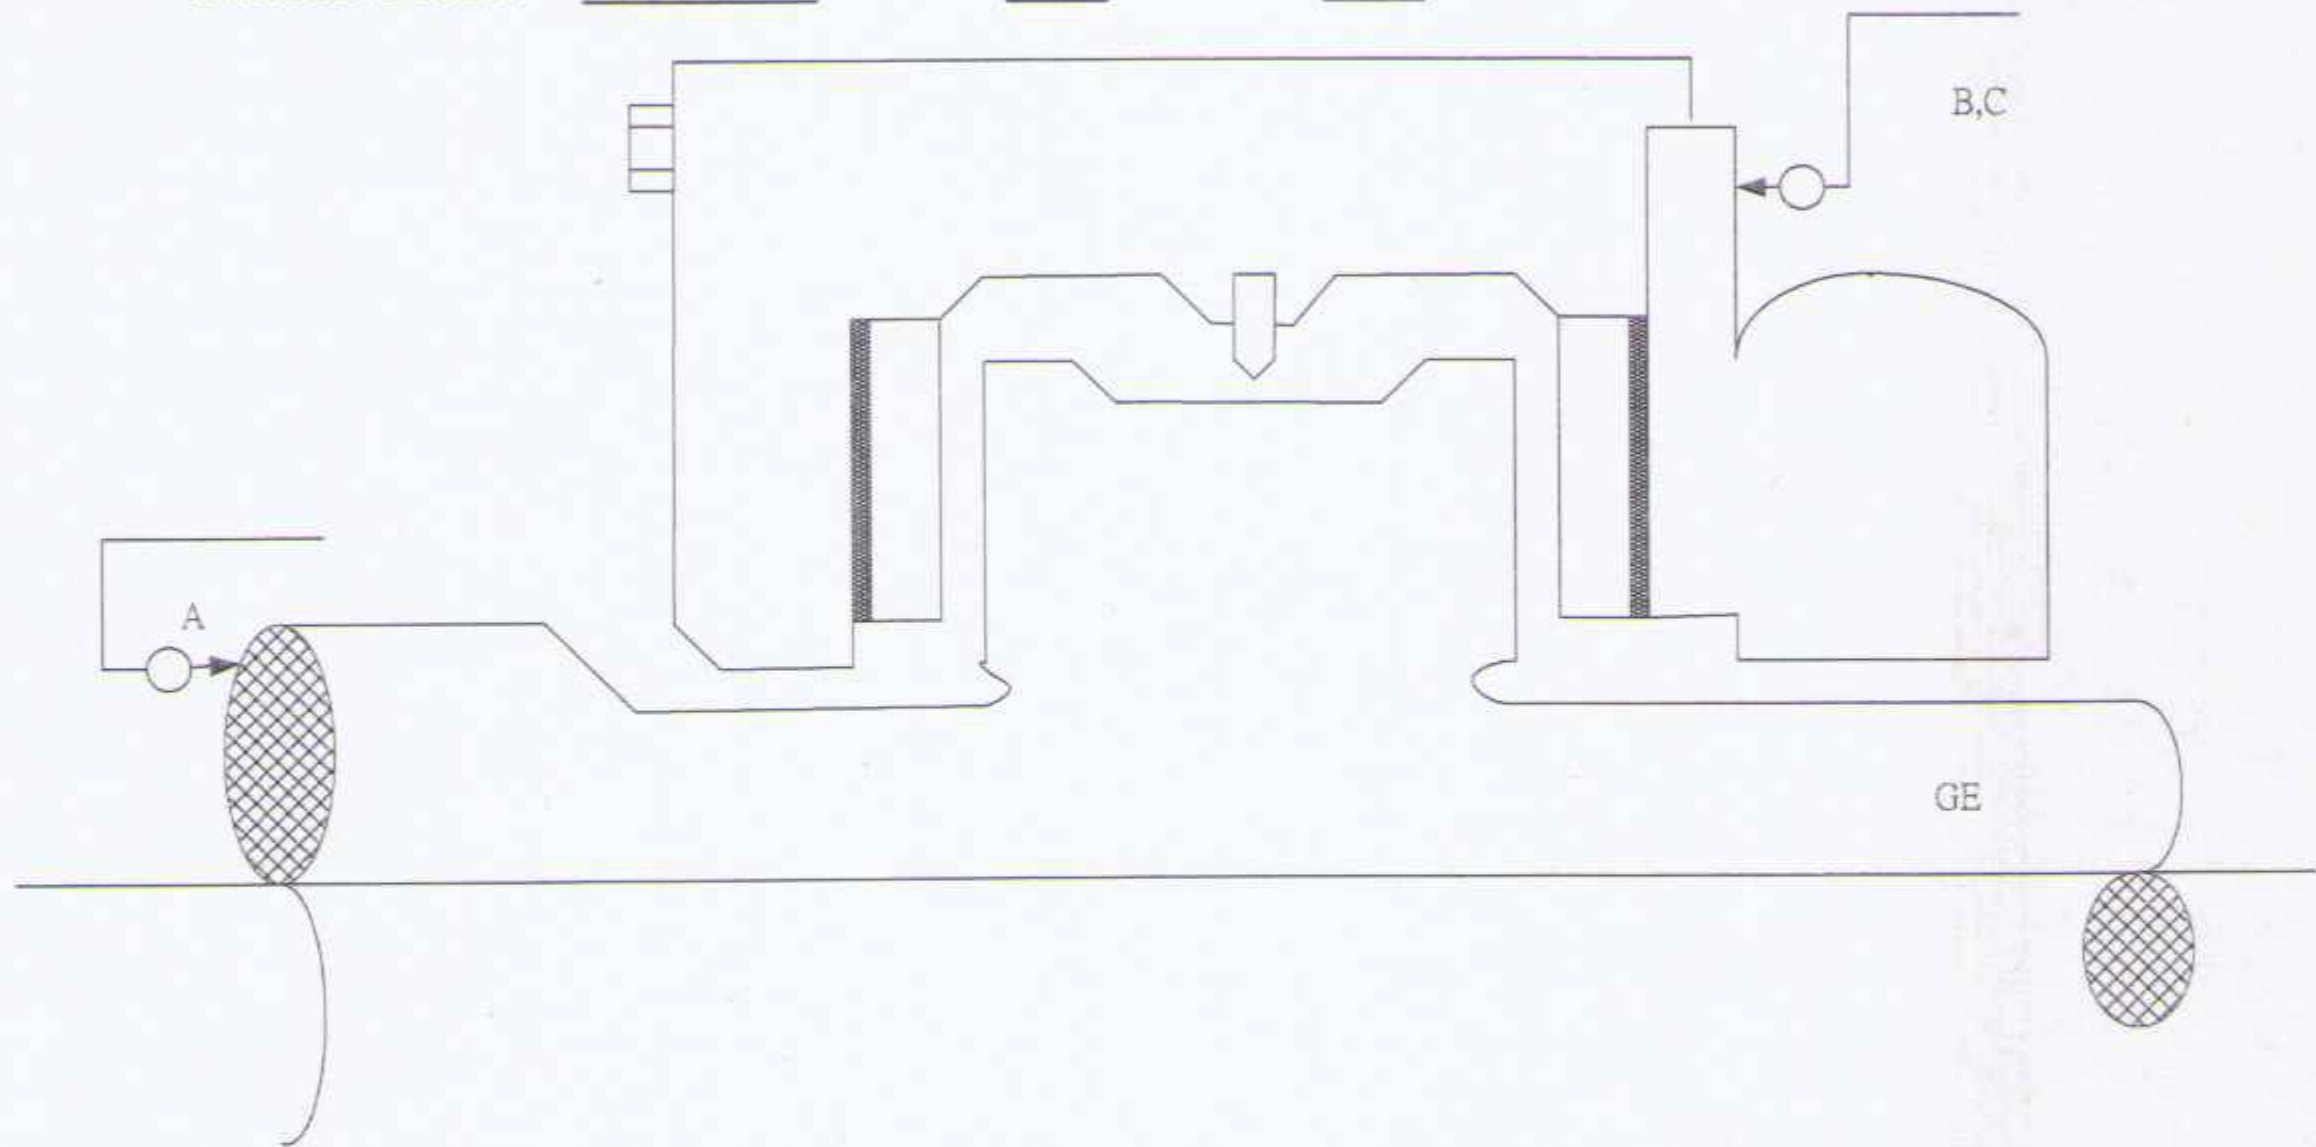
Thrust Brg Clearance Check

L	Casing L	Casing R	Gage	CLE	design
as found	rotor to TE	309.69	10.00	5.00	5.00		0.38~ 0.50
	rotor to GE	310.67	9.18	4.07	4.56	0.44

L	Casing L	Casing R	Gage	CLE	design
as left	rotor to TE	309.83	10.00	5.00	5.00		0.38~ 0.50
	rotor to GE	310.50	9.93	5.54	4.50	0.45

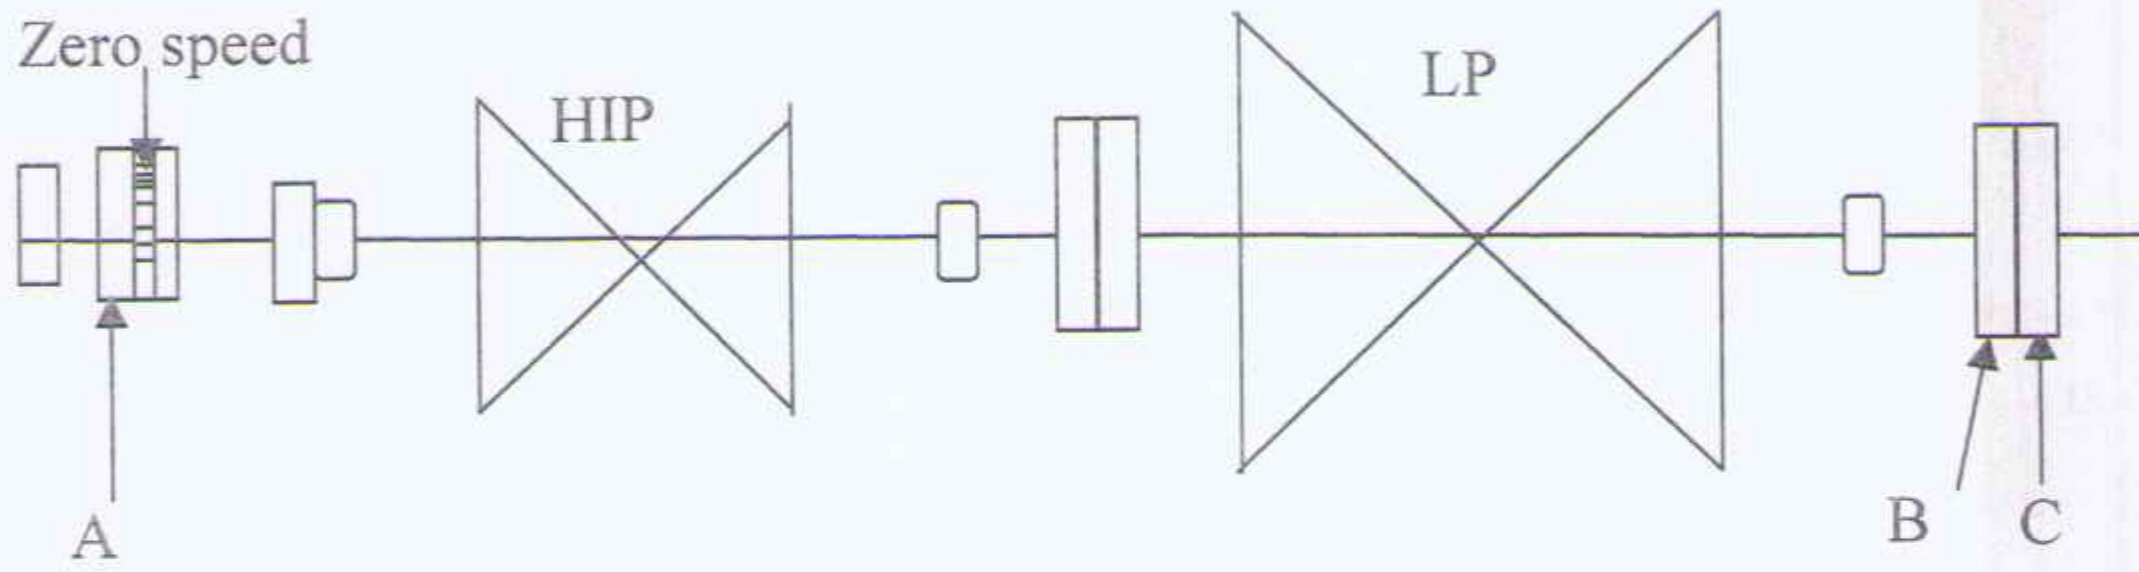
RUNOUT CHECK

A	B	C
1	13	12	11
2	13	12	11
3	16	12	10
4	16	11	9
5	17	11	9
6	16	10	9
7	15	11	10
8	14	11	11

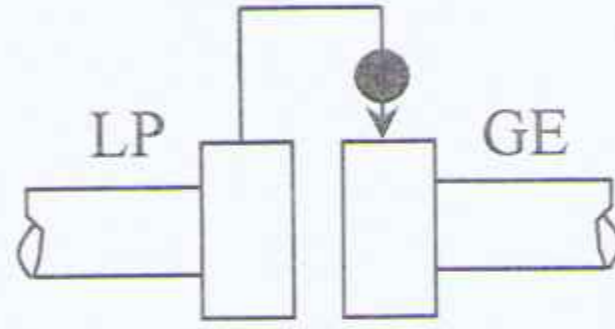
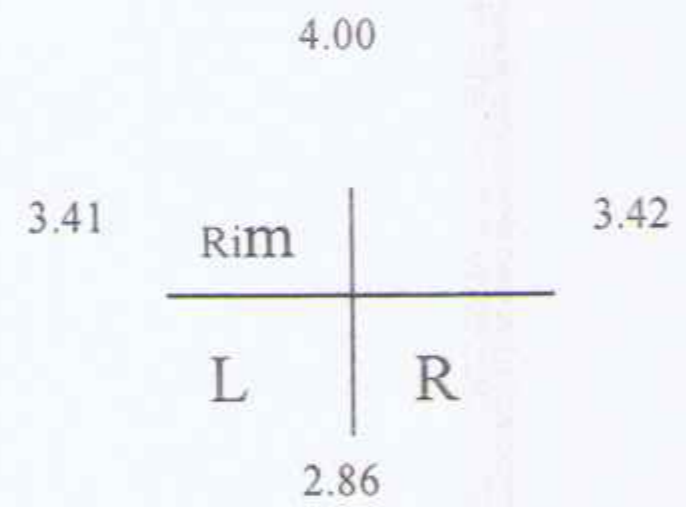
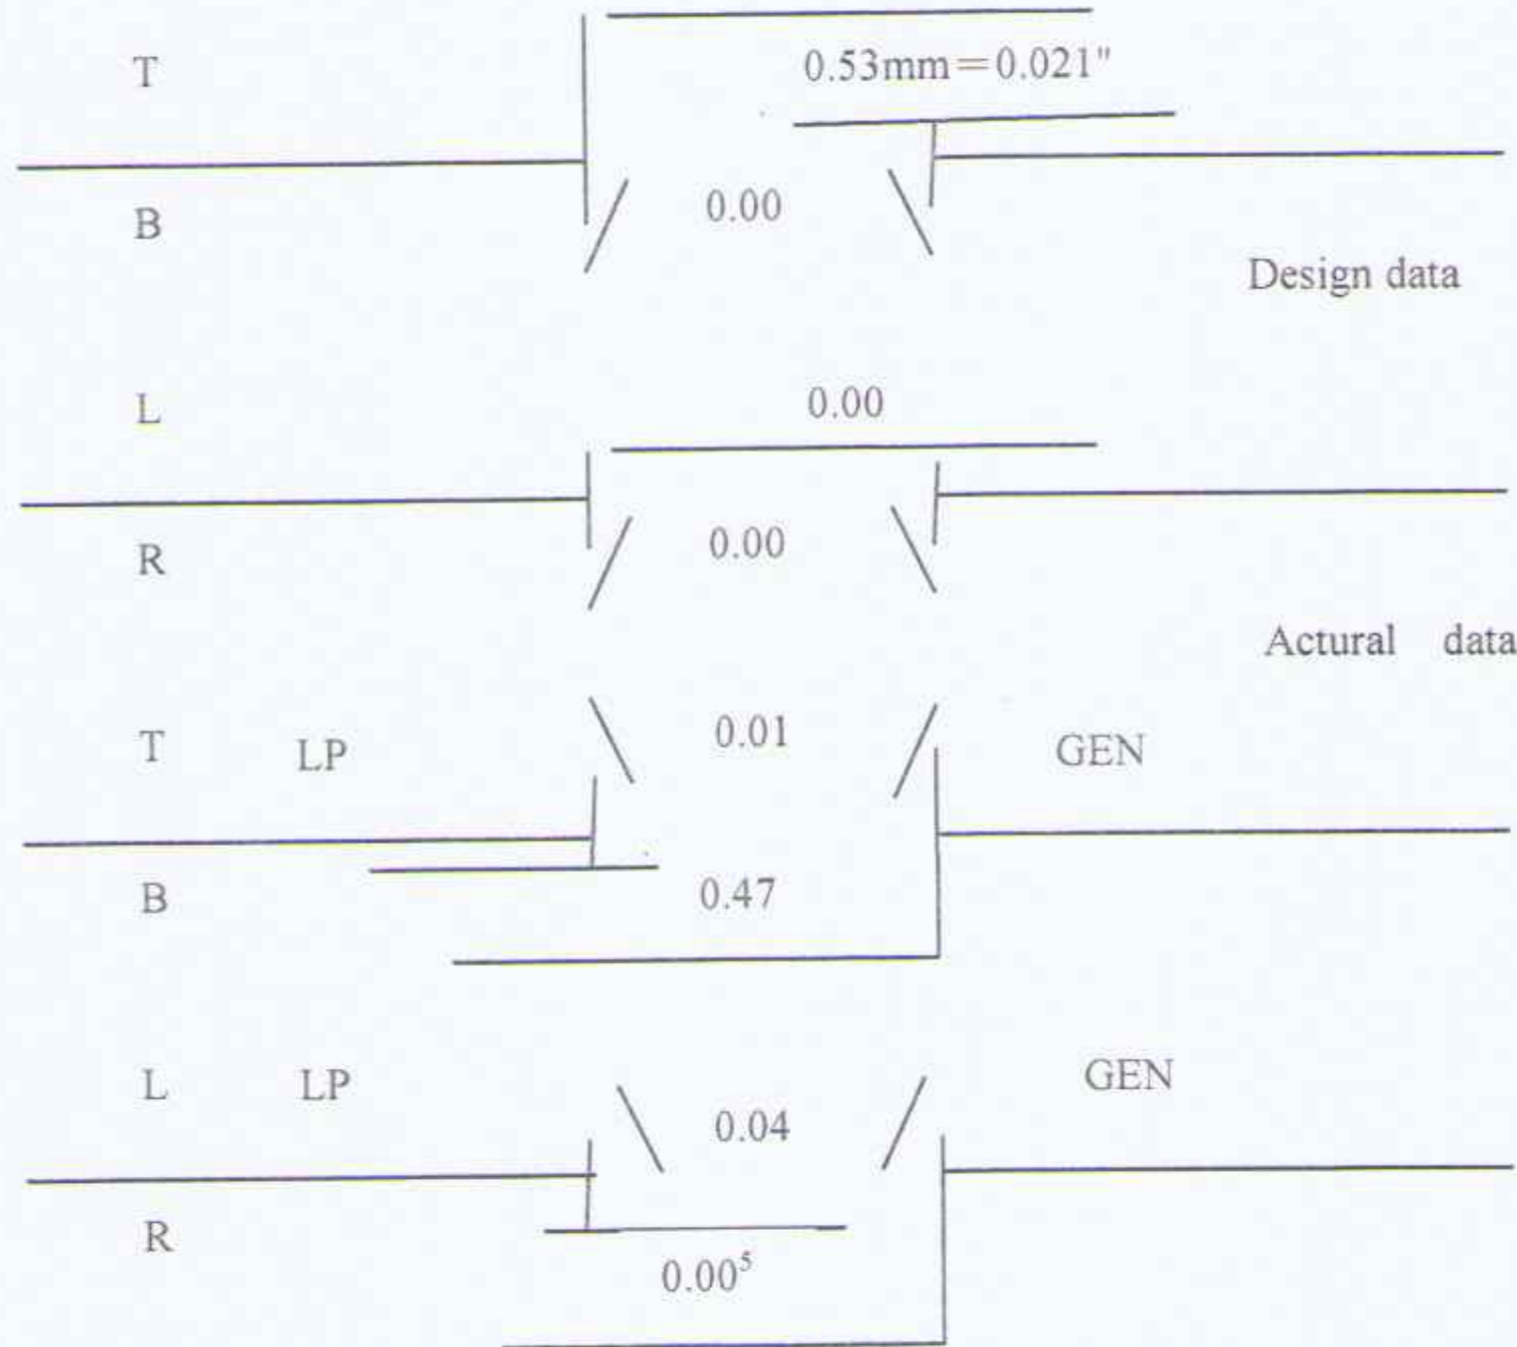
LP-GE Alignment

T	L	B	R
0	25.11	25.07	25.01	25.05
90	24.44	24.43	24.39	24.40
180	24.17	24.13	24.10	24.14
270	24.03	24.00	23.98	24.01
Ave	24.44	24.41	24.37	24.40

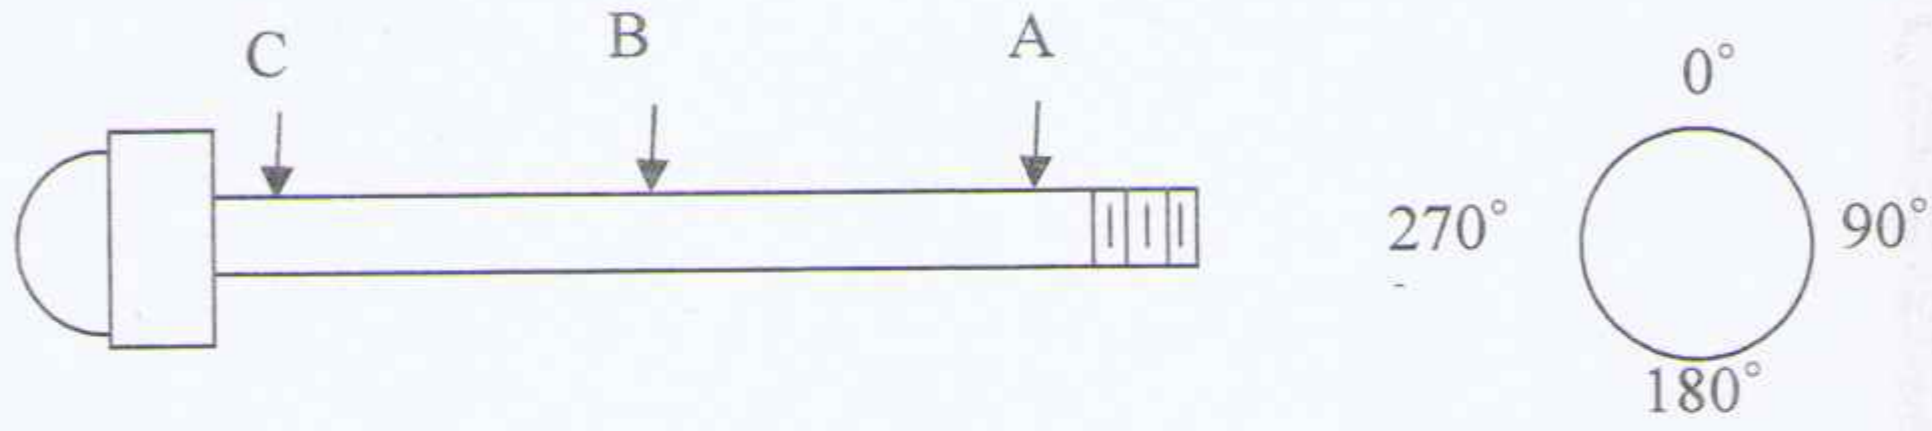
CV Stem Run Out Check

VALVE NO.	A				B				C			
	0°	90°	180°	270°	0°	90°	180°	270°	0°	90°	180°	270°
1	0	0	0	-1	0	1	-15	-15	0	1	2	0
2	0	0	0	0	0	0	-7	-1	0	2	2	-1
3	0	-3	0	-3	0	1	-12	-3	0	0	0	-1
4	0	-5	2	-2	0	-11	-17	-5	0	0	1	0
5	0	2	-2	1	0	-5	-1	-5	0	0	0	0
6	0	0	-1	-2	0	1	1	0	0	0	0	1

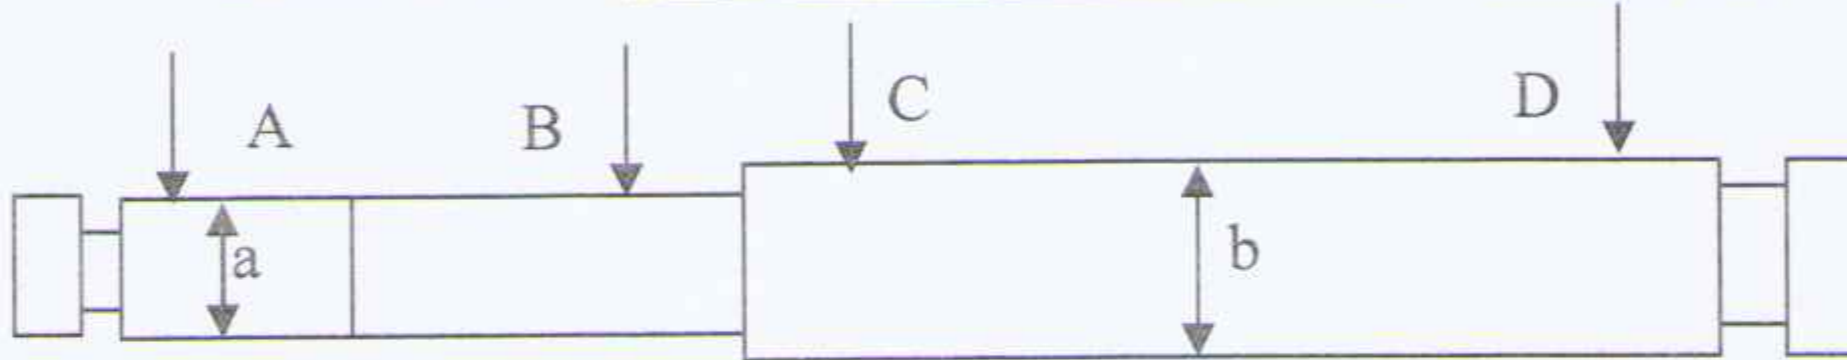
MSV Stem RUNOUT CHECK

A	B	C	D
1	0	0	0	0
2	5	1	1	0
3	-4	-1	0	0
4	-9	-2	0	0

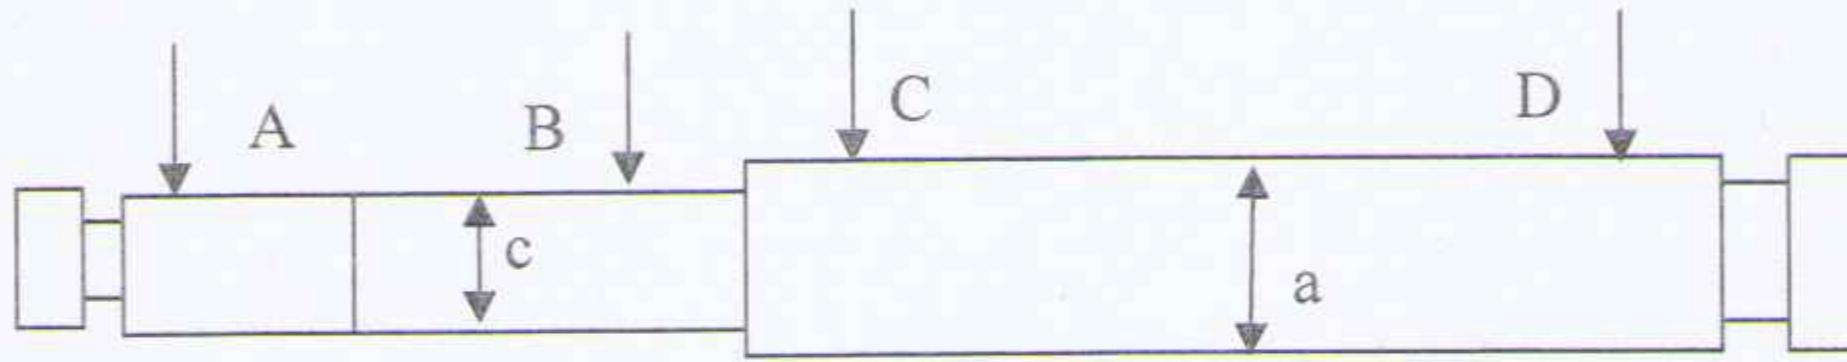
RSV Stem RUNOUT CHECK

A	B	C	D
1	0	0	0	0
2	1	0	0	0
3	0	-1	0	0
4	0	-1	0	0
