INSPECTION REPORT

GAS TURBINE MAINTENANCE

MS 5001 Turbine Rotor Clearances

FSR NO. _____ TURBINE NO. 05620 (Dededo #1) DATE 2016.10.29

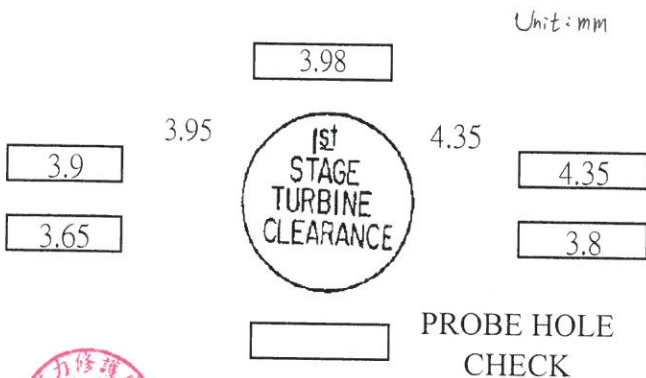
COMMENTS: *Measurement IN1 is somewhat high. We have to see upon the closing measurements of IR*

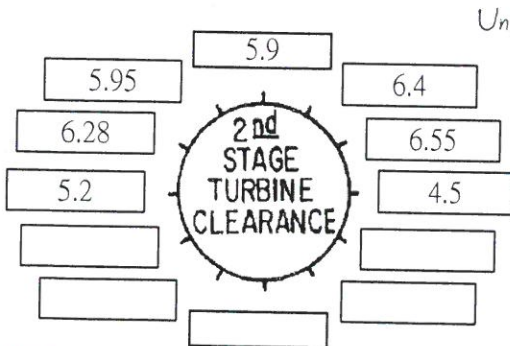
COMMENTS: 2N2, 2N3, 2F2 & 2R - not applicable for this blades / PL
 2F3, 2F4, 2A1 & 2A2 are out of tolerance, probably seals have some wear / PL
 XF - is out of tolerance - Probably the measurement was not right / PL

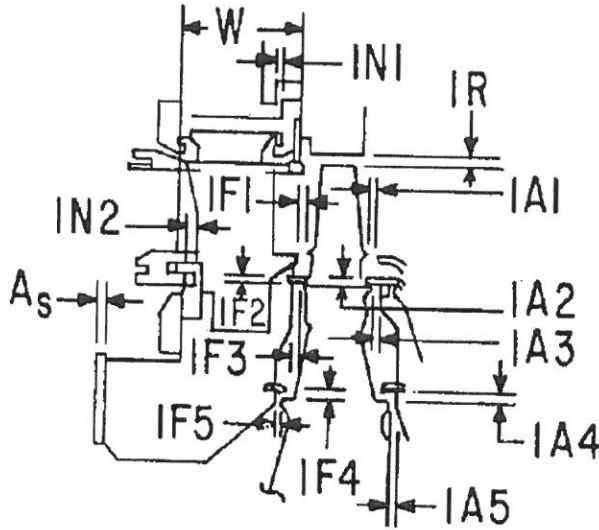
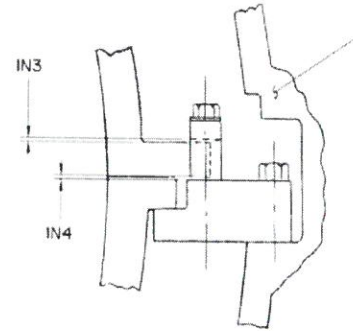
VIEW AT 1ST. STA NOZZLE CLAMP ARRANGEMENT

COMMENTS: *-IN1 is very high compared to spec. Looks like the nozzle is different that the one on the clearance diagram*

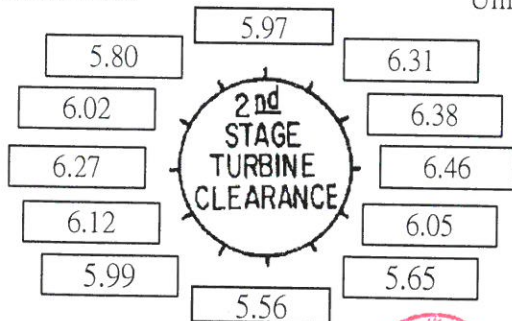
COMMENTS: *R is not applicable on this turbine*
- Zs + IPA are not applicable on this turbine. The nozzle is of a different kind.
 Witnessed + Approved
[Signature] 11/21/16
Juan Castellanos GE

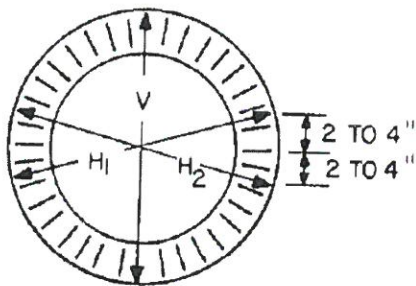
ELLIPTICITY:

Vertical dimension V = 1608.5 mm
 Horizontal dimension H (Average of H₁ and H₂) = 1605.25 mm
 (H₁:1605.00 ; H₂:1605.50)
 Ellipticity (difference between H and V) = 3.25 mm

COMMENTS: - Visual inspection & NDT is reported on the NDT reports (separate)
- The ellipticity is 0.71 mm higher. No major concern on this.

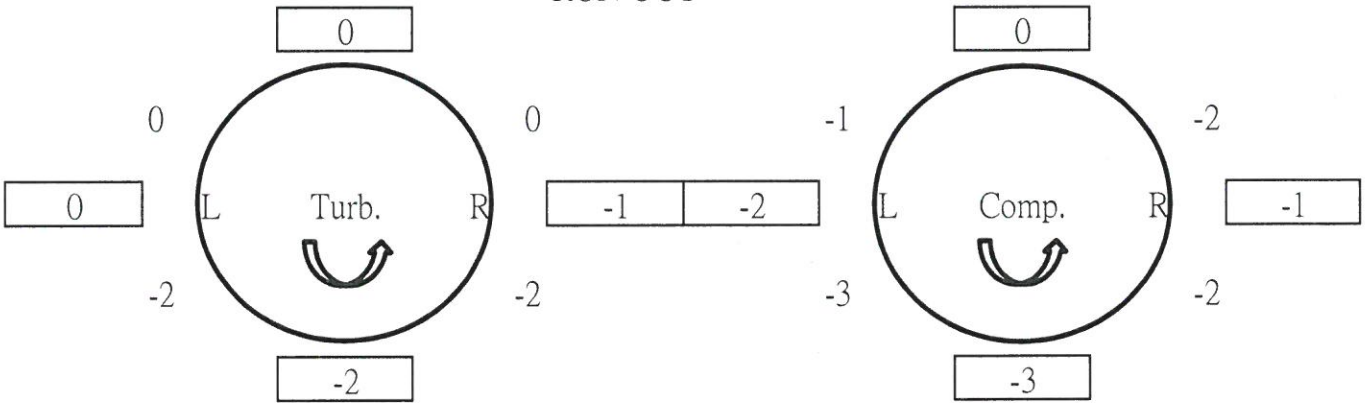
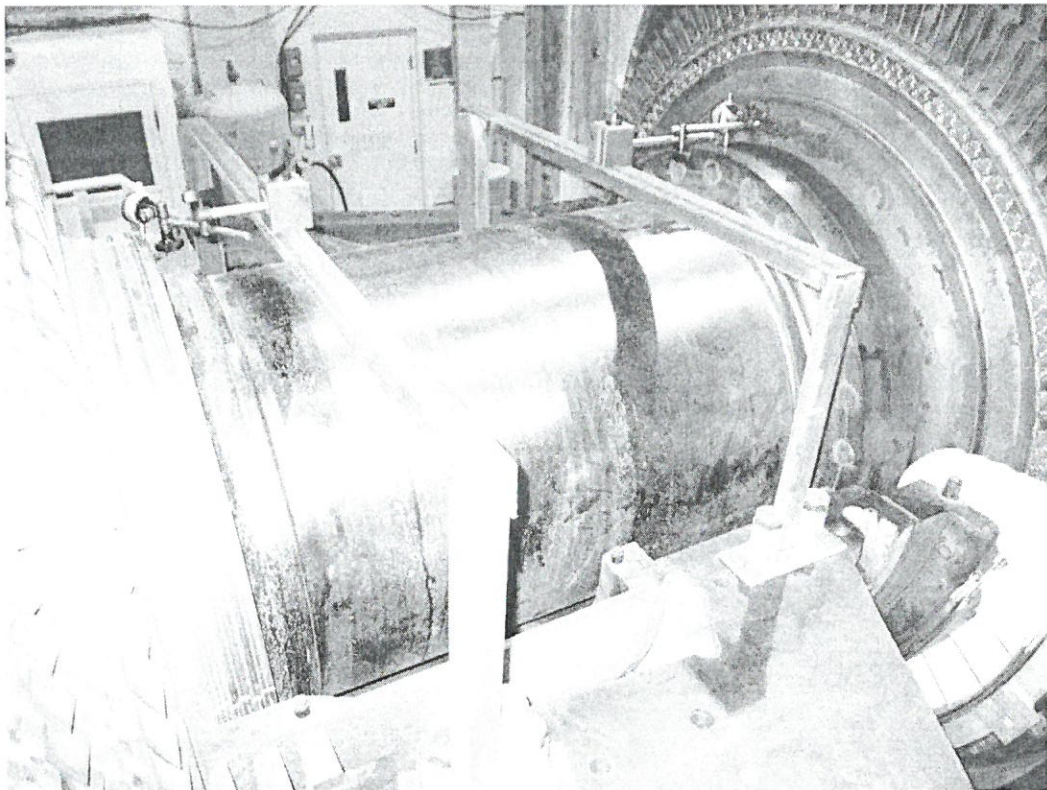
RUN OUT

Run out is good. Witnessed & reviewed 11/1/2016
Juan Castellanos
 Juan Castellanos

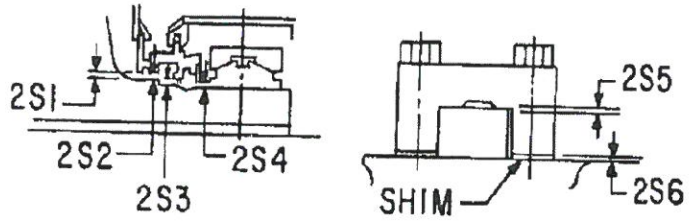
(VIEW AT #2 BEARING STRAP)
No. 2 BEARING AREA

| | CLEARANCES | | VISUAL INSPECTION | | COMMENTS |
|---|---|---|---|---|---|
| 1S1 | 0.35 | 0.40 | high clearance | N | Final. Replace on next outage. <i>JPC</i> |
| 1S2 | 0.37 | 0.37 | high clearance | N | Final. Replace on next outage. <i>JPC</i> |
| 1S7 | 0.25 | 0.20 | high clearance | N | Final. Replace on next outage. <i>JPC</i> |

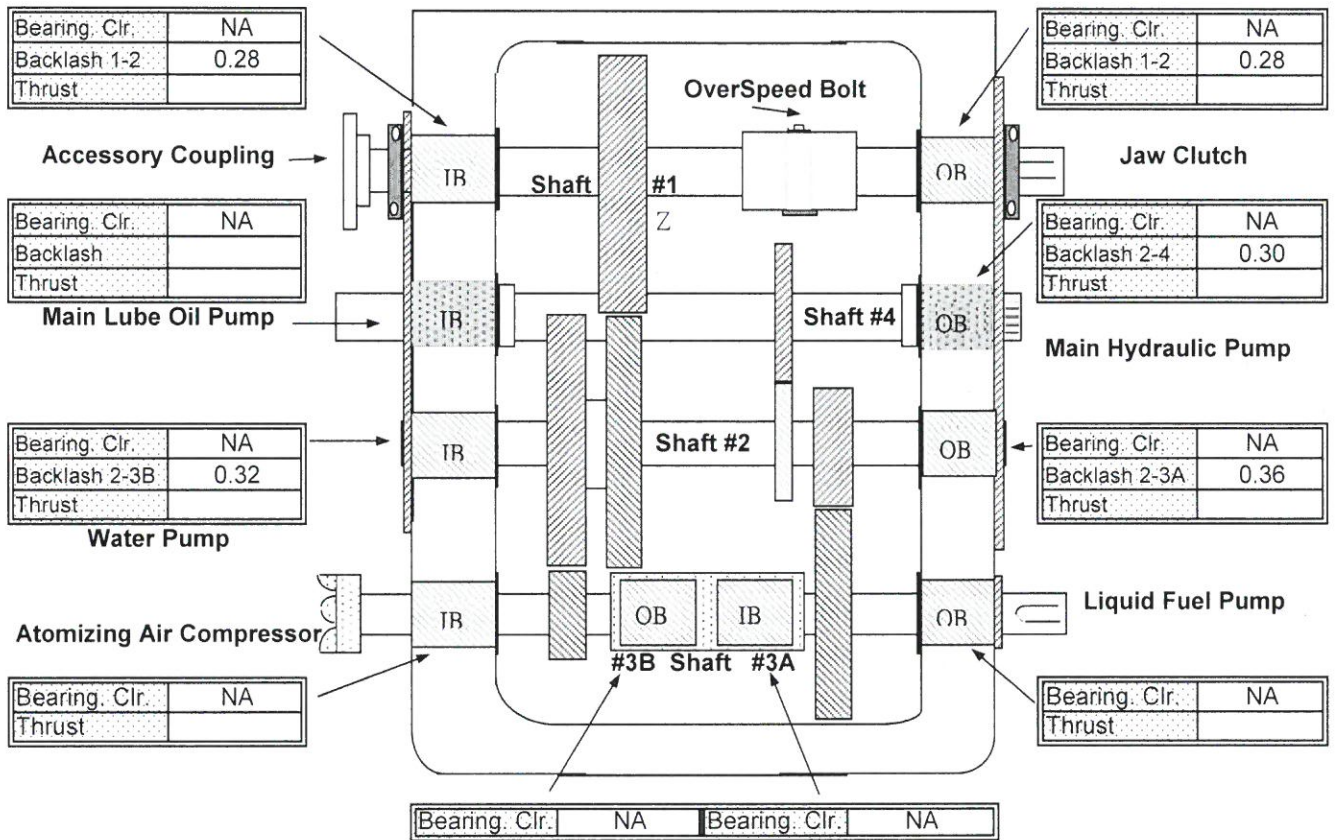
Comments:
 - Backlash is good. Spec is 0.13 to 0.40 mm
 - Thrust or brg. clearance could not be obtained

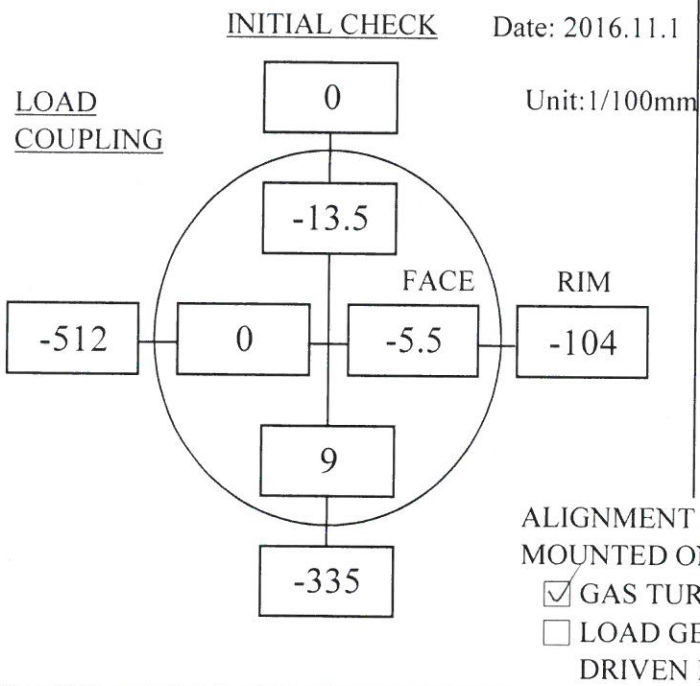
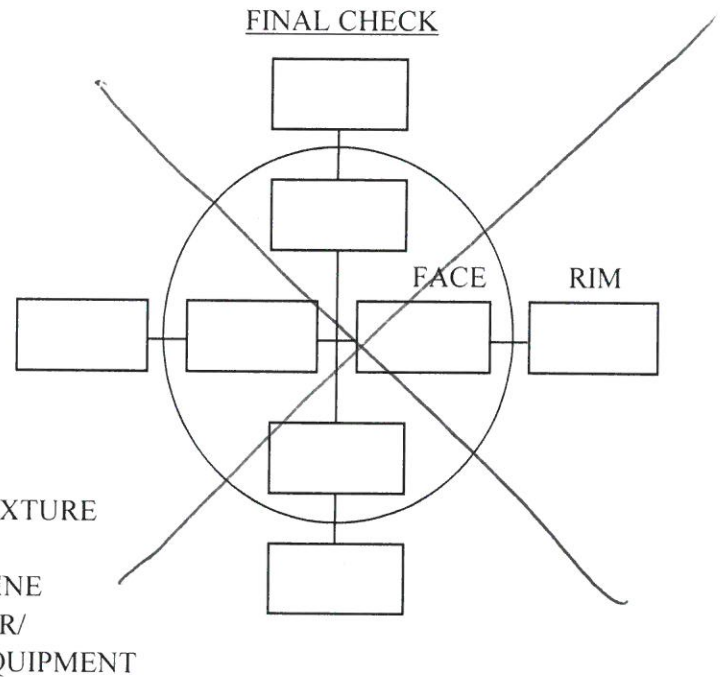
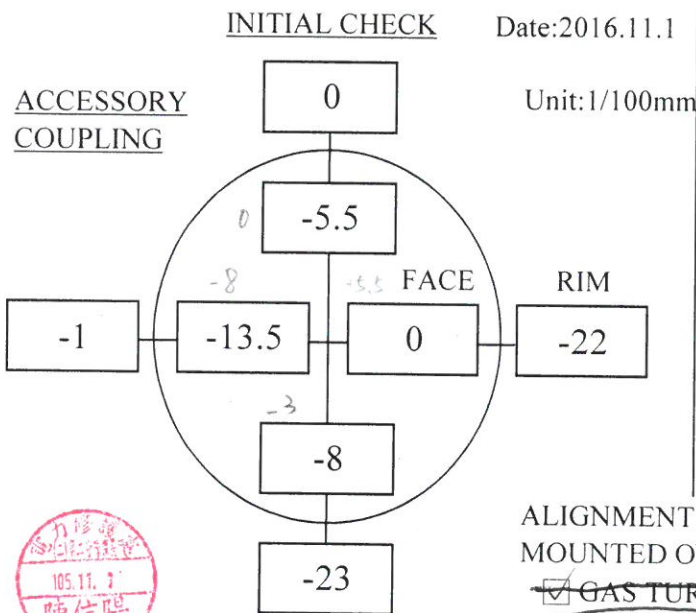
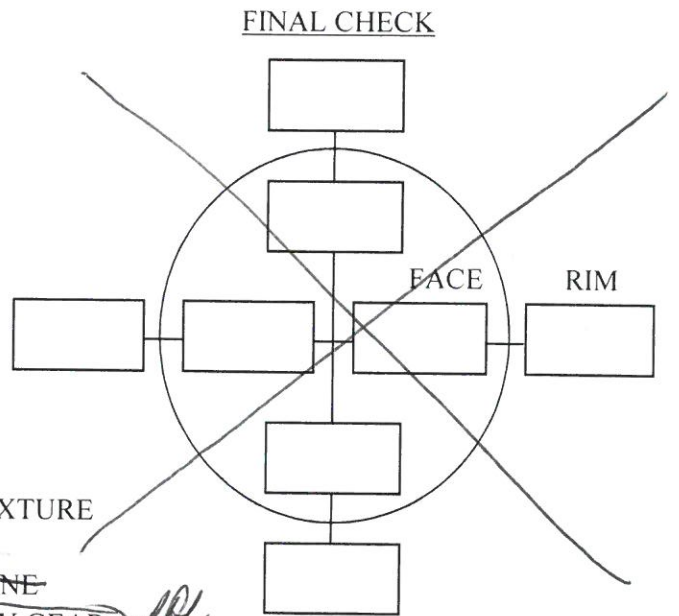
COMMENTS: Alignment is a little off on both load & accs. dpl
