INSPECTION REPORT

GAS TURBINE MAINTENANCE

MS 5001 Turbine Rotor Clearances

FSR NO. _____ TURBINE NO. 296274 (05528) Dededo #2 DATE 2016.10.21

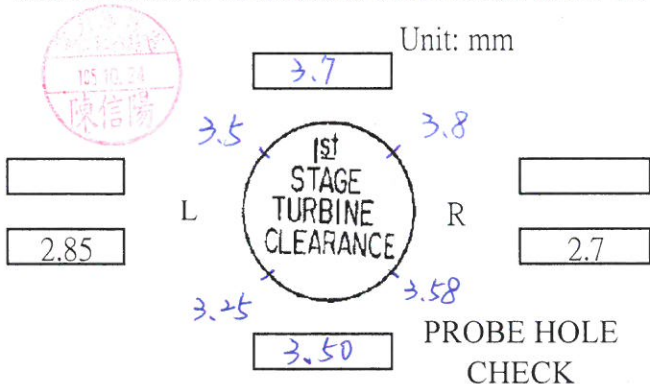
COMMENTS: - opening clearances.
 - W, IN1, IN2 are a little off but no major concern at this point
 - R is somewhat tight but no evidence of rubbing present
 - IF4 is a little open on this seal, should consider replacing seal
 by Juan Castellanos

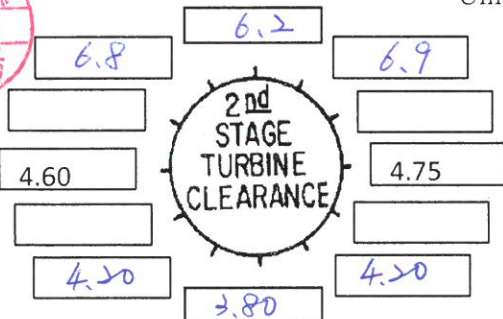
COMMENTS: -2F3 looks like the seal is broken
 -2A2 is a little open
 -Z needs to be modified at closing if necessary
 -XD+XF are off. need to be verified at closing
 JAC

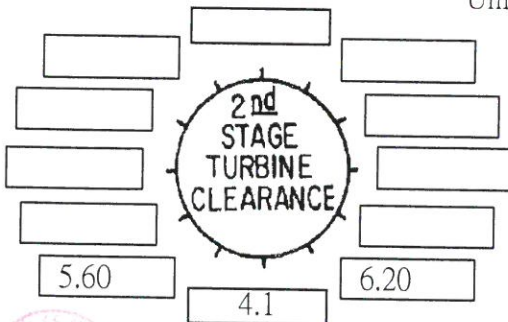
COMMENTS: -2R is not applicable on this turbine
 -2F3 the seal has wear
 -2A2 the seal has wear
 -XD close but no evidence of rubbing
 -XF open but no evidence of rubbing

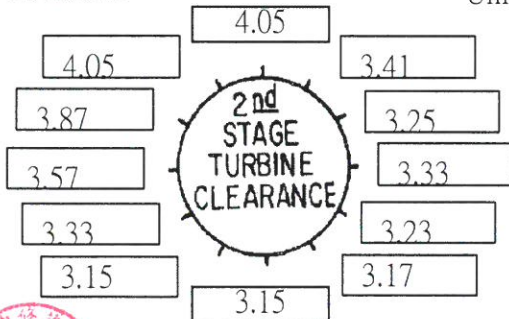
COMMENTS: *2N2 - tight, no major concern*
2F3 & 2A2 - the seal has wear
Z, IPA + IPH - clearances are off, but
no major concern on this
XD - tight, but no evidence of rubbing

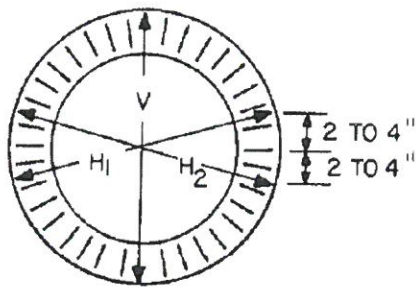
ELLIPTICITY:

Vertical dimension V = 1603.8
 Horizontal dimension H (Average of H₁ and H₂) = 1605.16
 (H₁:1604.67 ; H₂:1605.65)
 Ellipticity (difference between H and V) = 1.36

COMMENTS: - Visual and NDT inspections are reported on the NDT reports (separate)
- Ellipticity is good. Spec is 2.54mm max. JRC

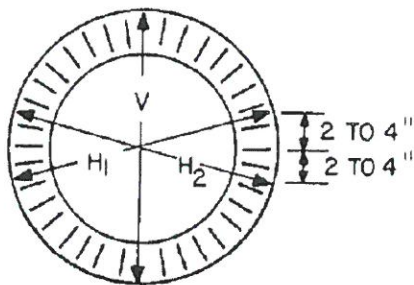
ELLIPTICITY:

Vertical dimension V = 1700.41
 Horizontal dimension H (Average of H₁ and H₂) = 1693.97
 (H₁:1694.5 ; H₂:1693.44)
 Ellipticity (difference between H and V) = 6.44

COMMENTS: - Visual + NDT inspections reported on separate NDT report.
- Ellipticity is double the specification, but the tool to measure was too short and (cont.)

(cont.) the measurements were extended using a ruler. This might have added measurements - errors. No major concern with this. *[Signature]*
 - Witnessed & Approved *[Signature]* 11/4/16
 Juan Castellanos GE

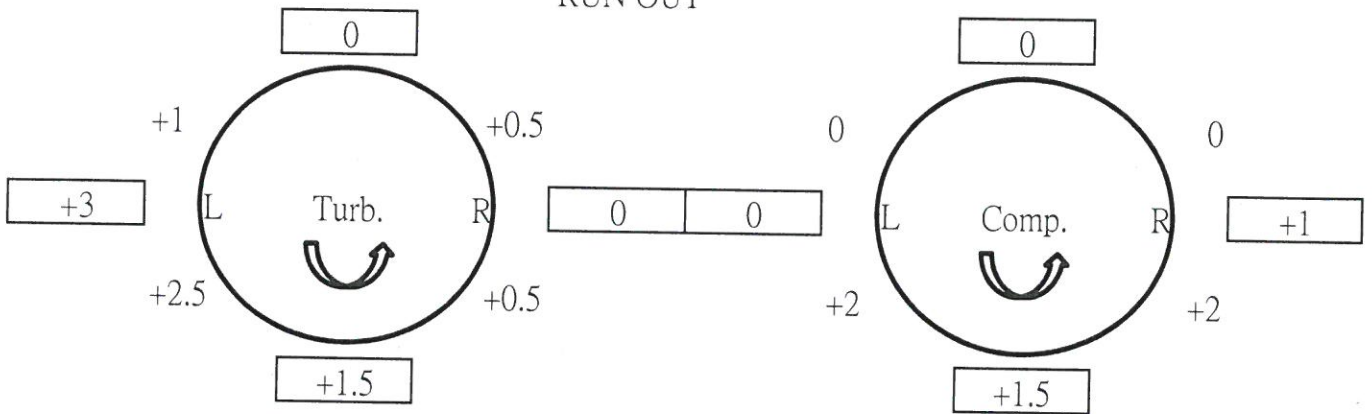
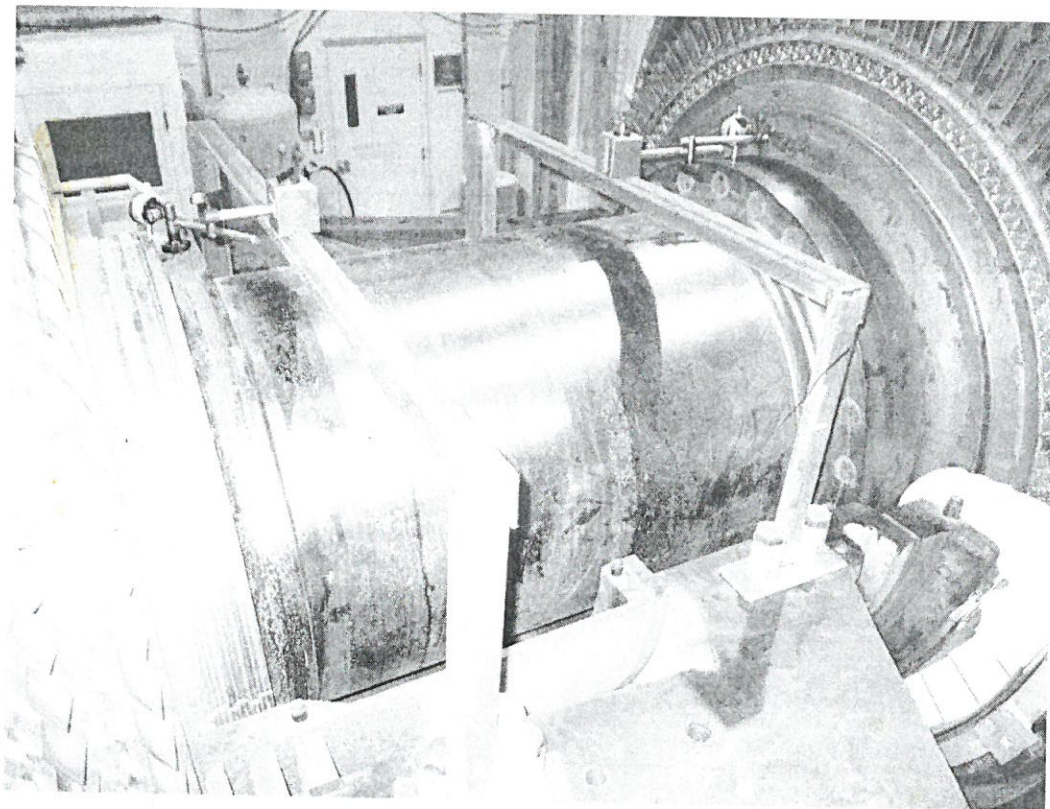
RUN OUT

The run out is acceptable.

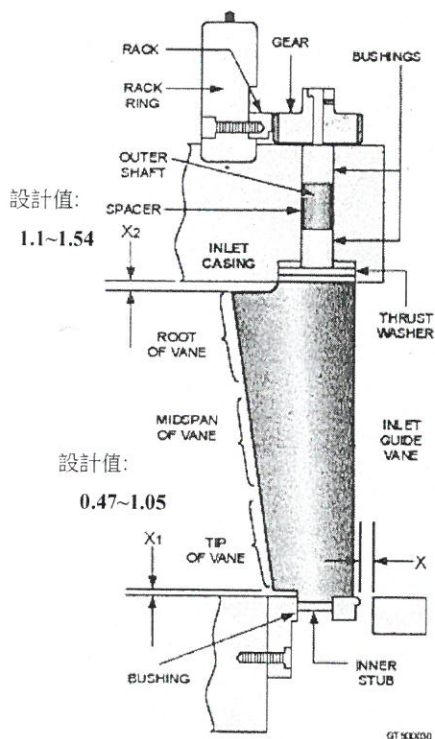
Note: X1 is bigger & X2 is shorter than spec. The thrust washers should be adjusted when the IGV blades are disassembled. No concern to run like that at the moment of 11/8/2016

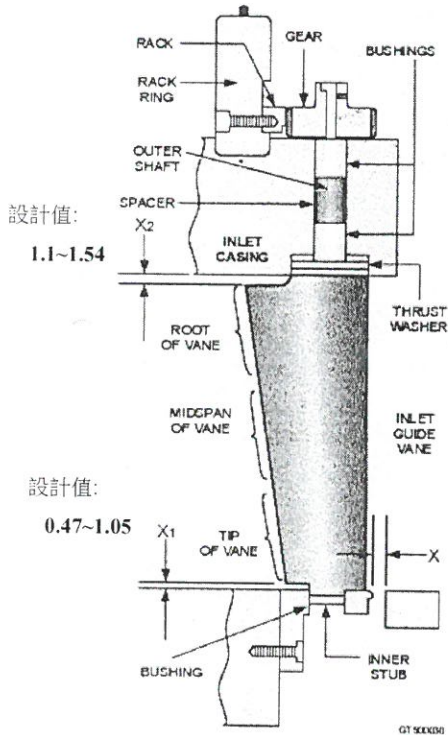
Note: X1 is bigger & X2 is smaller than spec. The thrust washers should be adjusted when the IGV blades are disassembled. No concern for run like that at the moment APE 11/8/2016

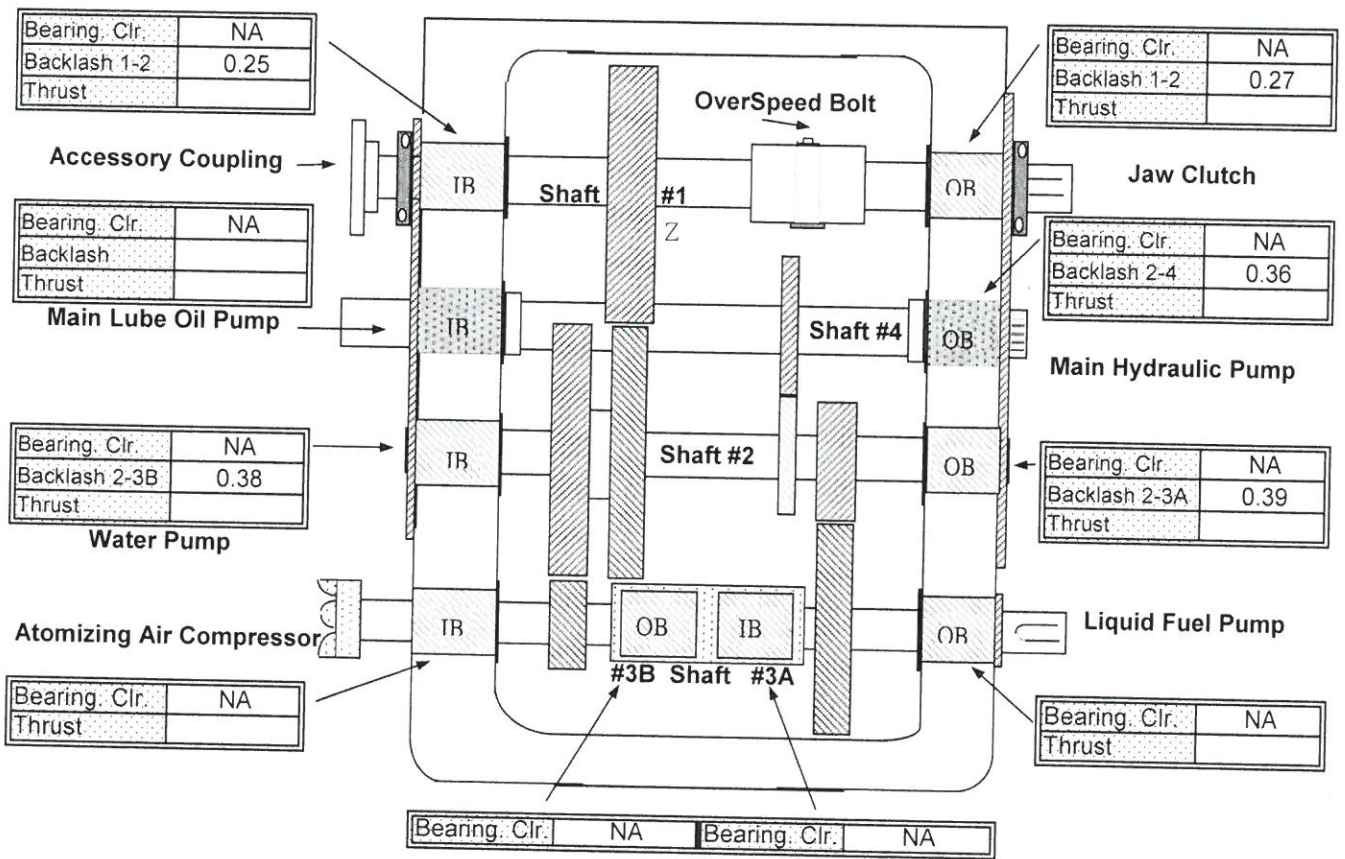
Comments:
 - Backlash is good. spec is 0.13 to 0.40 mm
 - Thrust or Brg clearance could not be obtained

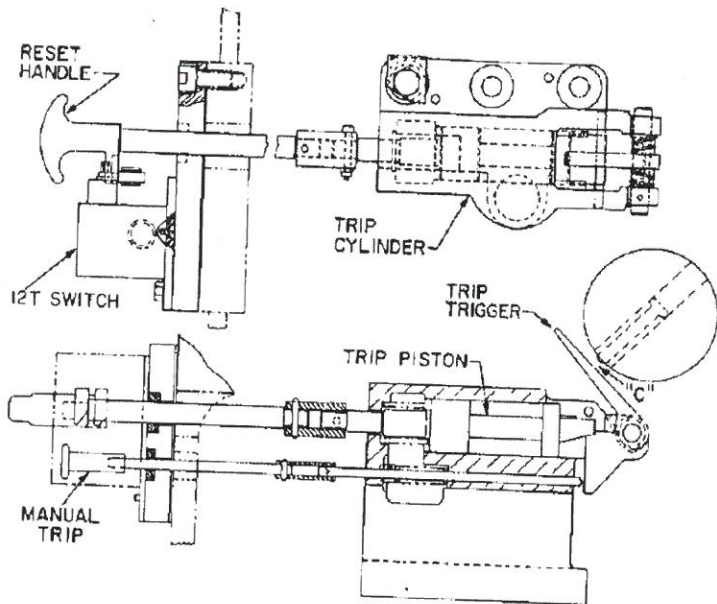
COMMENTS: *- The bolt was in good condition & stacked properly*
- The clearance is high by 0.13mm. No major concern here. APC
