出國報告（出國類別：洽公）

5,000 噸級油品化學品輪(平運輸)建造採購案(A2910T001)，船廠進度追蹤及品質查核

服務機關：台灣中油股份有限公司

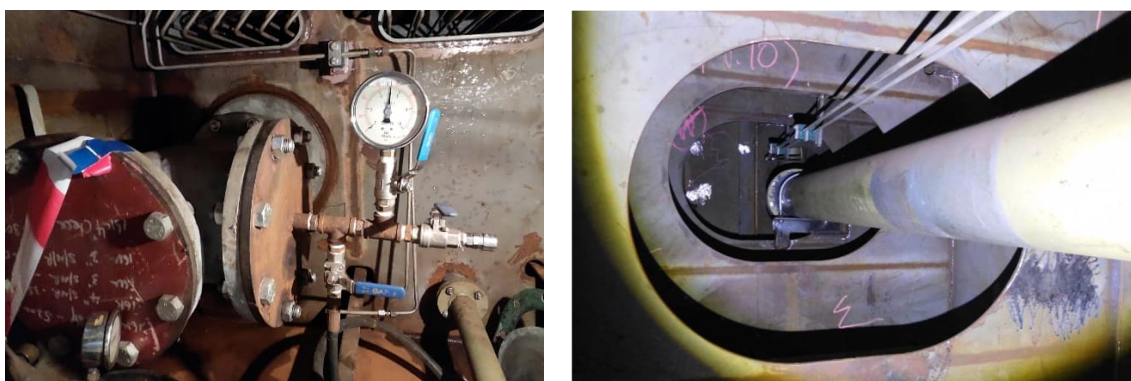
壓艙水管路壓力測試 5 Bar，位於 No. 01(PS)，02(PS)，03(PS)，04(PS)，05(PS)，Void Pump Trunk(PS) & Forepeak Tank，經確認壓力無變化，該測試點壓力表位於 PUMP ROOM，有發現 PUMP ROOM 相當擁擠，管線排列密集，導致

壓艙水泵之底座無法安裝，需要更改管線之佈置，該空間未來之保養空間會有不足之疑慮。

壓艙水管路試壓

- ✓ 壓載泵在泵房的安裝位置需重新排列附近之管線，因為該位置目前管線擁擠致使無法安裝泵浦底座。
- ✓ 主甲板滴水盤內的隔板無排水孔，請船廠改善，並注意安裝時之的管道傾斜度。

9.	CPC concerned about the ballast pump location/installation in the pump room as the location is currently congested by the piping.	ASL will find out a way to install ballast pumps by modifying the pipe routing.

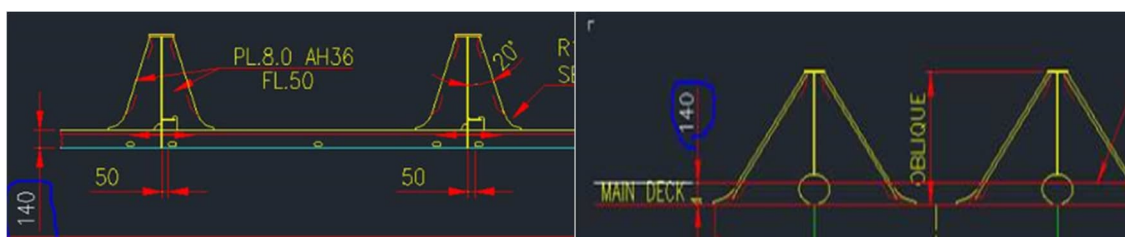
依據規範要求高度為 100 毫米需要塗第一道富鋅底漆，於 3 月份 ASL 訪查後經船廠同意覆蓋設計高度為 140 毫米的高度將 Deck Long. 完全包覆之方式施工噴塗，並應保持與“ T” 型結構及其他甲板配件項目標準相同的從主甲板 140 毫米高度噴 ZINC RICH PRIMER。

船廠同意主甲板施工噴塗範圍ZINC RICH PRIMER

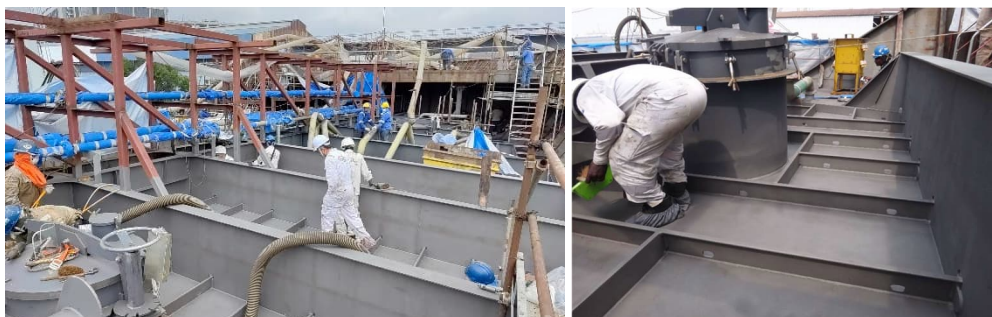
甲板噴砂作業建議應包含 CARGO TANK MANHOLE COVER，船廠應考量施工之順序及方式，避免使用人力已 POWER TOOLING 之方式進行，這部分需由現場監造人員依實際狀況與船廠持續溝通。

甲板噴砂檢查及清潔

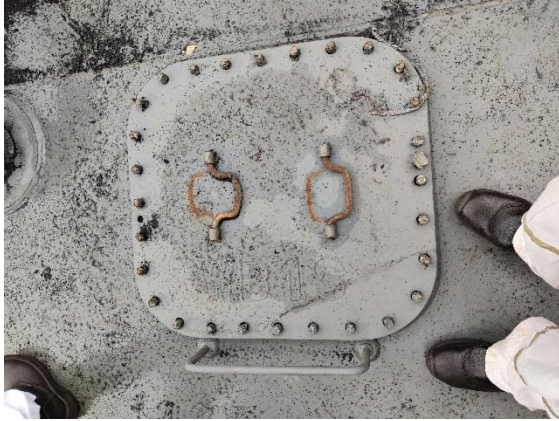
在甲板檢查過程中，發現船廠再噴漆時，艙蓋之手把處，噴漆之人員未能將手把背面一起油漆以及甲板管路油漆被局部破壞之情形，將造成翻工之問題，應多加

甲板艙口蓋把手之油漆瑕疵

由於上述之狀況，因而建議船廠將甲板之 OUTFITTING 集中後，進行噴砂再噴富鋅底漆，以節省施工時間及確保施工品質。

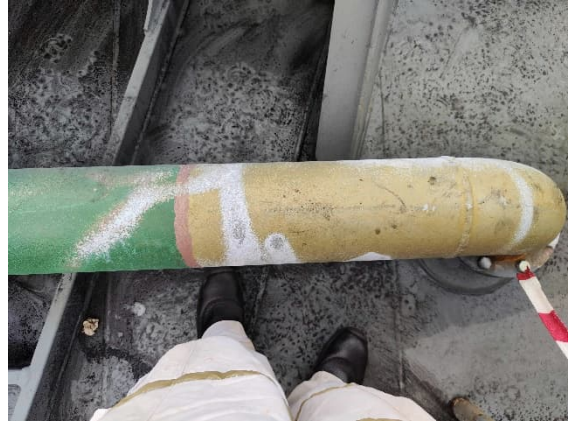
管路油漆局部破壞

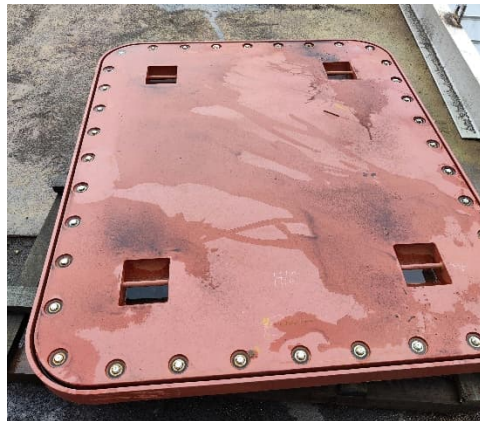
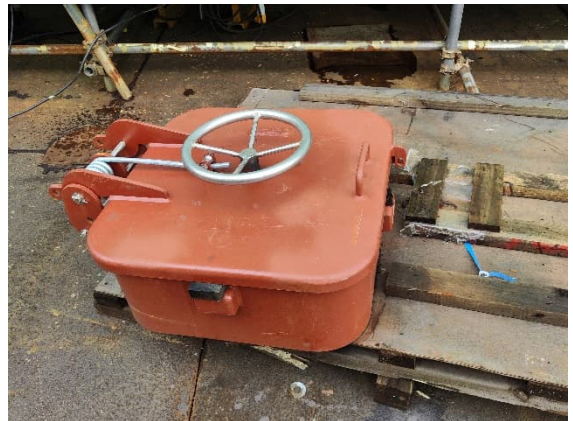
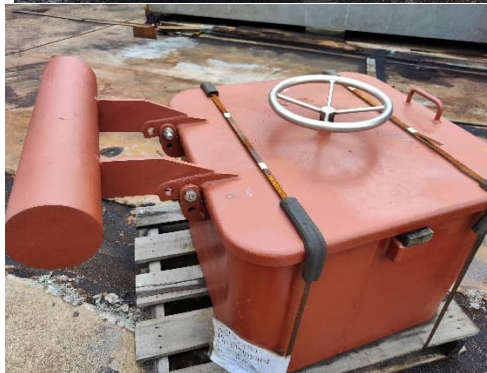
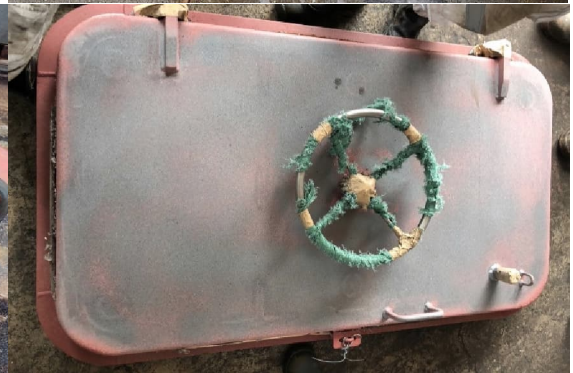
甲板OUTFITTING

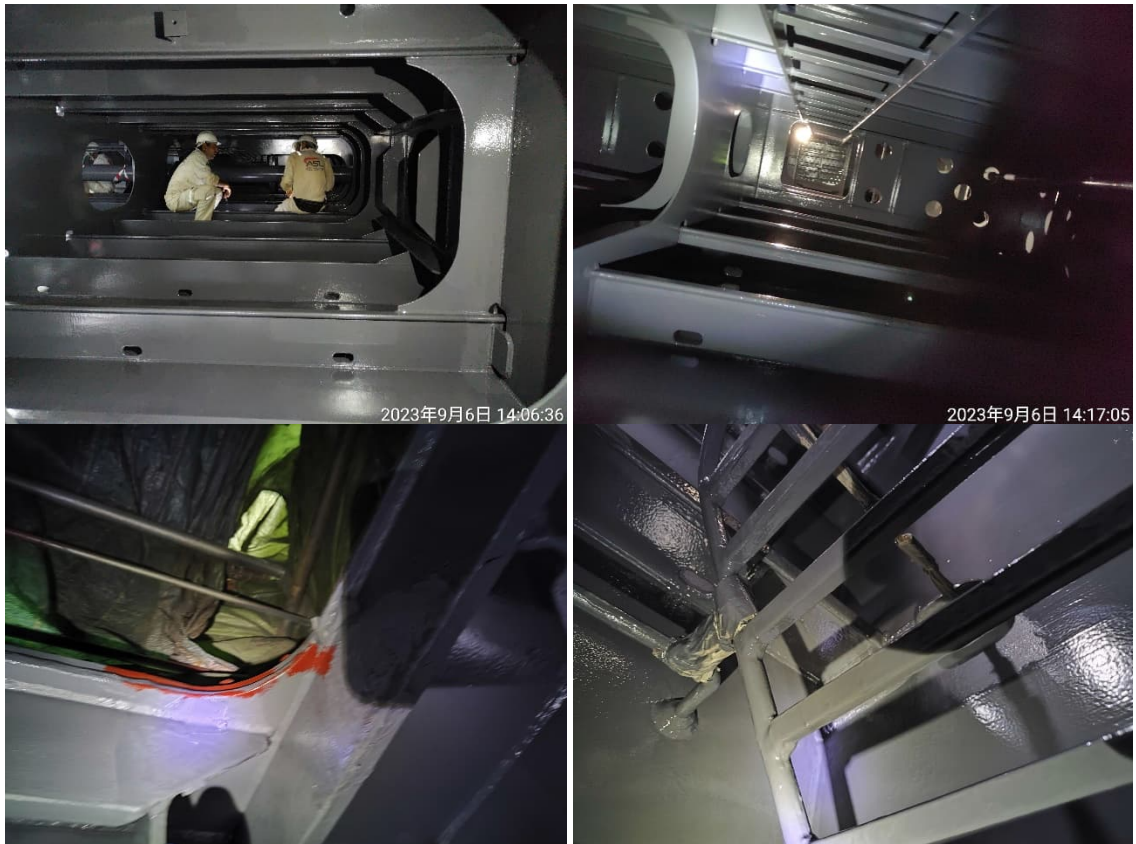
檢查結果發現 No. 5P WBT 之油漆膜厚不是太厚(約 1500u)就是太薄(約 100u)，因而導致須將太厚之膜厚位置磨至約 500u 後再重新補漆，而太薄之位置須補 2-3 次的漆，才能達到 PSPC 之標準，所以建議建議船廠使用被認可之 PAINT MARK PEN 將量測之膜厚寫在量測點上，可以讓補漆人員方便判斷該如何補漆，同時亦

此外由於艙蓋下方之保護措施不夠，造成其邊緣之油漆狀況不良以及開孔處之隔柵板，被固定保護部分之會因翻動而造成塗裝需再補漆，都是忽略的重點，建議應注意天氣之變化及翻動隔柵板進行必要之補漆

WBT No.5 P 油漆檢查

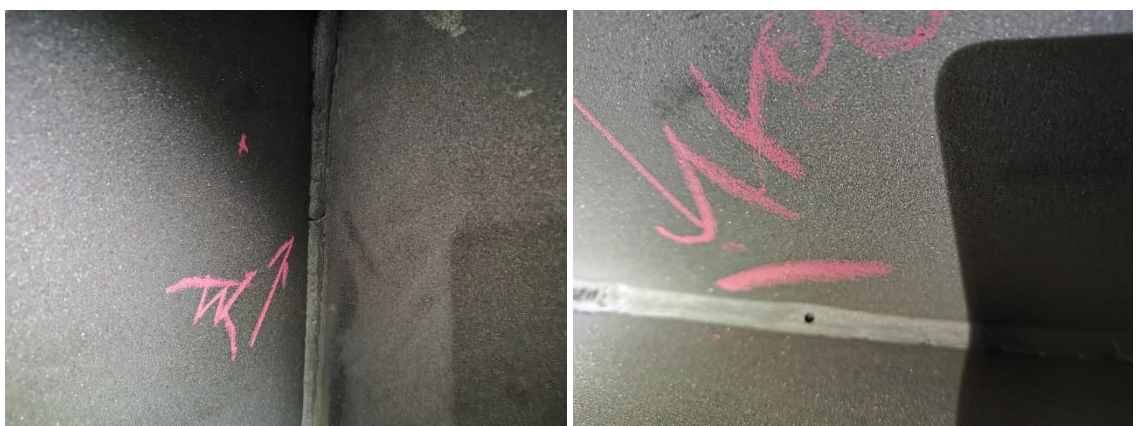
BWT No. 3S 為第 1 次噴砂完成厚之檢查，檢查重點為排水孔及邊邊角角與焊道，檢查重點為確認是否有未打到砂之 SCALE 或是焊道不良與孔洞與不連續之焊縫，要求船廠進行研磨或補焊，在進行完成後，重新檢查過後確認清潔度後才可同意噴第一道水艙油漆，因此噴第一道漆前之檢查相當的重要。

焊道瑕疵

焊道孔洞

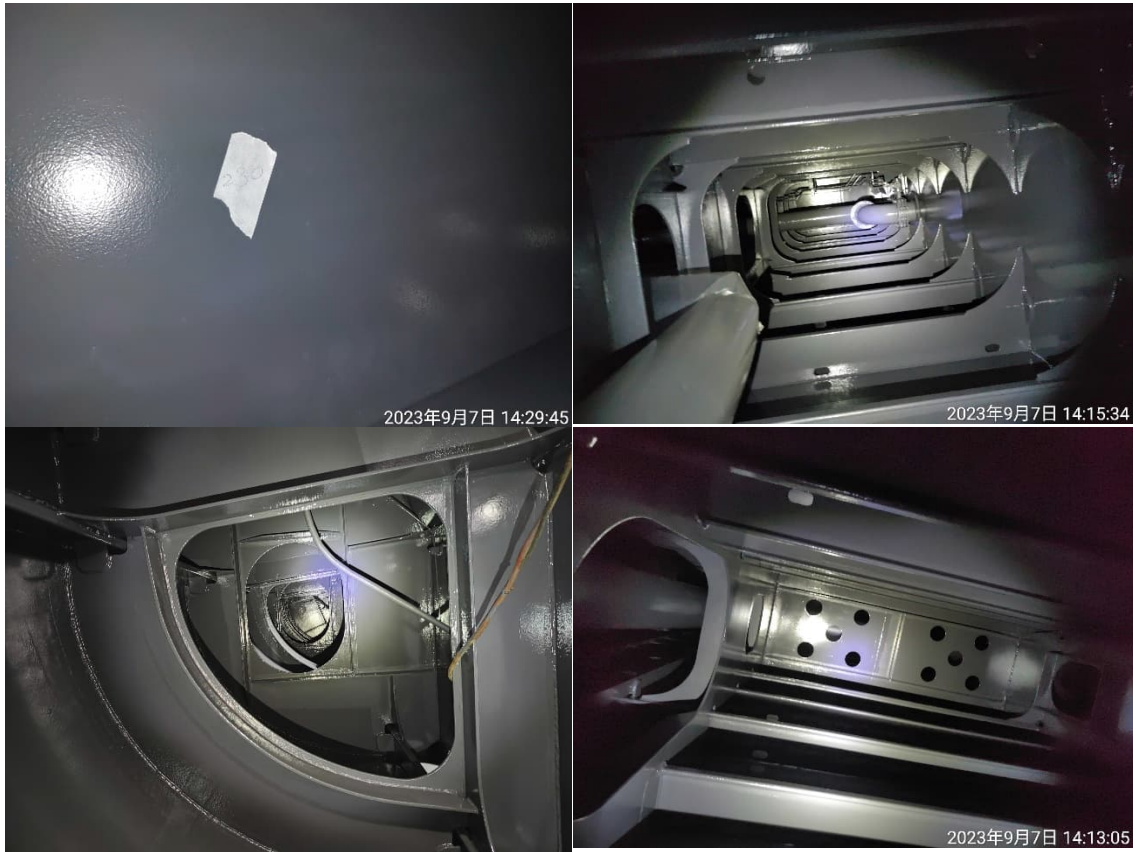
9月7日配合檢查 WBT No. 4S 的第二道 Stripe Coat 檢查，同樣有膜厚太厚或太薄之情況產生，狀況和 No. 5P 差不多。

BWT No.4S 油漆檢查

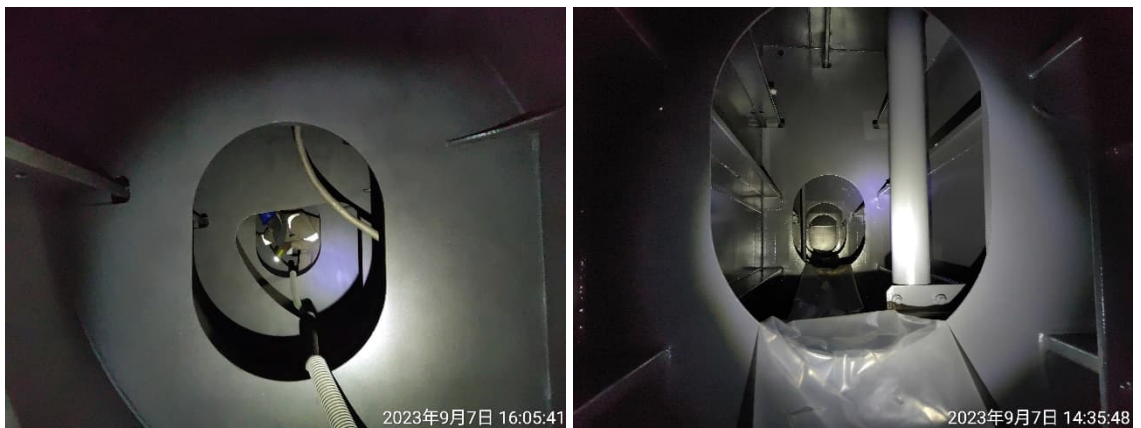
另外檢查 BWT No. 3P 的第二次噴砂後檢查，確認符合標準並在完成清潔後同意噴第一道油漆。

WBT No.3P噴漆前之檢查

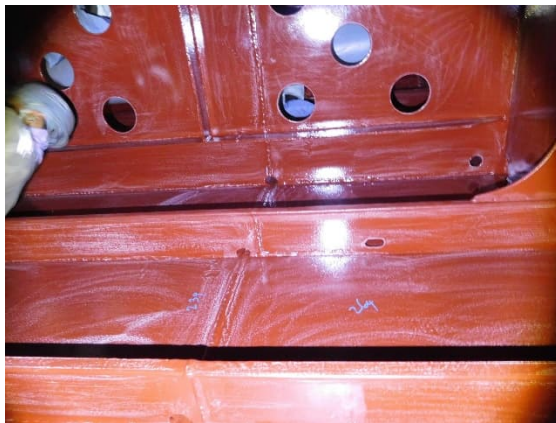
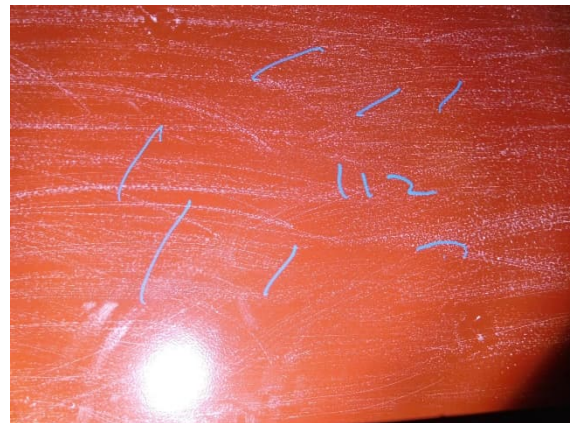
- ✓ 壓水艙噴塗後量測之乾膜厚(DFT)結果不是太厚(約1500u)或太薄(約100u)，為了避免造成膜厚不穩定及重複施工之問題不斷產生，建議船廠使用被認可之PAINT MARK PEN將量測之膜厚寫在量測點上，可以讓補漆人員方便判斷該如何補漆，同時亦有利於讓檢查人員進行抽檢，加速檢查之進行。

壓艙水艙膜厚量測

No.	Minutes	ASL Response
6.	Following a tank painting inspection, CPC required that low and high DFT readings be marked with a paint marker to make it easy for the responsible painter to identify and fix any DFT issues for both ballast and cargo tanks.	According to ASL, the DFT markings made with a marker cannot be removed. According to CPC, it's not a problem if the markings are still visible after final painting. We will try to implement this system.

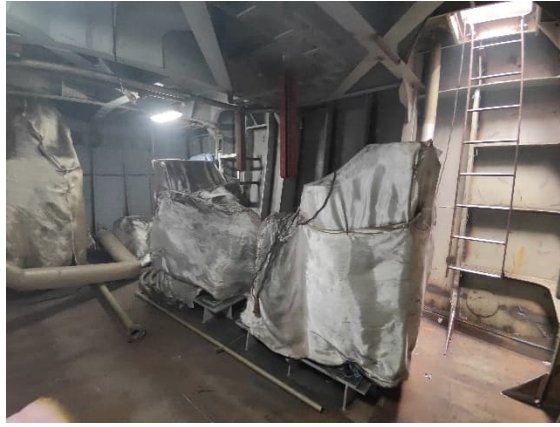
- ✓ IGG Blower 安裝之方向目前彼此相對，導致AIR出口在不同側，將不利於管線之安排，且可能干擾到控制箱之位置，建議將靠內側之鼓風機轉向，以利於後續之空間利用及管線佈置。

IGG BLOWER安裝位置

No.	Minutes	ASL Response
1.	In view of the air flow, CPC requested that the direction of the IG blower be changed from its existing position. The blower motors are currently facing each other.	ASL has agreed to change the orientation.

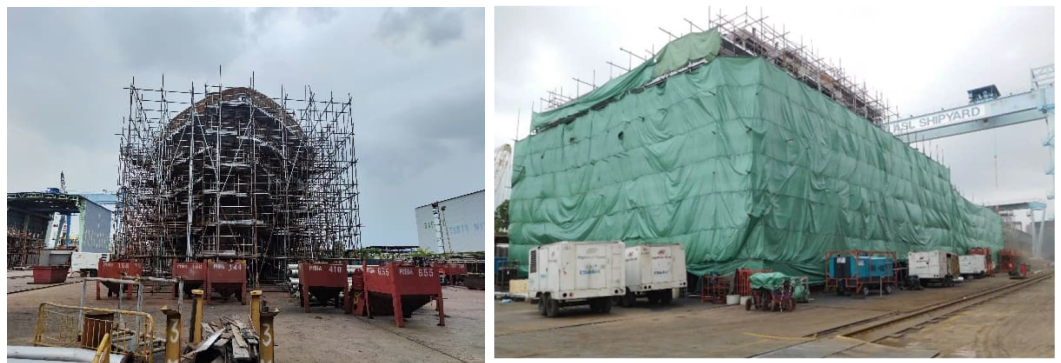
外板噴砂前之保護及搭架

7.	CPC concerned about the main deck and side shell being painted and blasted If it starts to rain and requested to cover with canvas in top in order to reduce re-blasting.	ASL will try to implement this proposal.

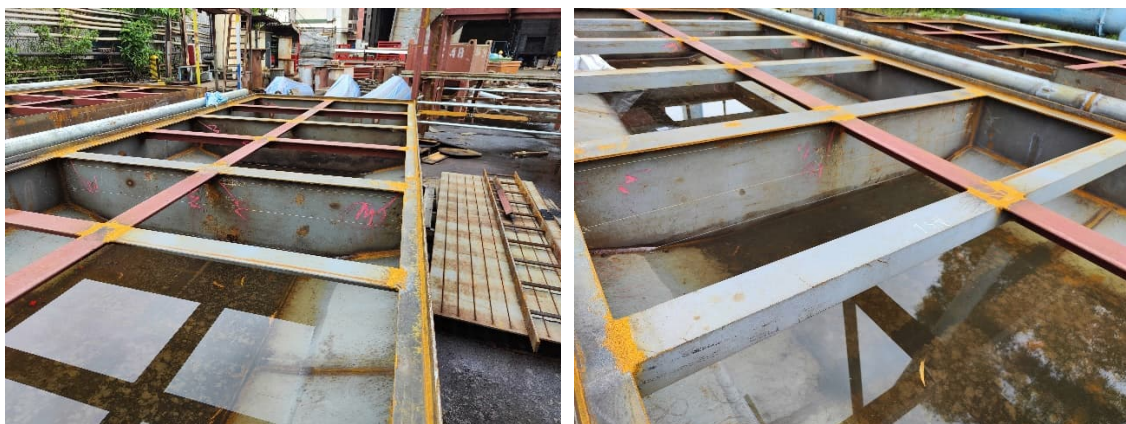
Drip Tray因下雨內部積水無法排出

10.	According to CPC, the piping from the main deck drip trays should be sloped to drain oil into the slope tanks.	ASL will look into it. The revised drip tray arrangement drawing will be submitted in response to SOIC site rep comments and will include the necessary slop for the pipeline.
