出國報告（出國類別：進修、業務接洽）

美國墾務局洽談合作計畫執行及參加大壩
安全等水利技術研習-大壩安全評估國際研
習班 (2019 Safety Evaluation of Existing
Dams (SEED) Seminar)

服務機關：經濟部水利署

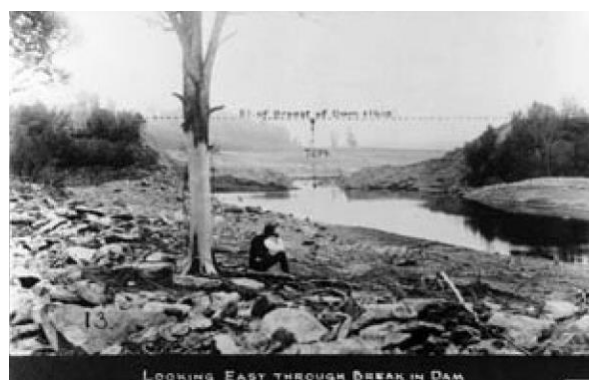
圖 9. South Fork 壩 1889 年損壞(2209 人死亡)。

1. 溢頂破壞: 賓州 South Fork 土石壩，壩高 21 公尺，水庫容量 1520 萬立方公尺，1853 年完工時是當時世界上最大的壩之一，其後又在壩頂建造道路，並再降低壩頂 1 公尺，以拓寬道路為雙向道。1889 年 5 月 30~31 日的暴雨，造成水庫達到滿水位開始洩洪，但漂流木等異物堵塞排洪道，導致洪水溢頂沖刷大壩壩體，潰壩造成 9~12 公尺高的洪水，在 10 分鐘內沖向下游社區，造成 2209 人死亡。

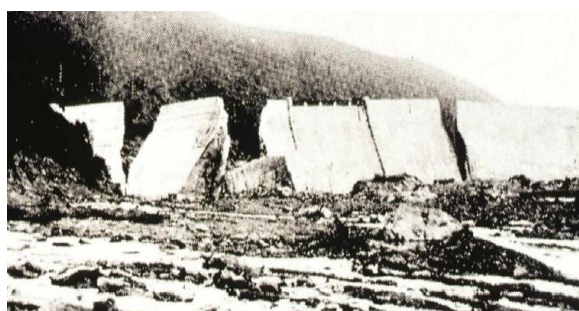
圖 10. Austin 壩 1911 年損壞(甫完工 2 年，80 人死亡)。

- (1)壩基地質條件不佳：Austin (Bayless)壩，位於美國賓州，壩高 15 公尺，1909 年完工，
混凝土重力壩，1911 年因為壩基礎弱面破壞，78 人死亡。(詳圖 22.)
- (2)壩旁邊坡滑動：Vaiont 壩，位於義大利，壩高 26 公尺，1960 年完工，混凝土拱壩，1963
年 10 月 9 日因庫區邊坡超過 2 億 7,000 萬立方公尺土方崩塌，造成湧浪越過大壩，
造成下游 2600 人死亡。(災害前後相片，詳圖 23.)
- (3)液化： Lower San Fernando 壩，位於美國加州，壩高 43 公尺，建於 1912 年，土石壩，
1971 年，壩身因 6.6 級地震產生超額孔隙水壓，造成土壤液化現象而損壞，講師特別
強調，土壤液化目前仍然是一個需要深入研究的課題，特別是對於以水力填築而成的
土石壩。
- (4)地震：臺灣石岡壩，199 年 9 月 21 日 7.6 級地震時部分壩身因斷層錯位而損壞，因屬

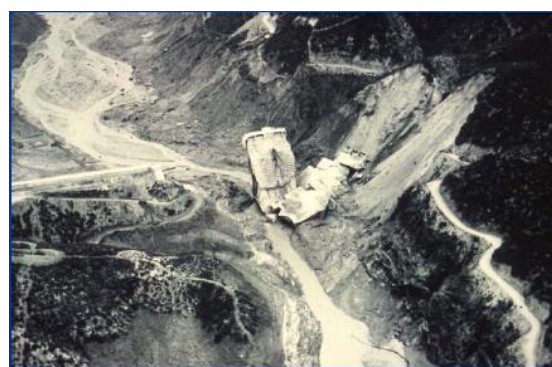
圖 11. St. Francis 壩 1928 年損壞。(450 人死亡)

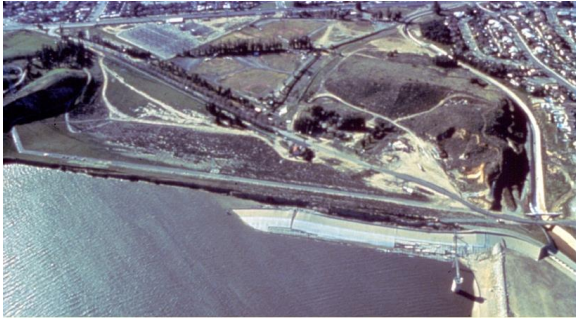
圖 12. Lower San Fernando 壩 1971 年損壞(8 萬人撤離)。

圖 24. Lower San Fernando 壩因地震誘發液化造成損壞

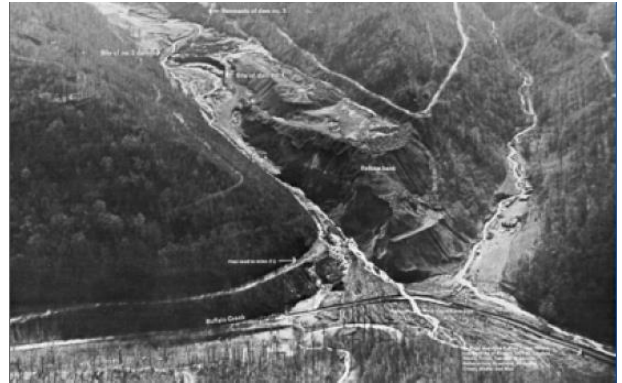
圖 13. Buffalo Creek 壩 1972 年損壞(125 人死亡)。

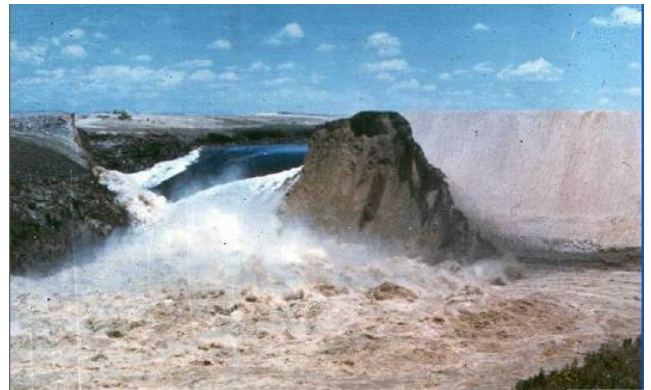
圖 15. Teton Dam 壩 1976 年損壞(11 人死亡)。

- 壩體或壩基滲漏管湧: Teton 土石壩，位於愛達荷州，壩高 93 公尺，1975 年完工，原本預計以每天上升 0.3 公尺的速率蓄水，受暴雨及出水工尚未完工的影響，實際水位蓄升速度達到每天 1.2 公尺，在 1976 年 6 月接近滿水位，6 月 5 日早上 8 點 30 分發現大壩下游側坡趾處滲漏，其後雖然調派挖土機嘗試搶修填補，滲流仍快速增加，3 小時後，約在 11 點 55 分即造成壩頂崩毀，最大流量達到每秒 30,000 立方公尺(CMS)，造成下游 11 人死亡，超過 5 億美元的損失。其失敗的原因除了蓄水速度過快，無法即時阻止管湧惡化外，經檢討亦有灌漿蓋下的滲漏、水壓或不均勻沉陷裂縫引發管湧、岩層節理內滲漏等因素。

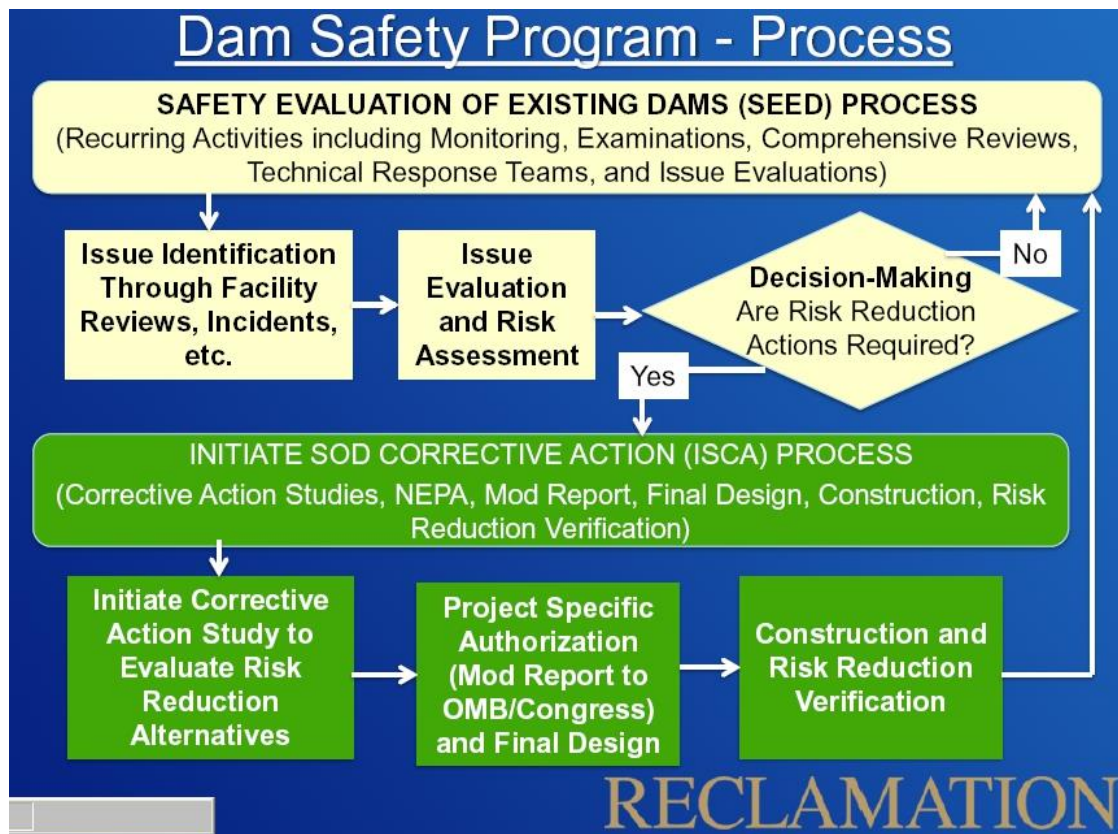
圖 16. 墾務局現有水庫安全評估作業流程。

為符合前述「聯邦大壩安全指南」和「國家大壩安全檢查法」的規定，墾務局已建立了一套基於風險的評估方法，針對現有水庫安全評估作業流程如圖 16，其每 8 年進行一次詳細的綜合評估，以協助優先分配資源。

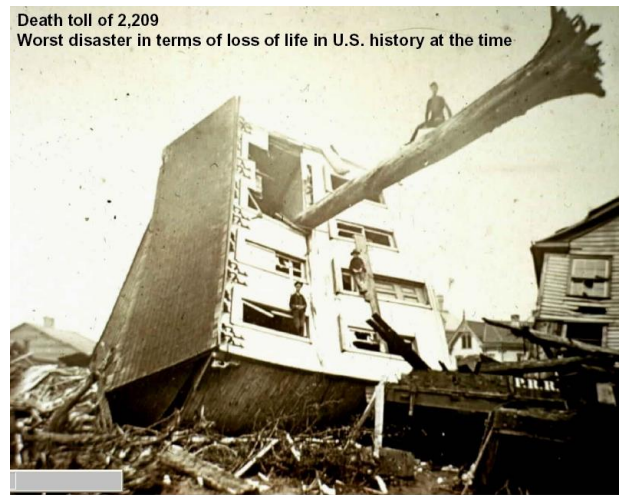
圖 18. 下游受災情形及漂流木。

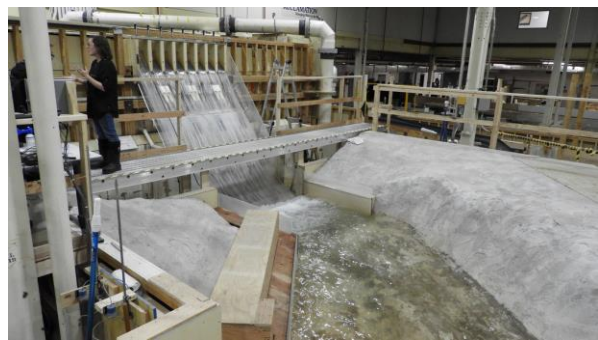
圖 26. Shasta 壩水工模型(比例 1:60)

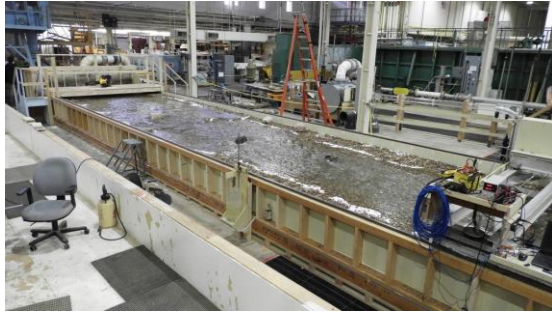
圖 27.全室內水工模型試驗室

- (五) 設施操作與維護(講師 Katherine Dahm)：以『從搖籃到墳墓』(Cradle to grave)的生命全周期概念，計算大壩從規劃、設計、施工、營運、維護和拆除的所有成本，其中操作與維護成本即佔總成本的 80%，遠大於施工成本，說明適當操作維護的重要性。
- (六) 參訪壩務局工程研究實驗室、混凝土圓柱試驗室：該實驗室位於丹佛市壩務局大樓後方，負責許多水工模型試驗，且均位於室內，水工模型製作精細，加上各種材料試驗室完善嚴謹，對於壩務局在工程設計及品質控制上，發揮甚大助益。(現場相片詳圖 25.~圖 28.)

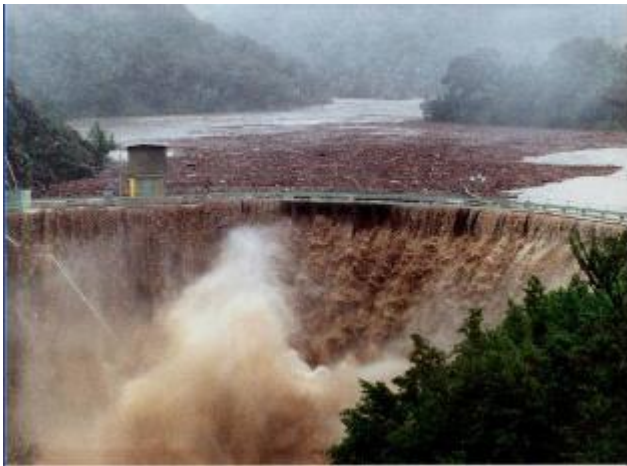
圖 33. San Clemente 壩壩前漂流木

(十二) 漂流木模型(講師 Kent Walker)：講師表示在這方面的歷史案例非常少，但其對水工設施影響甚大(如圖 33.及圖 34.)，希望透過水工模型試驗找出不同水工閘門開度及閘門前水深下，漂流木影響最小的操作方式。經試驗後 $GI=0.36$ 時，排洪較有效率(GI 算法詳如圖 34.)。另外，亦針對喇叭口溢流道進行水工模型試驗。(如圖 35.及圖 36.)

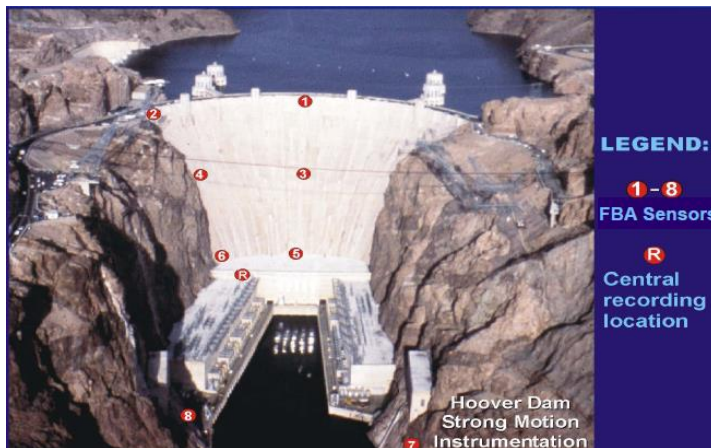
圖 38. Hoover 壩的地震監測佈設

(十六) 大壩地震災害案例(講師 Dan Levish)：地震監測目的有(1)改善緊急應變作為、(2)偵測可能引起破壞的負載、(3)確定應變工作範圍與優先順序、(4)增加通知下游居民時間、(5)管理未來長時間風險與改善依據、(6)提供地震工程師分析數據、(7)驗證結構行為。在強震監測上需同時兼顧量測與即時傳輸。(Hoover 壩的監測佈設如圖 38.)

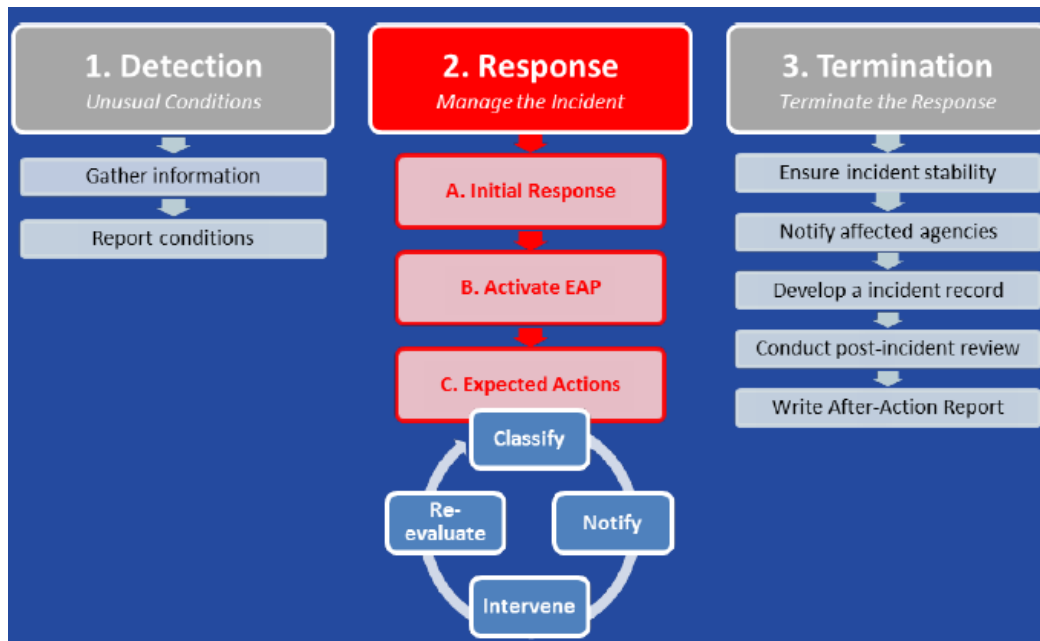
圖 40.緊急應變計畫流程

(十八) 緊急應變計畫與演練(講師 Ben Claggett)：緊急應變計畫(Emergency Action Plan, EAP)是以書面文件包含大壩所有的應變程序，以便快速反應及通知。採取的步驟有(1)識別風險，了解可能出現的問題、(2)制定書面計畫，知道該怎麼做、(3)培訓人員，建立應變能力、(4)進行演練習，以測試人員反應、計畫內容，並找出缺點、(5)改進計畫內容，再進行培訓和持續改進。(EAP 流程如圖 40.) 應變層級分為四級：(1)級別 1: 無生命威脅的情況、(2)級別 2: 潛在生命威脅、(3)級別 3: 危及生命的緊急情況，此時需立即採取拯救人命的行動，(4)級別 4: 危及生命的緊急情況，潰壩，應變人員必須立即離開危險區域。

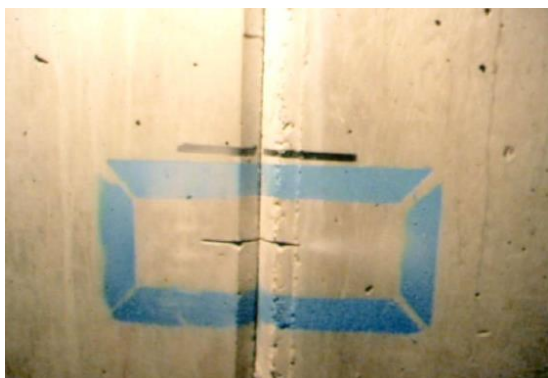
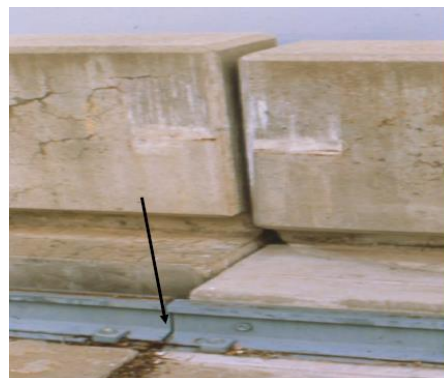
圖 41.裂縫檢查標記。

(廿一) 混凝土壩檢查方式(講師 Jaron Hasenbalg)：先說明混凝土壩有重力壩、拱壩、扶壁式、綜合等四種形式，再介紹混凝土的各種問題、影響混凝土壩強度與耐久性的因素，最後指導檢查項目與哪些地方需要檢查。檢查地點與其項目有:基礎與墩座(檢查開裂、錯位、沉陷、細粒料隨滲漏移動等)、壩身上下游兩面(檢查裂縫、風化、剝落、水平裂縫或施工縫造成的滲漏)、廊道(檢查裂縫、位移、排水堵塞、接面或裂縫的滲漏、滲漏量變化等)、壩頂(檢查裂縫是否隨機且淺？是否很深？是否延伸到上下游表面、接縫處的垂直差異移動、橫向差異變位，最好能沿著護欄或扶手等觀察)。

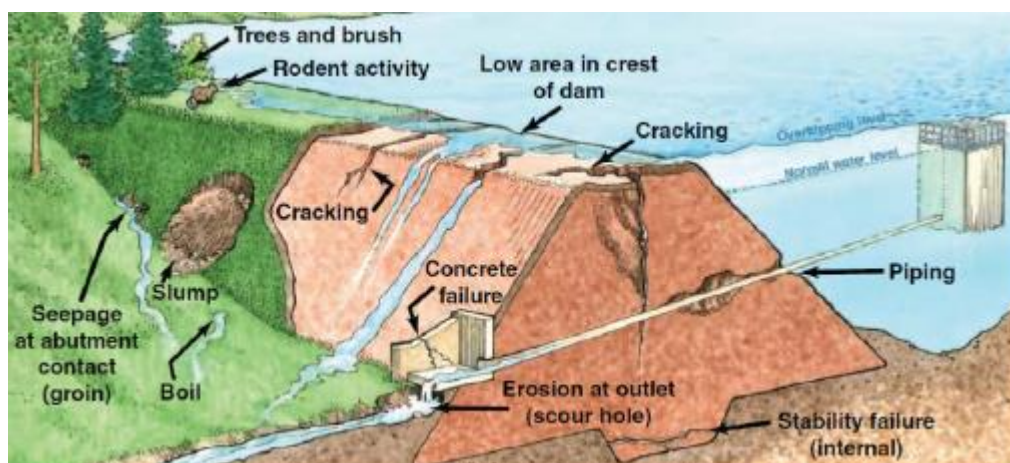
圖 43.土石壩各種破壞因素

(廿二) 土石壩檢查方式(講師 Paul Craig): 檢查應採系統化(一直線或梯形方式前進)查看所土石壩表面和周邊區域，並從各種破壞因素(如圖 43)說明對應檢查方式。例如: 滲漏可藉由目視壩身植生狀況初步判斷(如圖 44.)，檢視管壁、翼牆周圍等不同材質接合面。

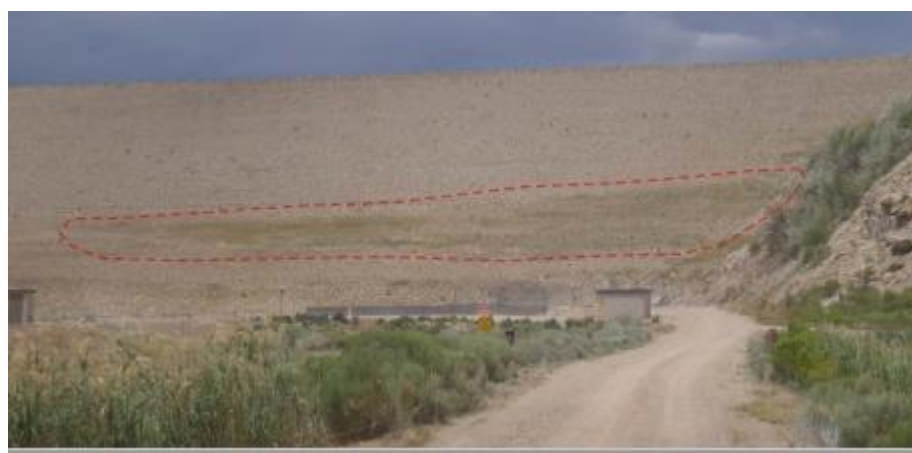
圖 44.壩身植生較多範圍可能是滲漏區

在土石壩檢查教學時，壩務局人員介紹目視檢查方法與要領，該局建議除了壩身不宜有喬木外，在距離壩址 25 英尺(約 7.6 公尺)範圍內亦不要種植喬木，另外也可從壩身坡面變化、植生變化等推測該範圍可能能滲漏情形，以縮小範圍進一步做較詳細的檢測。(現場相片詳圖 49.~圖 56.)

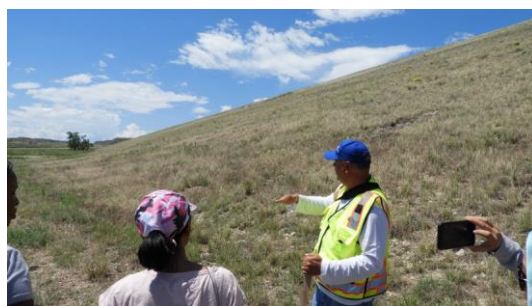
圖 50. 土石壩檢查教學

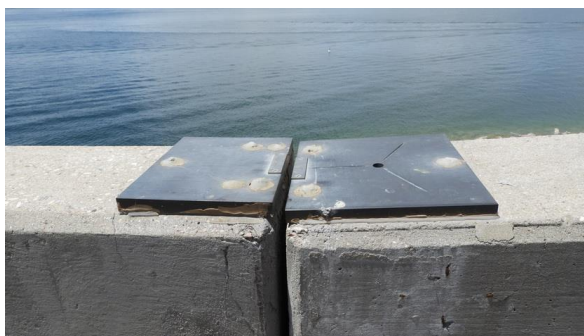
圖 51.混凝土壩護欄變位觀測

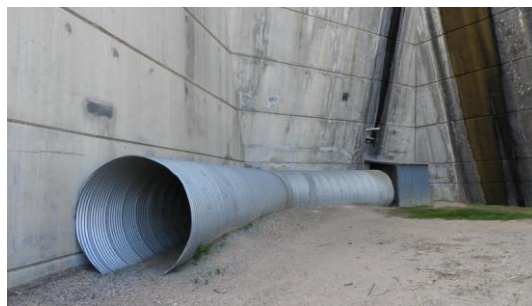
圖 52.檢查廊道入口(鐵皮為防止冬季時壩上方冰柱掉落傷人，廊道內禁止拍照)

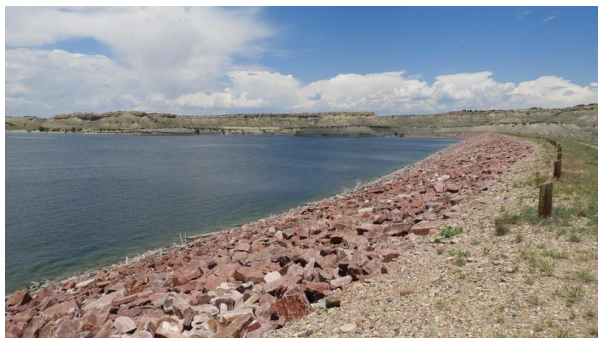
圖 53.土石壩上游面

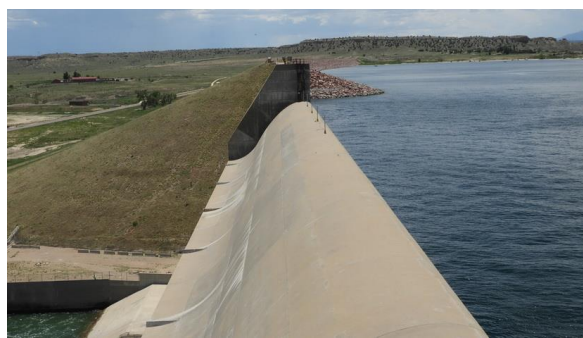
圖 54.壩頂自由溢流道

阿肯色河上，主要功能為灌溉、民生用水和休憩活動等多功能，長達 3 公里的壩身主要是土石壩，溢洪道部分則為混凝土壩，採自然溢流方式排洪，設計最大溢流量為 5,422 CMS (立方公尺/秒)，當日參訪分為三組同時進行(土石壩檢查、混凝土壩檢查、廊道檢查)，再以換組方式讓所有學員均能充分學習。同時亦發給學員土石壩及混凝土壩的檢查表，由壩務局人員依據檢查表重點，實地解說檢查要領。

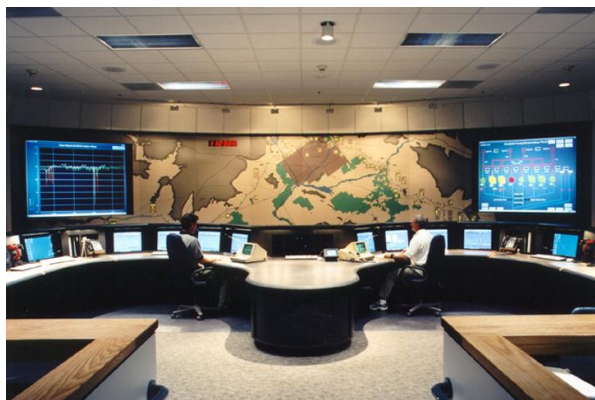
圖 59.CAP 操作中心(擷自網路，參訪禁止拍照)

室內的操作中心遠端控制(如圖 59.，因參訪時禁止拍照，故擷自網路，)，而全線 13 個全天候運作的巨大抽水加壓站，更使得 CAP 每年使用 28 億千瓦時的電力，成為亞利桑那州成為最大的電力消費者。

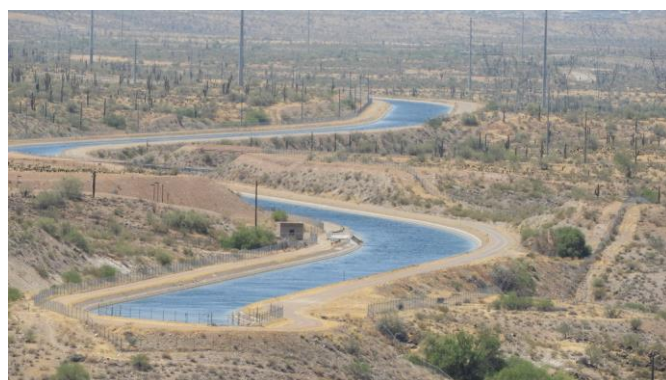
圖 60. CAP 輸水渠道

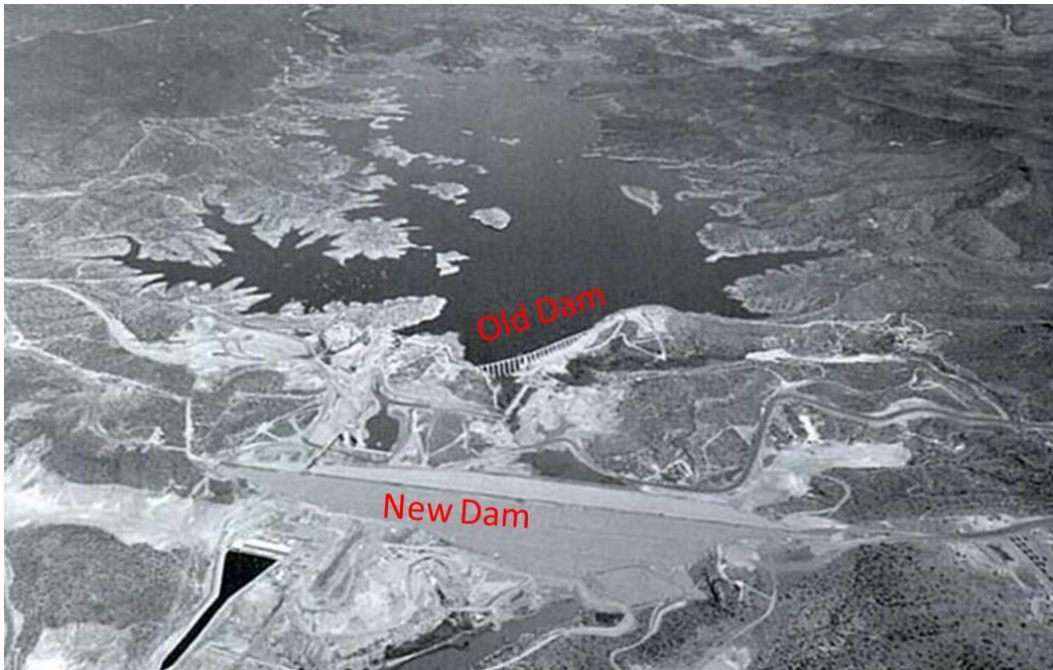
圖 61.新、舊 Waddell 壩(擷自網路)

本次參訪時墾務局人員特別介紹水庫排放到下游 Waddell 運河(如圖 62.)，透過運河兩端不同水位高程的控制，可以雙向流動決定給水或引水，給水是提供下游運河水量，引水則是提供水力電廠發電使用。

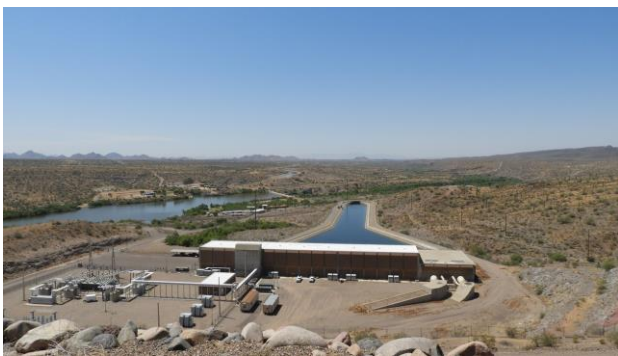
圖 62. Waddell 壩下游運河

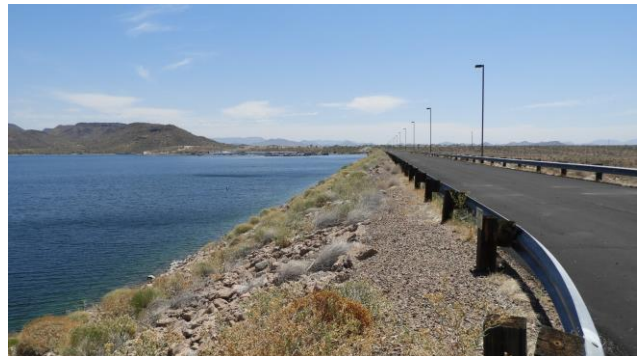
圖 63. Waddell 壩壩頂

(三) 參訪新 **Waddell 壩**：土石壩，壩高 134 公尺，壩長：1,493 公尺，溢洪道設計流量：5,295 立方公尺/秒，庫容量約 13.7 億立方公尺。建於 1985 年至 1994 年之間，為上述 CAP 項目之一，建造目的是為了滿足不斷增加的用水需求，故在舊 Waddell 壩（1927 年建）下游約 800 公尺處增建新壩而成，庫容量也從舊壩的 1.85 億立方公尺，增加到目前的 12.3 億立方公尺，舊壩目前已淹沒在庫區中。(新舊壩如圖 61.)該壩位於 Agua Fria 上，除攔蓄該河流量外，也儲蓄科羅拉多河經由 CAP 系統泵送而來的

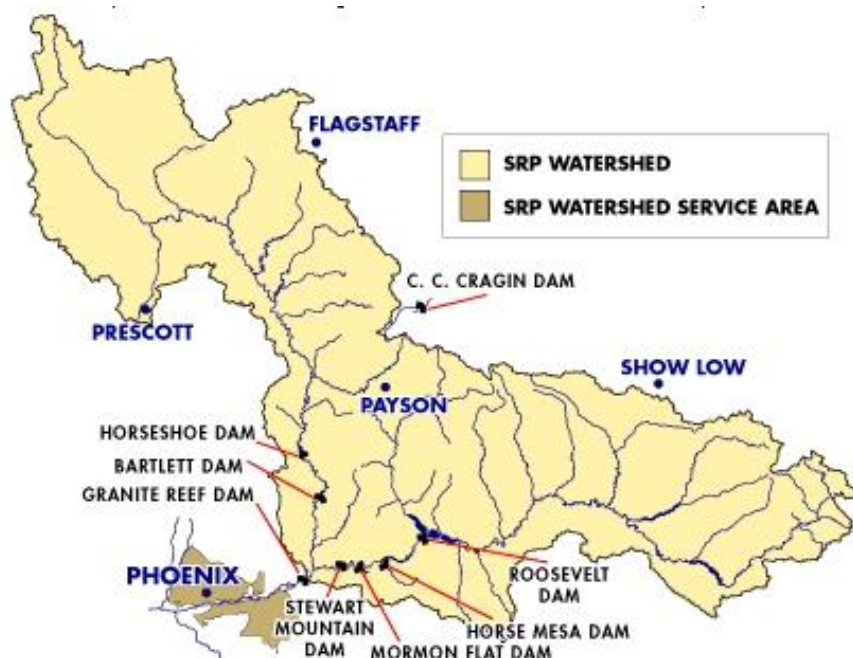
圖 64.鹽河計畫位置圖

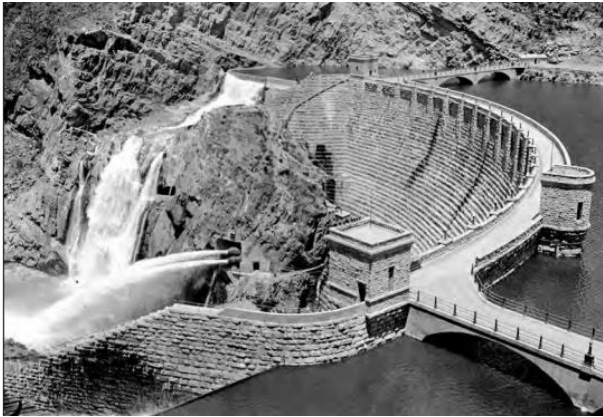
圖 67. 舊 Roosevelt 壩

(五) 參訪 Roosevelt 壩：混凝土壩，壩高 109 公尺，壩長 369 公尺，洩洪道設計容量 4200 立方公尺/秒，庫容量約 20.4 億立方公尺。Roosevelt 壩是 SRP 的關鍵項目，舊壩壩高 85 公尺，在 1911 年完工時，是世界上最高的磚石壩(如圖 67.)。因 SRP 係由美國 Roosevelt 總統致力促成，故以 Roosevelt 為大壩和水庫命名。1996 年，為提高水庫容量在舊壩下游側重新鋪設混凝土，將壩高增加 23 公尺(77 英尺)，使庫容量增加 20% 以上，並提供防洪空間。然而，在完工後不久，該地區進入了長時間的乾旱期，一直到 2005

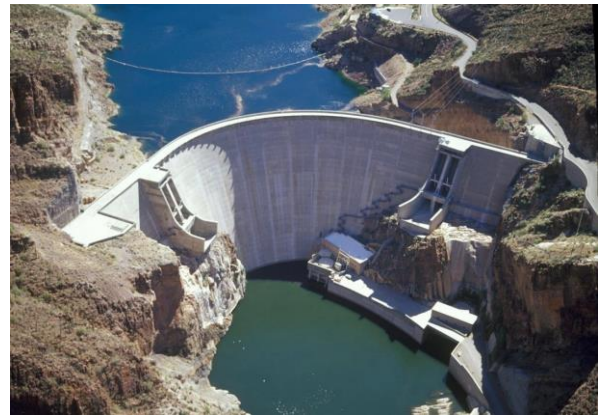
圖 68. Roosevelt 壩現況

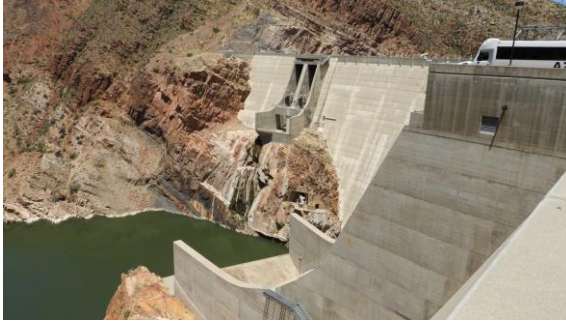
圖 73. 對稱式兩座排洪口

參訪時墾務局將學員分為兩組，進入壩區前先進行安全宣導及危害因子告知，學員均需佩戴安全帽、護目鏡及耳塞，以保護學員安全。參訪過程除介紹上述新舊壩建造過程外，亦說明相關水工設施改善措施；Roosevelt 壩的排洪設施，為左右兩側同時洩洪，藉由兩股水流互相撞擊而達到消能的目的，是墾務局唯一如此設計的方案。而新舊壩的檢查廊道亦可互相通聯。該壩亦設有一座豎軸式發電機。

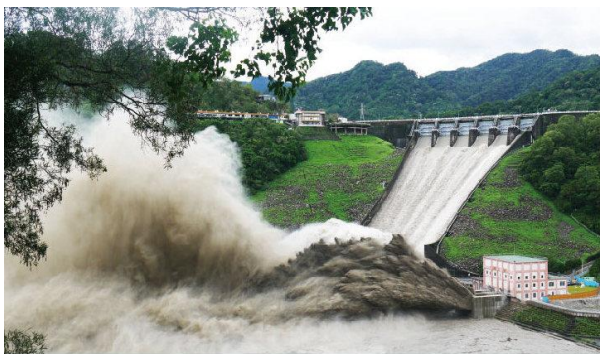
圖 82.石門水庫電廠防淤

如上述，美國大壩天然條件明顯較臺灣優良，臺灣水庫長年在面臨乾旱、強降雨、地震、淤積等問題挑戰下，對於水庫操作、管理、清淤、水力排砂等工作，已逐漸發展獨特與領先技術。例如石門水庫的分層取水工、電廠防淤、阿姆坪排淤隧道等，持續增加水力排砂設施容量，促使水庫能永續利用(如圖 82、圖 83)。也因此，臺灣於 108 年 9 月與墾務局、國合會首次共同開辦「2019 年水資源管理研習班-永續水庫(2019

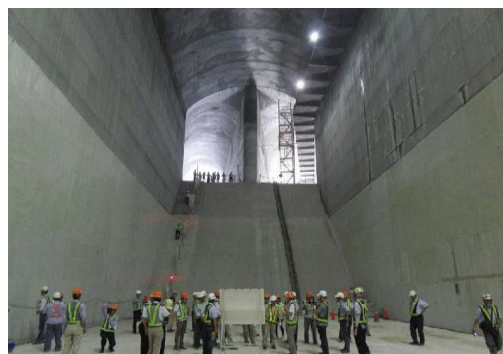
圖 83.曾文水庫防淤隧道

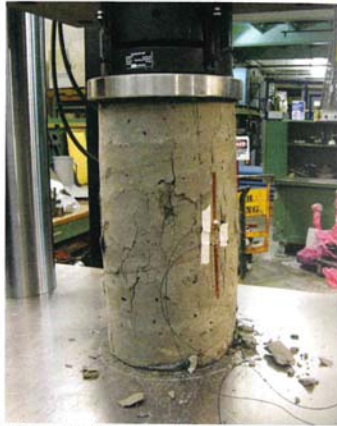
Concrete testing at Denver Engineering and Research Laboratory facilities, Lakewood, CO.

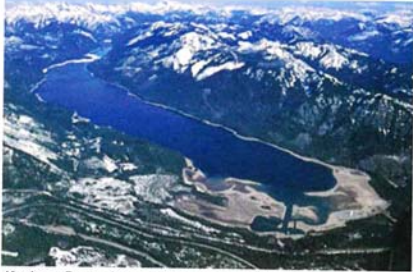
Kachess Dam - Construction was completed in 1912. It is a zoned earthfill dam with a height of 115 feet (35 meters) with a crest length of 1,400 feet (426.7 meters). Seepage issues are being monitored. Simulated dam safety exam will be conducted.

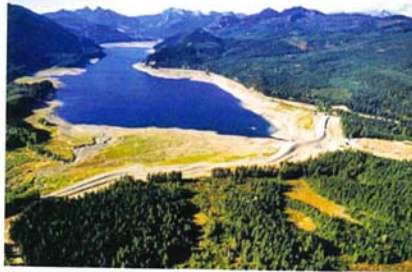
Keechelus Dam - Construction was completed on 1917. It is a zoned earthfill dam with a height of 128 feet (39 meters) with a crest length of 6,550 feet (1,996.4 meters). Modifications are planned to address internal erosion caused by seepage.

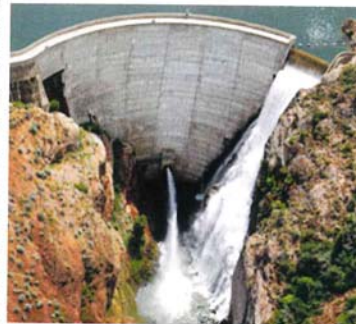
East Canyon Dam - Construction was completed in 1966. It is a double-curvature, thin-arch concrete dam with a height of 260 feet (79 meters) with a crest length of 440 feet (134 meters). Operation is integrated with overall Weber Basin project water requirements for irrigation, municipal and industrial power, and flood control.

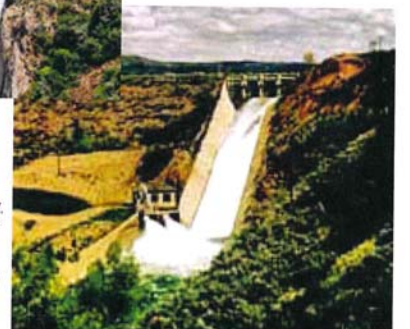
Echo Dam - Construction completed in 1931. It is a zoned earthfill dam with a height of 158 feet (48 meters) with a crest length of 1,887 feet (575 meters). A powerplant was installed in 1987. The primary purpose of the dam is water conservation, however, it is also used for recreation purposes. Water from the Echo reservoir is released into the Weber River and is diverted into 41 privately built canals and laterals leading to the irrigable land.

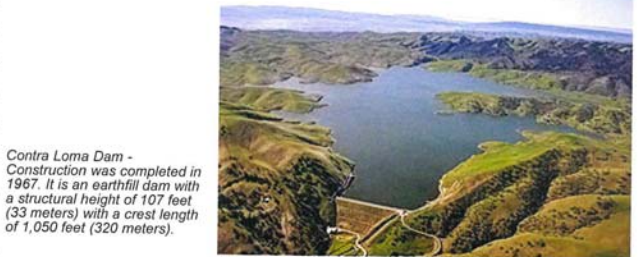
Contra Loma Dam - Construction was completed in 1967. It is an earthfill dam with a structural height of 107 feet (33 meters) with a crest length of 1,050 feet (320 meters).

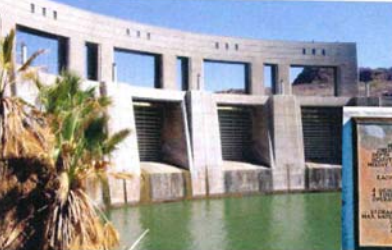
Parker Dam - a concrete arch dam with a structural height of 97 meters. Only 28 meters of the dam's structure is visible since 73 percent of the dam's structural height is below the original riverbed.

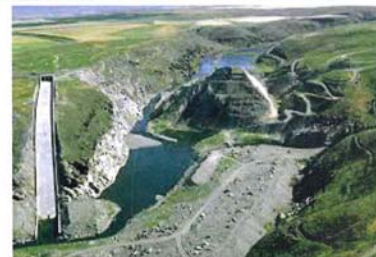
Teton Dam near Rexburg, Idaho.

A presentation was given on the Teton Dam failure in 1976 and Reclamation's geomorphology and river hydraulics study during 1997-2000. Participants traveled to the Teton Dam site near Rexburg, Idaho to visit the Upper/Lower Mesa Falls.

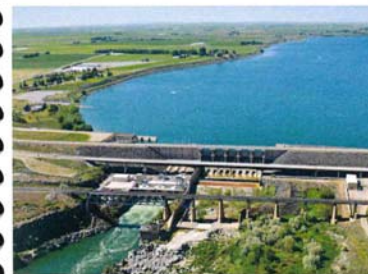
American Falls Dam, Idaho.

The study tour continued with travel to American Falls Dam where participants walked through an abbreviated exam.

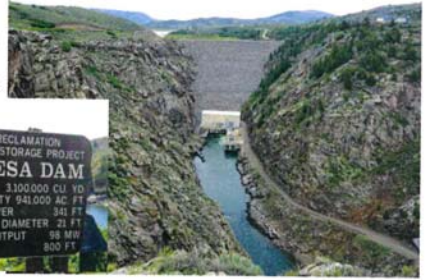
Blue Mesa Dam is on the Gunnison river about 30 miles below Gunnison, and 1.5 miles below Sapinero, Colorado. The zoned earthfill embankment has a structural height of 390 feet, a crest length of 785 feet, and a volume of 3,080,000 cubic yards of materials.

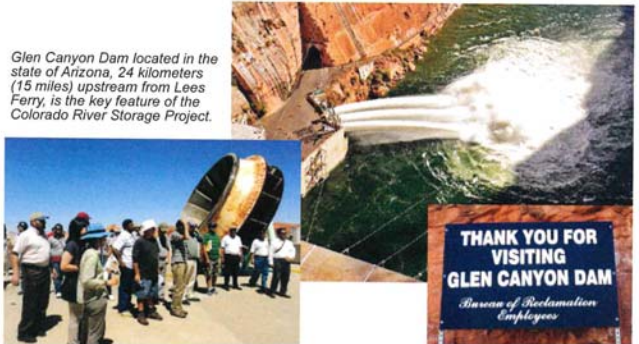
Glen Canyon Dam located in the state of Arizona, 24 kilometers (15 miles) upstream from Lees Ferry, is the key feature of the Colorado River Storage Project.

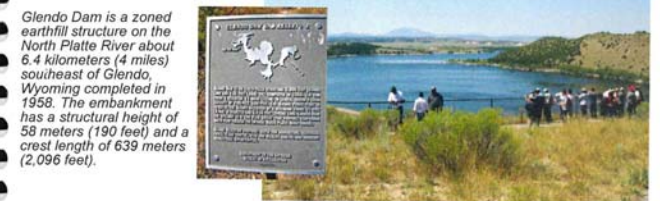
Glendo Dam is a zoned earthfill structure on the North Platte River about 6.4 kilometers (4 miles) southeast of Glendo, Wyoming completed in 1958. The embankment has a structural height of 58 meters (190 feet) and a crest length of 639 meters (2,096 feet).

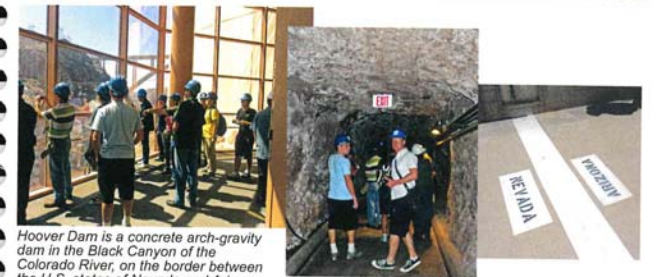
Hoover Dam is a concrete arch-gravity dam in the Black Canyon of the Colorado River, on the border between the U.S. states of Nevada and Arizona.

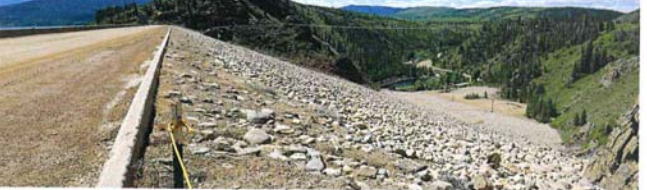
Granby Dam - Granby Dam is located on the Colorado River about 9.6 kilometers (6 miles) northeast of Granby, Colorado. It collects and stores most of the project water supply, including the flow of the Colorado River and water pumped from Willow Creek. There are 3,877 meters (12,722 feet) of auxiliary dikes. The reservoir has a capacity of 666 million cubic meters (539,800 acre-feet).

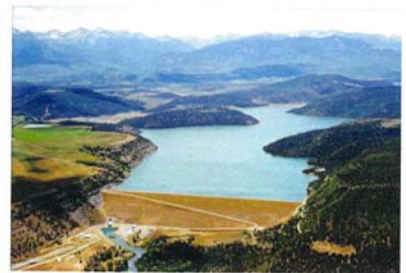
Ridgeway Dam - Ridgeway Dam of the Dallas Creek Project, a rolled-earthfill dam was constructed on the Uncompahgre River in 1987.

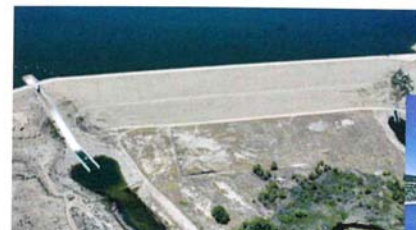
Starvation Dam is a zoned earthfill dam located three miles northwest of Duchesne, Utah on the Strawberry River.

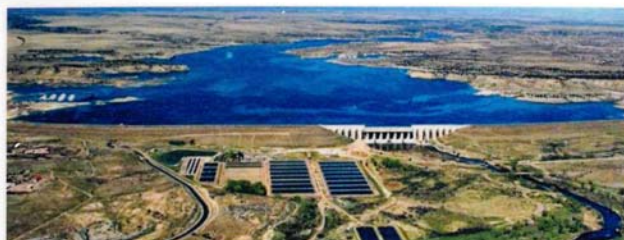
Pueblo Dam - located on the Arkansas River in Pueblo County about 6 miles upstream and west of the city of Pueblo, Colorado.

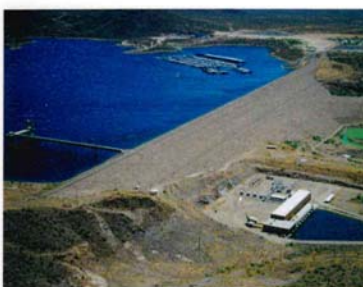
New Waddell Dam - constructed between 1985 and 1994, stores Colorado River water for the Central Arizona Project, and also stores Agua Fria River runoff and provides flood protection by controlling river flows. The dam is on the Agua Fria River about 35 miles above the Gila River confluence and is located one-half mile downstream of the now submerged historic Waddell Dam.
