A Story
Narrated in Stacked Stone:
The Achievements of Our Ancestors

Sediment Control

on the Dodo River

Japanese Sediment Control in the Preserving

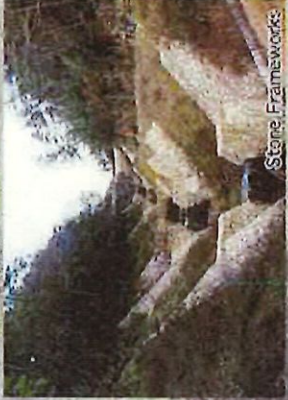
Stone Frameworks

Tobiasako and Uchihiro check dams are built on tributaries of the Dodo River. Portions of them had collapsed but were rebuilt to match the stonework seen in remaining parts of the dams. New stone frameworks were constructed as seen above.

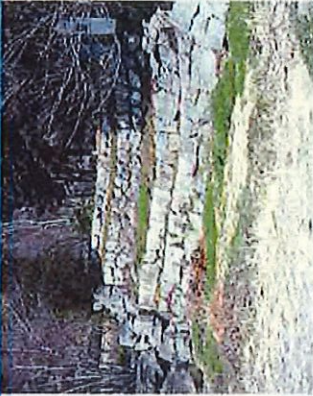
Dodo River Check Dam No.1

Registration No.34-0075

Size : 3.2m tall, 9.6m wide
 Structure : Block-stone Embankment
 Method of Construction : Layered Stone
 Year of Construction : Before 1773 (est.)

This dam is believed to be the first dam built to protect houses and rice fields from sediment disaster. What we see today is a portion of the original check dam repeatedly expanded. According to ancient village "Locality Specification" records found in Shimogoryo Village, it used to be a large-scale check dam extending approximately 20 meters.

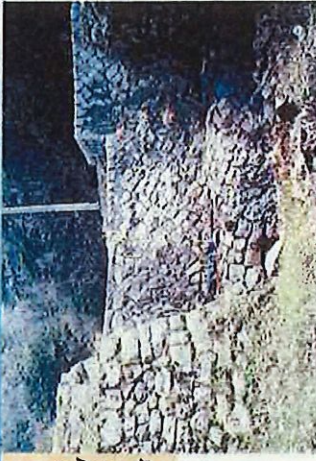
Dodo River Check Dam No.2

Registration No.34-0076

Size : 3.9m tall, 25.8m wide
 Structure : Stone Wall Embankment
 Method of Construction : Right bank - Irregular Stacked Masonry
 Left bank/spillway-Unoursed Masonry
 Year of Construction : Dam was constructed between 1700 and the 1860's (est.)
 Spillway and left bank was rebuilt after 1868.

This dam is believed to have been constructed in the late Edo Period (between 1700's and 1860's). However, the uncoursed masonry of the spillway was added from 1912 to 1915. The direct connection to a spillway and the installation of an erosion-preventing apron at the base are special characteristics of Check Dam No. 2.

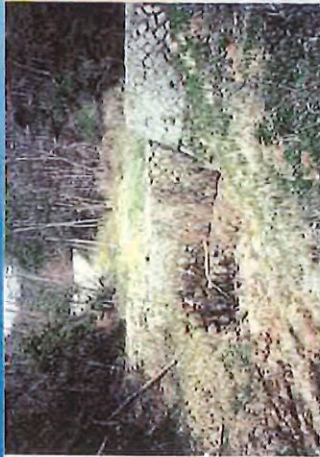
Dodo River Check Dam No.4

Registration No.34-0078

Size : 3.3m tall, 31.5m wide
 Structure : Stone Wall Embankment
 Method of Construction : Right bank - Coursed, Layered Stone
 Left bank/Spillway - Uncoursed Masonry
 Year of Construction : Between 1700's and 1860's (est)
 Reconstruction conducted after: 1868.

Although Dam No.4 is believed to have been constructed in the late Edo Period (between 1700's and 1860's), recorded proof has yet to be discovered. Like Check Dam No. 2, it is directly connected to a spillway with an apron at the base.

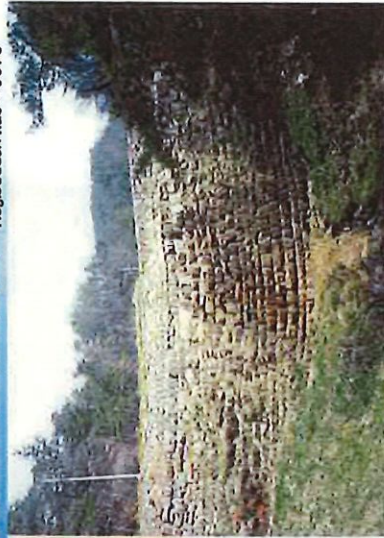
Dodo River Check Dam No.5

Registration No.34-0079

Size : 8.8m tall, 31.4m wide
 Structure : Blocked-stone Embankment /Reinforcing Stone Retaining Wall
 Method of Construction : Semi-layered Stone
 Year of Construction : Between 1832-1835 (est)
 Top layer was expanded after 1926.

Although no records are available to determine the precise year of construction, the method and shape of the stonework seems to indicate that the No.5 check dam was constructed following the No.3 dam. Strong structural similarity is thought to exist between the No.5 and No.3 dams. Although initially the structure extended to the edge of the mountain, a portion of it was destroyed due to the road work, leading to its current form.

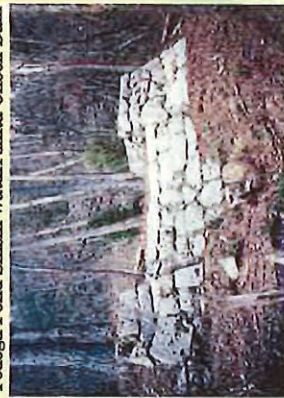
Photos Taken in October 1994

Check dams built by the Fukuyama Domain can still be found in Fukuyama City today. Repeatedly heightened and expanded, many of them are still in use. Of these, in 2006 the Dodo River check dams (No.1 ~ No.6, Tobigasako and Uchihiro check dams) were registered as national "Tangible Cultural Properties."
