關島 cabras 電廠#2 機
汽機大修報告

服務機關：台灣電力公司電力修護處

CABRAS # 1 STEAM TURBINE OVERHAUL FINAL REPORT 2016

關島 cabras 電廠#2 機汽機大修預定工期 45 天 2016 年 2 月 22 日開始大修至 4 月 6 日。大修主要工作內容為，高低壓開蓋大修、高壓轉子第一、四、七級動葉片更換、低壓轉子#22 級 TE&GE 端動葉片更換。大修開蓋後發現中壓第一級(#10 級)動葉片似乎遭異物撞擊而損傷，廠方決定一同更換。另汽機主閥全部拆卸檢修。MSV&RSV 之 SEAT 及 DISC 接觸狀況都不好，此次大修將 MSV&RSV 做了研磨。MSV&RSV 之彈簧也予以更換。#1CV、#5CV 彈簧也予以更換希望能改善閥之開關控制。N1 汽封運轉中有洩漏蒸汽之情形，檢修中發現止回閥未開，因此拆卸檢修後將止回閥打開，並作記號確保止回閥在開的位置。汽機之汽封更換了七級包括 IP5、IP10 之 SEAL STRIP，HP7、HP8、IP6、IP8、IP9 之 Packing ring。低壓外缸之安全膜片也做了更換。大修過程中因葉片拆解後量測才製造，第 1、10 級葉片至 3 月 18 日才到廠，最後 L-0 至 3 月 30 日到廠，經全力趕工使原本預定四月六日啟動日期延期至四月 16 日才啟動並聯，比重新修訂工期提前 3 天完工。

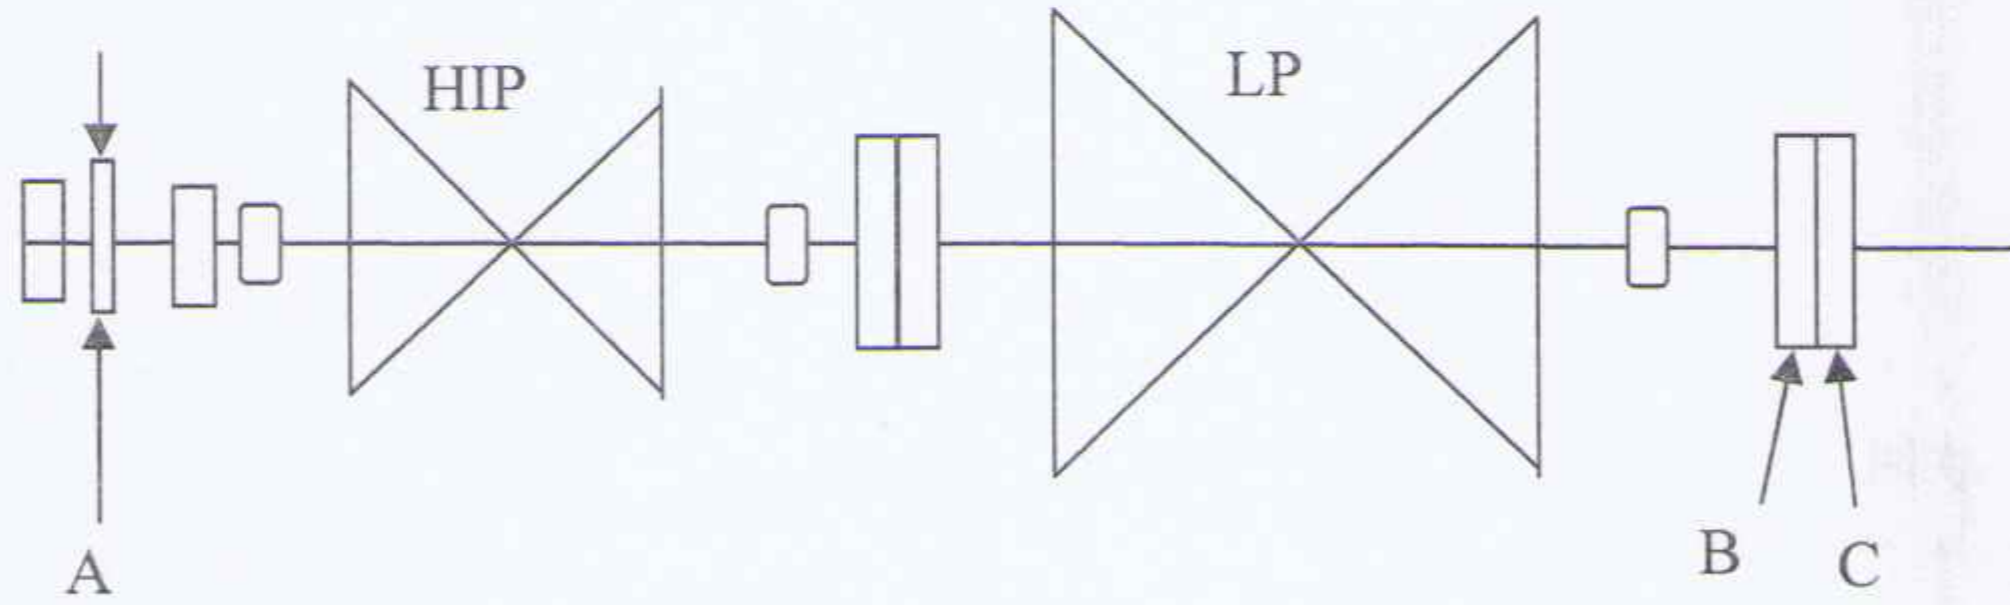
UNIT : 1/100mm

A	B	C
1	13	12	11
2	13	12	11
3	16	12	10
4	16	11	9
5	17	11	9
6	16	10	9
7	15	11	10
8	14	11	11

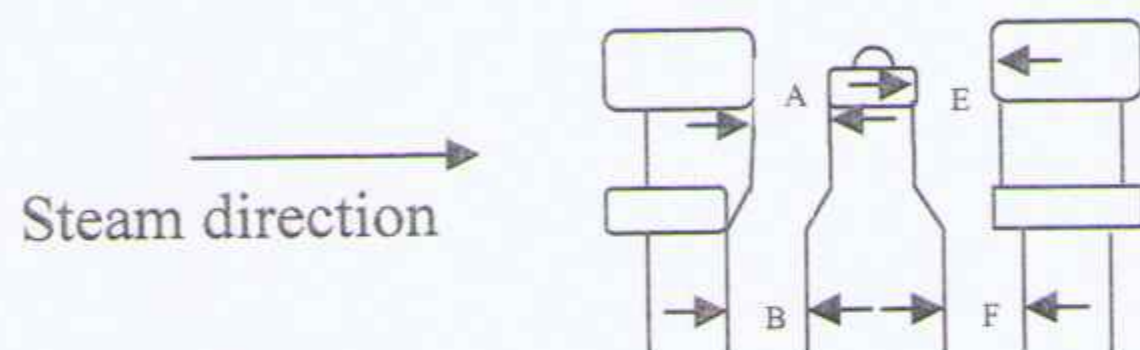
HP Rotor Axial Clearance

design HP-LH				HP-RH			
		A	B	E	F	A	B	E	F
1	design	2.9	2.9	NA	NA	2.9	2.9	NA	NA
	actual	5.2	4.1			5.4	4.9		
2	design	2.9	2.9	NA	8.2	2.9	2.9	NA	8.2
	actual	4.2	4.3		10.6	4.4	4.6		10.8
3	design	2.9	2.9	NA	8.2	2.9	2.9	NA	8.2
	actual	3.8	4.2		10.4	4.2	4.2		10.6
4	design	4.3	4.3	NA	8.5	4.3	4.3	NA	8.5
	actual	4.4	4.5		11.8	4.2	4.6		11.6
5	design	4.2	4.2	NA	8.5	4.2	4.2	NA	8.5
	actual	4.1	3.9		11.0	4.4	4.1		11.3
6	design	4.2	4.2	NA	8.5	4.2	4.2	NA	8.5
	actual	4.1	3.9		9.1	3.9	4.0		9.5
7	design	4.2	4.2	NA	8.5	4.2	4.2	NA	8.5
	actual	4.1	3.8		6.8	3.9	3.6		7.2
8	design	4.2	4.4	NA	8.5	4.2	4.4	NA	8.5
	actual	4.3	4.6		7.6	3.8	3.9		7.9
9	design	4.4	4.4	NA	8.5	4.4	4.4	NA	8.5
	actual	4.7	5.2		8.1	3.8	3.9		7.9

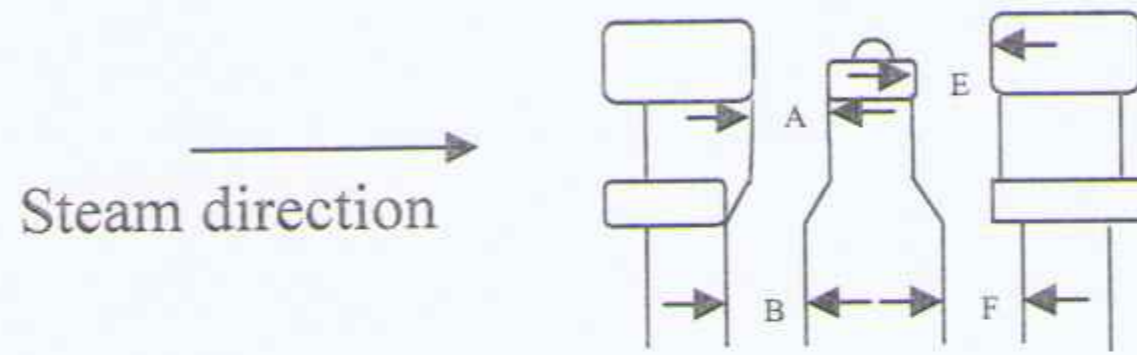
HP Rotor Axial Clearance

HP-LH				HP-RH			
		A	B	E	F	A	B	E	F
1	design	2.9	2.9	NA	NA	2.9	2.9	NA	NA
	actual	5.1	4.0			4.5	4.0		
2	design	2.9	2.9	NA	8.2	2.9	2.9	NA	8.2
	actual	4.0	4.7		10.7	3.9	4.6		10.1
3	design	2.9	2.9	NA	8.2	2.9	2.9	NA	8.2
	actual	4.0	4.0		10.3	3.9	4.0		10.2
4	design	4.3	4.3	NA	8.5	4.3	4.3	NA	8.5
	actual	4.2	3.6		12.2	4.0	3.6		11.1
5	design	4.2	4.2	NA	8.5	4.2	4.2	NA	8.5
	actual	3.9	3.7		10.2	3.9	3.8		9.5
6	design	4.2	4.2	NA	8.5	4.2	4.2	NA	8.5
	actual	4.0	3.9		8.9	3.9	3.8		9.5
7	design	4.2	4.2	NA	8.5	4.2	4.2	NA	8.5
	actual	4.0	3.3		6.5	4.8	3.3		6.5
8	design	4.2	4.4	NA	8.5	4.2	4.4	NA	8.5
	actual	4.5	4.3		7.2	4.2	4.4		7.7
9	design	4.4	4.4	NA	8.5	4.4	4.4	NA	8.5
	actual	4.9	5.4		8.2	4.2	4.5		8.1

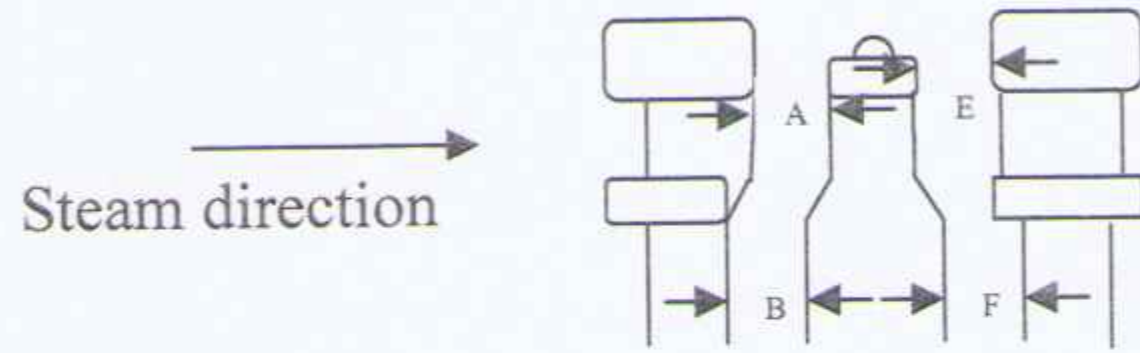
IP Rotor Axial Clearance

IP-LH				IP-RH			
		A	B	E	F	A	B	E	F
1	design	2.3	2.5	NA	14.5	2.3	2.5	NA	14.5
	actual	2.0	3.9		15.00	1.9	4.3		13.6
2	design	3.6	3.4	NA	15.5	3.6	3.4	NA	15.5
	actual	3.8	2.8		14.6	3.1	3.2		14.7
3	design	4.8	4.8	NA	15.8	4.8	4.8	NA	15.8
	actual	4.5	4.6		14.8	4.6	4.7		14.8
4	design	4.0	4.0	NA	15.2	4.0	4.0	NA	15.2
	actual	4.0	3.9		14.8	3.9	4.0		14.2
5	design	4.5	4.5	NA	15.3	4.5	4.5	NA	15.3
	actual	3.8	3.7		14.2	4.1	3.9		13.9
6	design	4.5	4.5	NA	16.0	4.5	4.5	NA	16.0
	actual	4.3	4.1		14.6	3.6	3.8		14.9
7	design	4.5	4.5	NA	17.6	4.5	4.5	NA	17.6
	actual	4.2	4.3		16.2	3.7	3.9		17.2
8	design	4.6	4.6	NA	18.2	4.6	4.6	NA	18.2
	actual	4.2	4.1		16.8	3.8	4.1		17.1
9	design	4.6	4.6	NA	NA	4.6	4.6	NA	NA
	actual	4.4	4.2			4.1	4.2

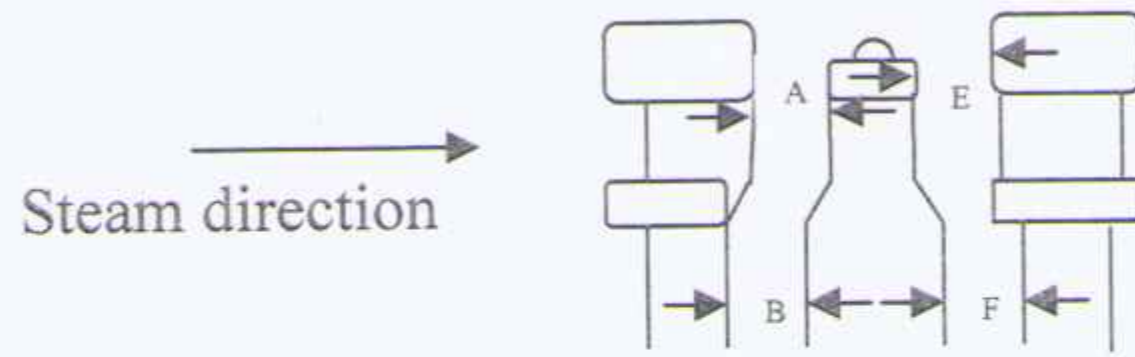
IP Rotor Axial Clearance

IP-LH				IP-RH			
		A	B	E	F	A	B	E	F
1	design	2.3	2.5	NA	14.5	2.3	2.5	NA	14.5
	actual	1.3	4.0		12.8	1.5	4.9		13.3
2	design	3.6	3.4	NA	15.5	3.6	3.4	NA	15.5
	actual	3.5	2.2		14.5	2.8	2.5		14.7
3	design	4.8	4.8	NA	15.8	4.8	4.8	NA	15.8
	actual	4.3	4.3		14.8	3.9	3.1		14.5
4	design	4.0	4.0	NA	15.2	4.0	4.0	NA	15.2
	actual	3.8	3.2		14.6	3.8	3.0		14.8
5	design	4.5	4.5	NA	15.3	4.5	4.5	NA	15.3
	actual	3.6	3.8		13.8	3.3	4.0		14.4
6	design	4.5	4.5	NA	16.0	4.5	4.5	NA	16.0
	actual	3.9	3.6		14.8	3.5	3.6		14.8
7	design	4.5	4.5	NA	17.6	4.5	4.5	NA	17.6
	actual	4.2	4.2		16.0	3.5	3.8		17.4
8	design	4.6	4.6	NA	18.2	4.6	4.6	NA	18.2
	actual	4.2	4.4		16.5	3.6	3.9		16.3
9	design	4.6	4.6	NA	NA	4.6	4.6	NA	NA
	actual	4.2	4.3			3.7	4.3

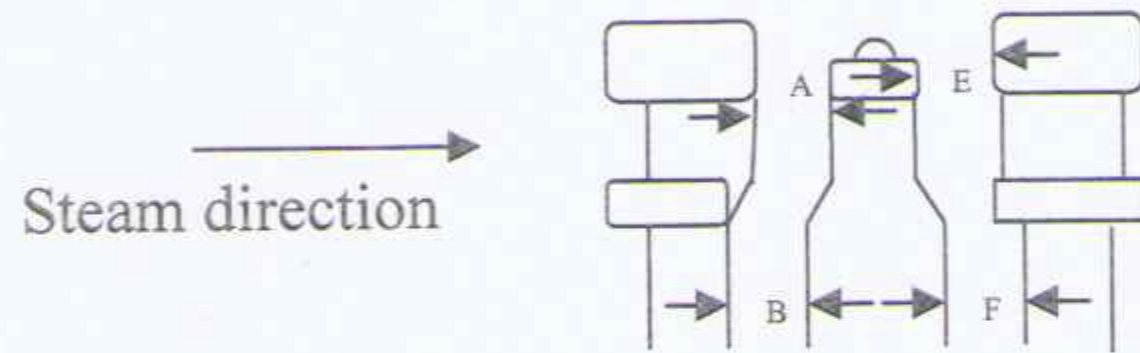
LP Rotor Axial&Radial Clearance

LP-LH				LP-RH			
		A	B	E	F	A	B	E	F
TE4	design	12.5	18.5	NA	NA	12.5	18.5	NA	NA
	actual	12.0	12.5			12.1	12.3		
TE3	design	13.3	18.5	NA	15.4	13.3	18.5	NA	15.4
	actual	12.0	12.8		11.60	12.1	12.5		16.40
TE2	design	13.3	18.5	NA	14.9	13.3	18.5	NA	14.9
	actual	11.7	11.5		11.70	11.6	11.5		14.80
TE1	design	11.2	16.3	NA	14.2	11.2	16.3	NA	14.2
	actual	11.20	12.0		11.00	11.3	12.1		14.50
GE1	design	9.9	9.9	NA	16.1	9.9	9.9	NA	16.1
	actual	7.4	7.7		10.10	7.3	7.6		15.50
GE2	design	11.8	13.5	NA	17.2	11.8	13.5	NA	17.2
	actual	7.7	8.2		11.00	7.8	8.3		16.10
GE3	design	11.6	12.3	NA	17.5	11.6	12.30	NA	17.5
	actual	8.8	8.30		12.00	8.8	8.4		16.80
GE4	design	11.6	16.8	NA	NA	11.6	16.8	NA	NA
	actual	8.8	15.5			8.9	15.8

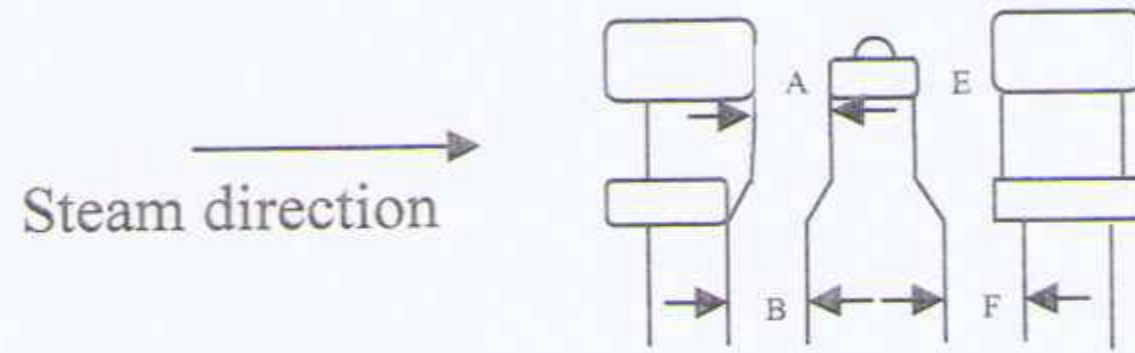
LP Rotor Axial&Radial Clearance

LP-LH				LP-RH			
		A	B	E	F	A	B	E	F
TE4	design	12.5	18.5	NA	NA	12.5	18.5	NA	NA
	actual	11.9	17.8			12.4	18.1		
TE3	design	13.3	18.5	NA	15.4	13.3	18.5	NA	15.4
	actual	11.7	16.3		13.6	11.5	16.0		12.1
TE2	design	13.3	18.5	NA	14.9	13.3	18.5	NA	14.9
	actual	11.3	14.7		12.4	11.0	14.3		13.1
TE1	design	11.2	16.3	NA	14.2	11.2	16.3	NA	14.2
	actual	10.7	13.9		11.4	11.6	13.8		11.4
GE1	design	9.9	9.9	NA	16.1	9.9	9.9	NA	16.1
	actual	7.8	10.7		14.4	8.1	10.6		14.8
GE2	design	11.8	13.5	NA	17.2	11.8	13.5	NA	17.2
	actual	8.8	12.2		15.8	8.8	11.7		15.5
GE3	design	11.6	12.30	NA	17.5	11.6	12.30	NA	17.5
	actual	8.3	12.3		15.3	8.8	12.5		15.8
GE4	design	11.6	16.8	NA	NA	11.6	16.8	NA	NA
	actual	9.3	15.3			7.6	15.3

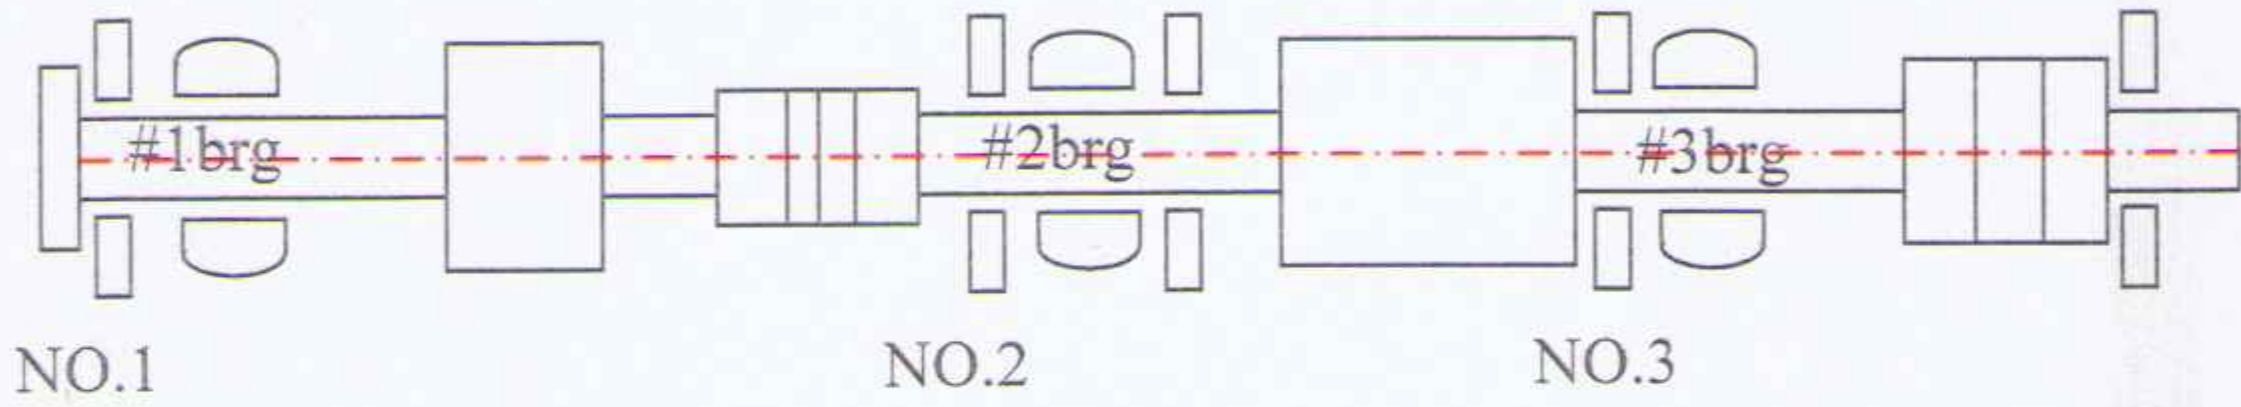
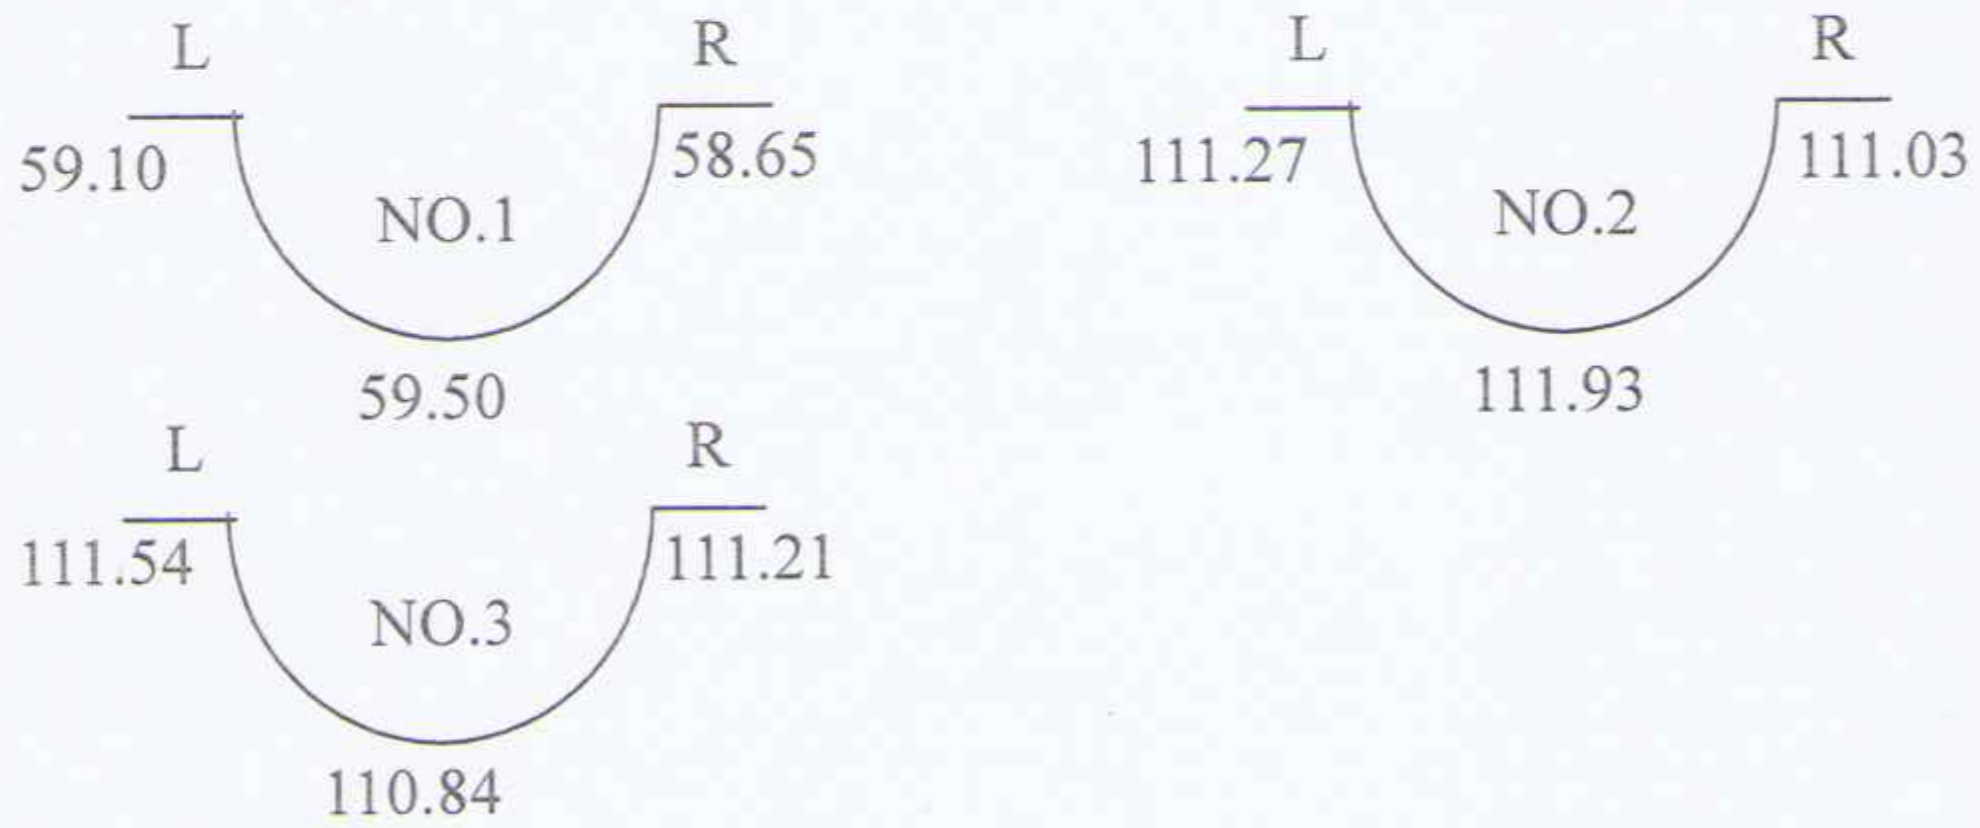
OIL RING BORE Measurement

CLEARANCE BETWEEN OIL RING BORE AND SHAFT

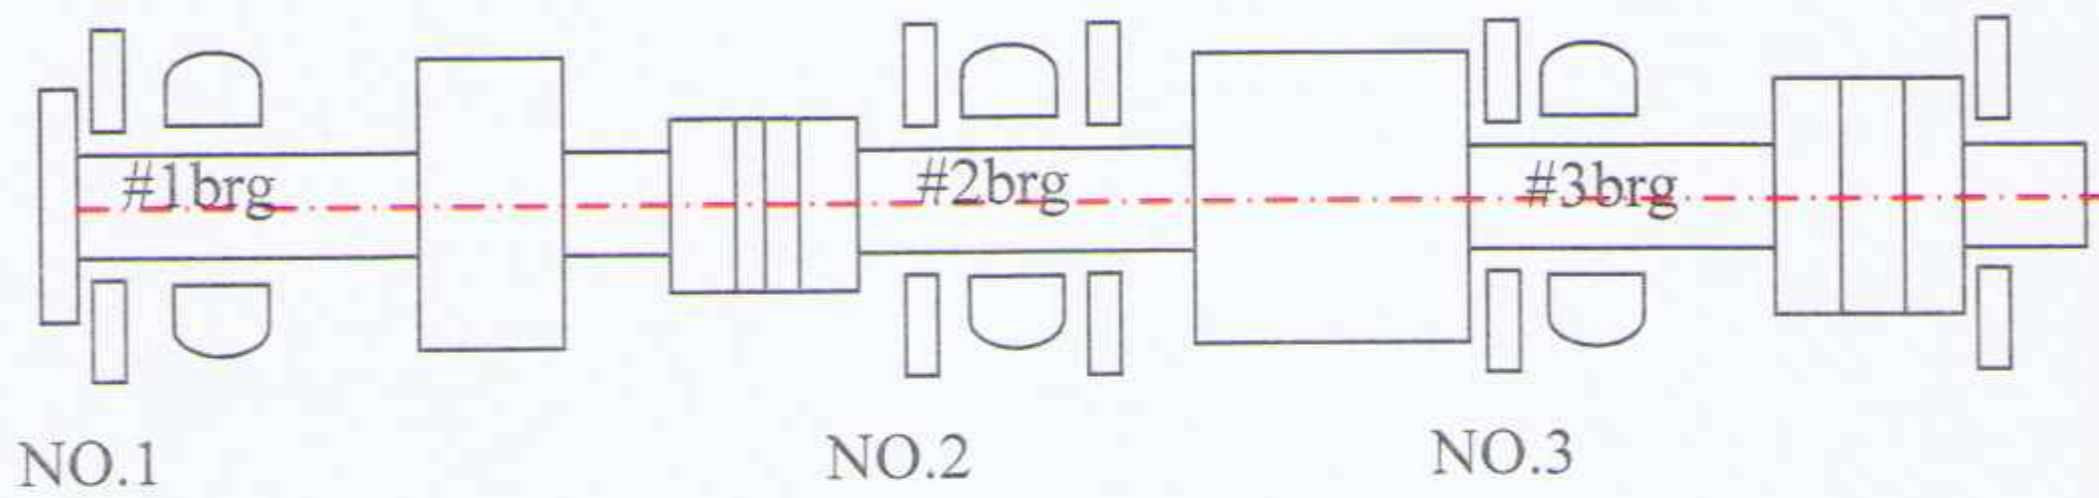
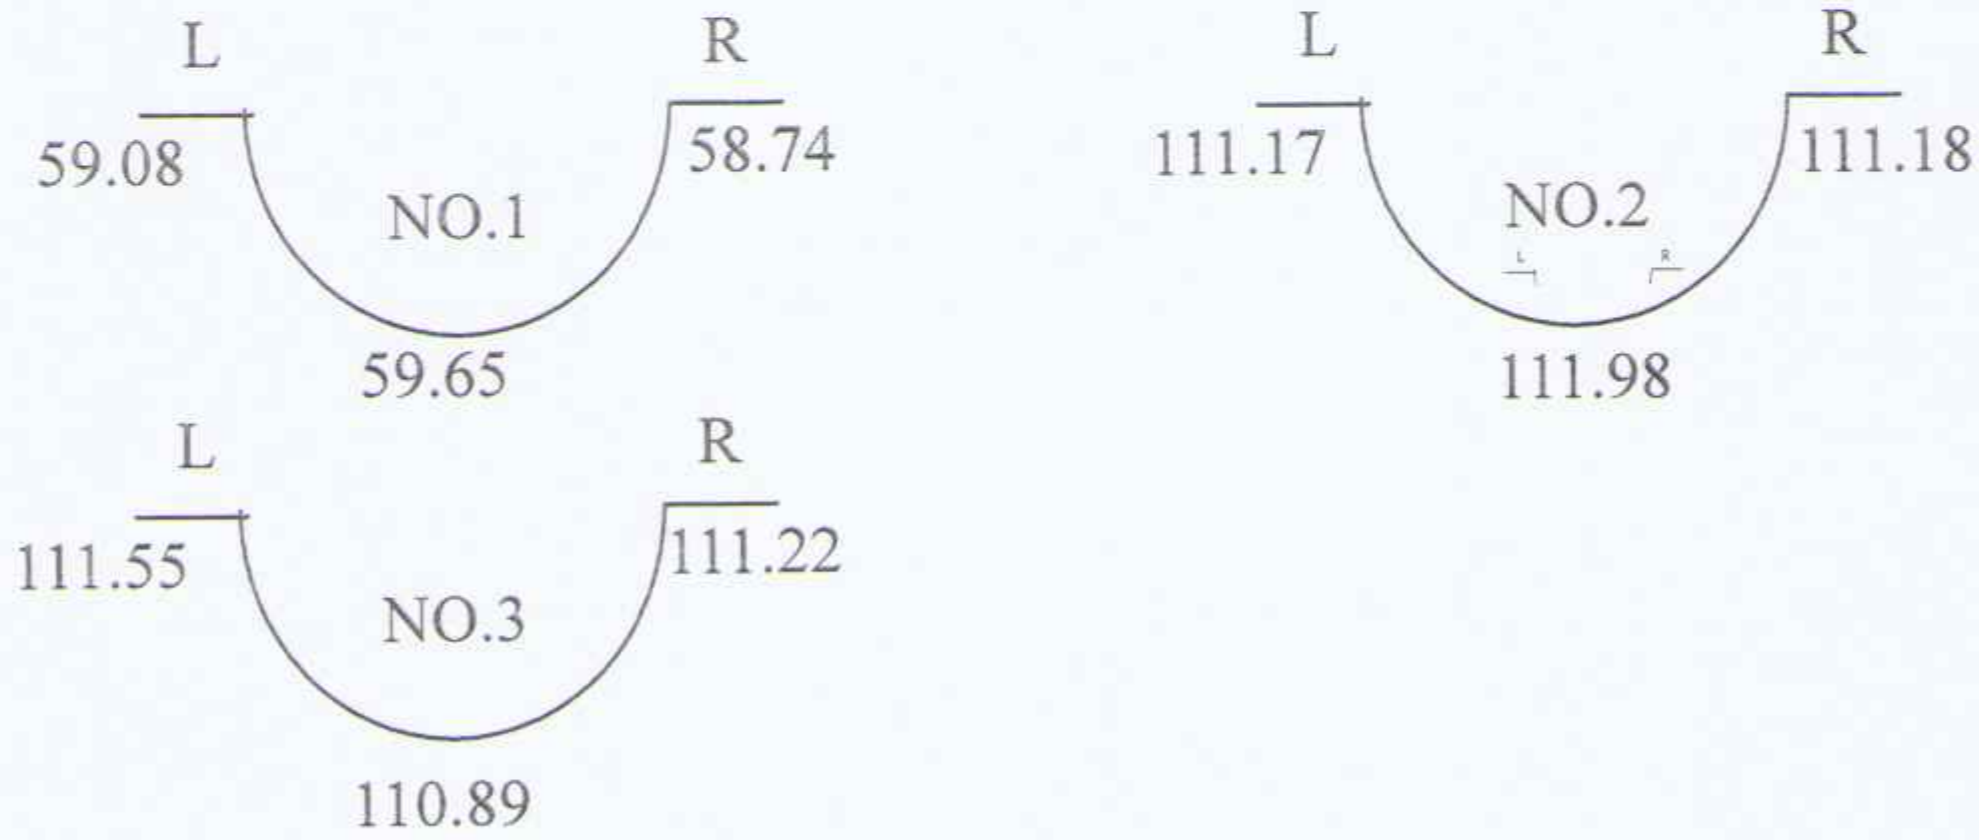
OIL RING BORE Measurement

CLEARANCE BETWEEN OIL RING BORE AND SHAFT

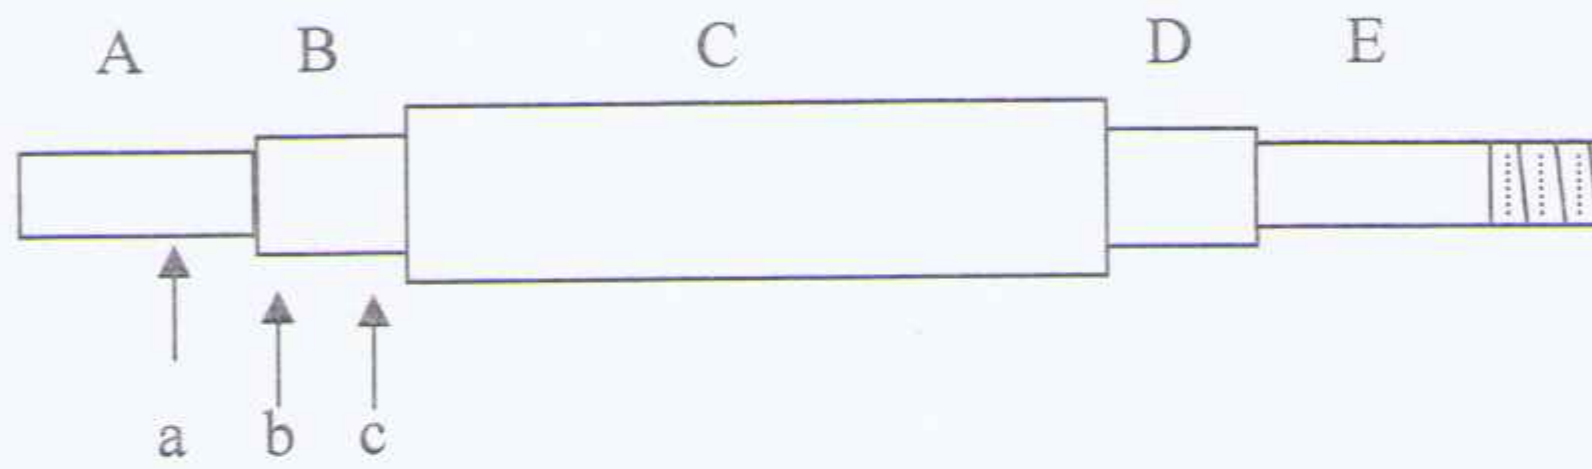
ACP-1(1A) STEM RUN OUT CHECK

A	B	C	D	E
1	0	0	0	0	0
2	-1	0	0	0	-4
3	0	0	0	-1	0
4	2	-2	0	2	0

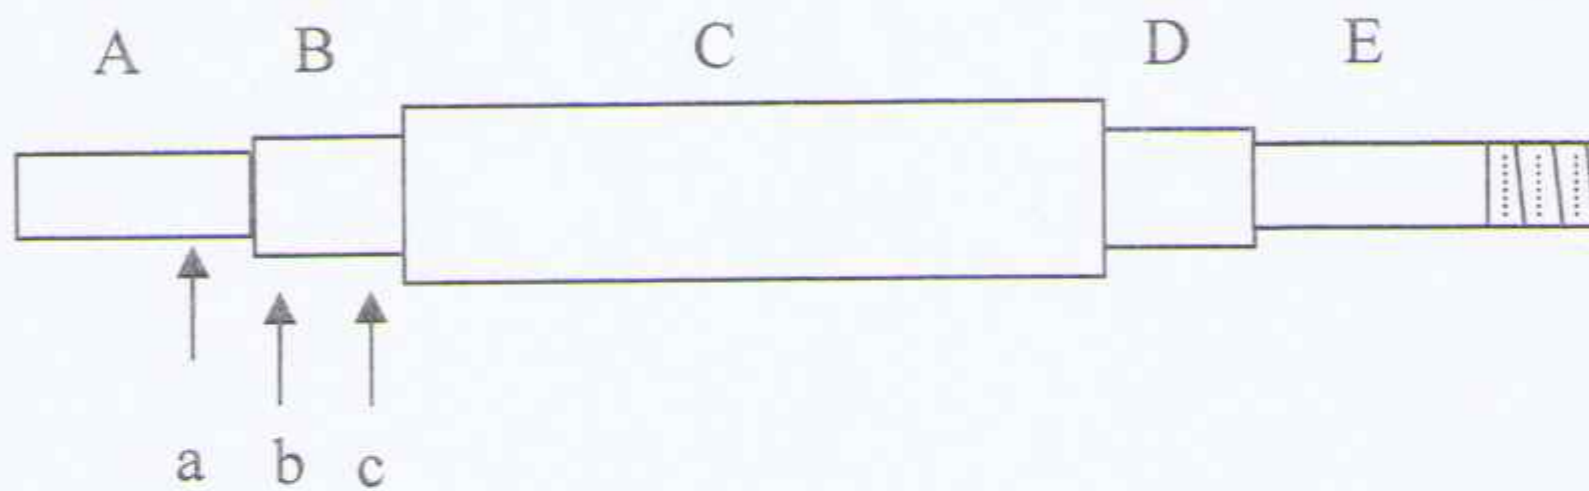
ACP-2(2A) STEM RUN OUT CHECK

A	B	C	D	E
1	0	0	0	0	01
2	8	5	0	1	3
3	13	8	0	0	1
4	4	5	0	1

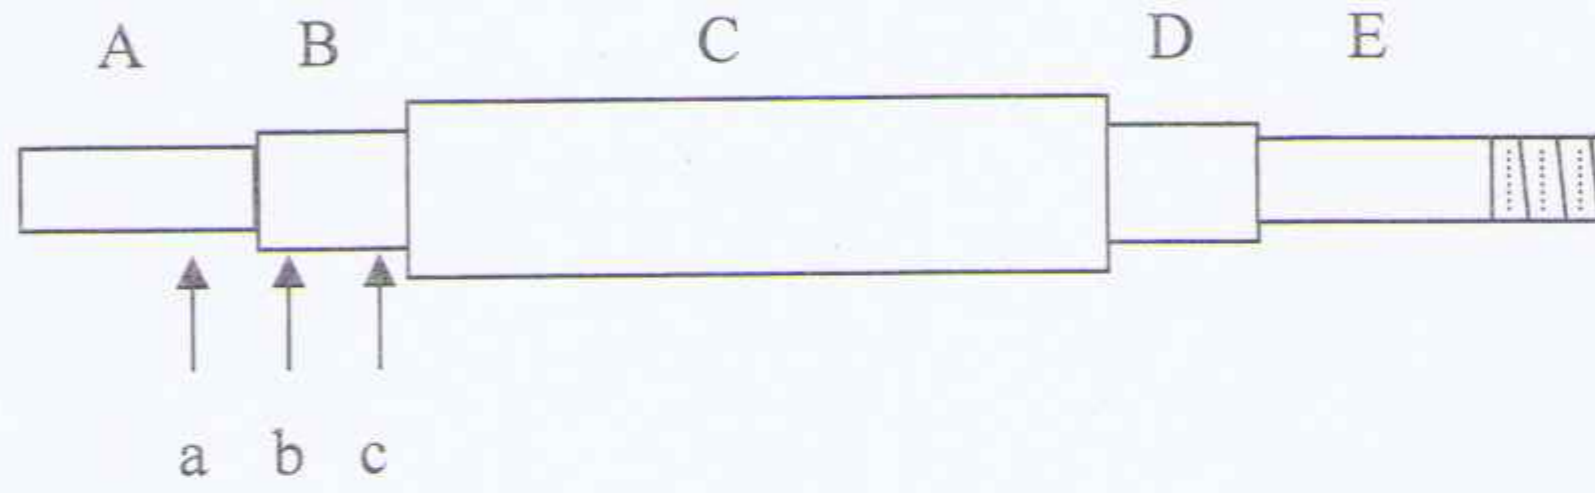
DCP-(EP) STEM RUN OUT CHECK

A	B	C	D	E
1	0	0	0	0	0
2	6	10	0	0	2
3	3	4	0	-3	2
4	-8	4	0	-2	0
