INSPECTION REPORT

GAS TURBINE MAINTENANCE

MS 5001 Turbine Rotor Clearances

FSR NO. _____ TURBINE NO. 05620 (Dededo #1) DATE 2016.10.29

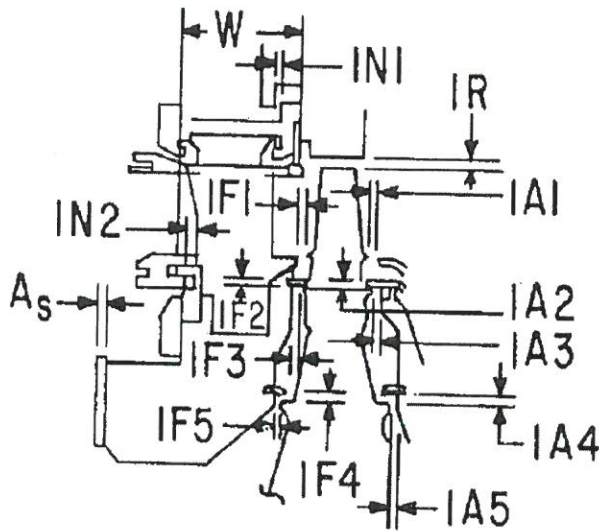
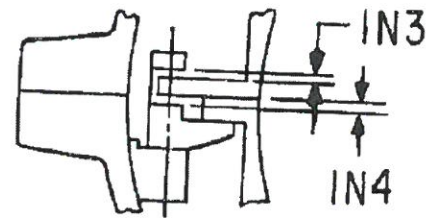
FIRST STAGE TURBINE

COMMENTS: *Measurement IN1 is somewhat high. We have to see upon the closing measurements of IR*

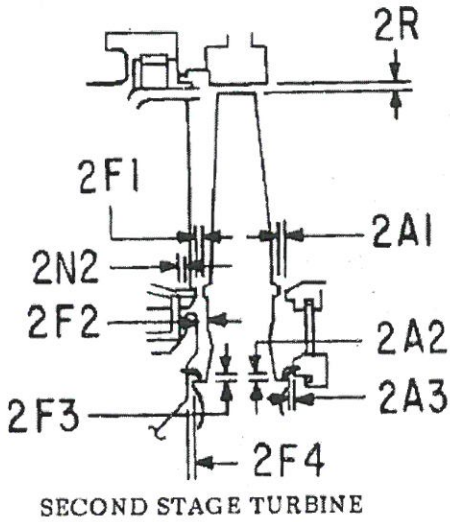
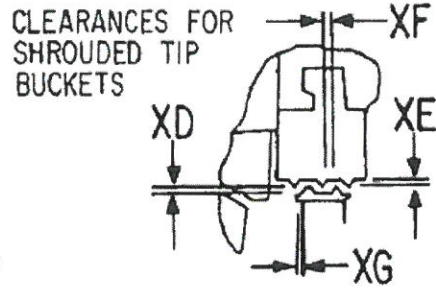
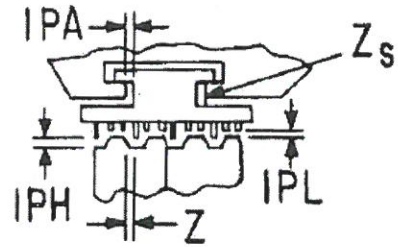
SECOND STAGE TURBINE

COMMENTS: 2N2, 2N3, 2F2 & 2R - not applicable for this blades / PL
 2F3, 2F4, 2A1 & 2A2 are out of tolerance, probably seals have some wear / PL
 XF - is out of tolerance - Probably the measurement was not right / PL

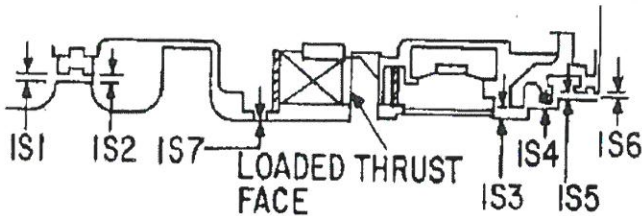
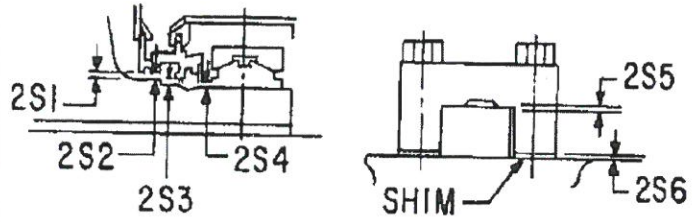
No. 1 BEARING AREA

| | CLEARANCES | | VISUAL INSPECTION | | COMMENTS |
|---|---|---|---|---|---|
| IS7 | 0.35 | 0.25 | OK, W | N | needs replacement next outage |

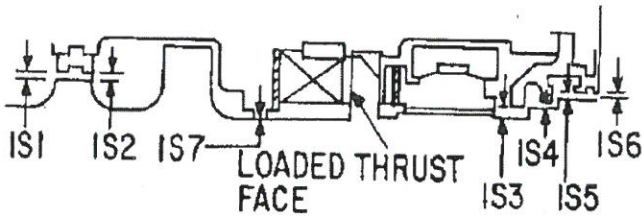
No. 1 BEARING AREA

| | CLEARANCES | | VISUAL INSPECTION | | COMMENTS |
|---|---|---|---|---|---|
| 1S1 | 0.35 | 0.40 | high clearance | N | Final. Replace on next outage. <i>JPC</i> |
| 1S2 | 0.37 | 0.37 | high clearance | N | Final. Replace on next outage. <i>JPC</i> |
| 1S7 | 0.25 | 0.20 | high clearance | N | Final. Replace on next outage. <i>JPC</i> |
