INSPECTION REPORT

GAS TURBINE MAINTENANCE

MS 5001 Turbine Rotor Clearances

FSR NO. _____ TURBINE NO. 296274 (05528) Dededo #2 DATE 2016.10.21

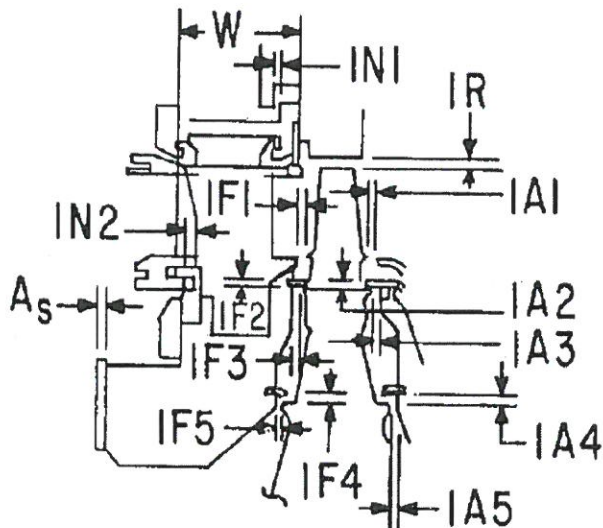
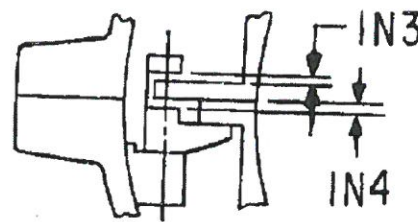
FIRST STAGE TURBINE

COMMENTS: - opening clearances.
 - W, IN1, IN2 are a little off but no major concern at this point
 - R is somewhat tight but no evidence of rubbing present
 - IF4 is a little open on this seal, should consider replacing seal
 by Juan Castellanos

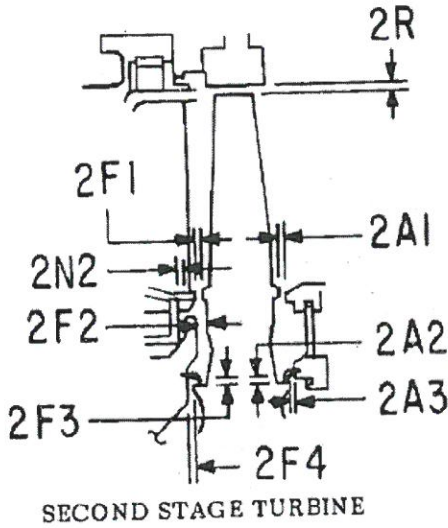
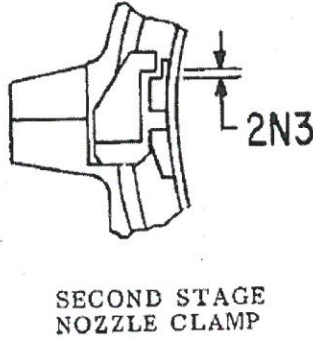
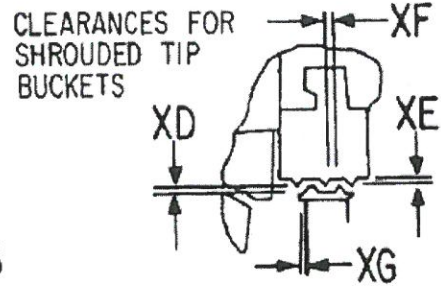
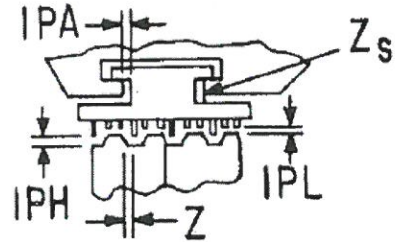
SECOND STAGE PACKING SEALS

COMMENTS: -2F3 looks like the seal is broken
 -2A2 is a little open
 -Z needs to be modified at closing if necessary
 -XD+XF are off. need to be verified at closing
 JAC

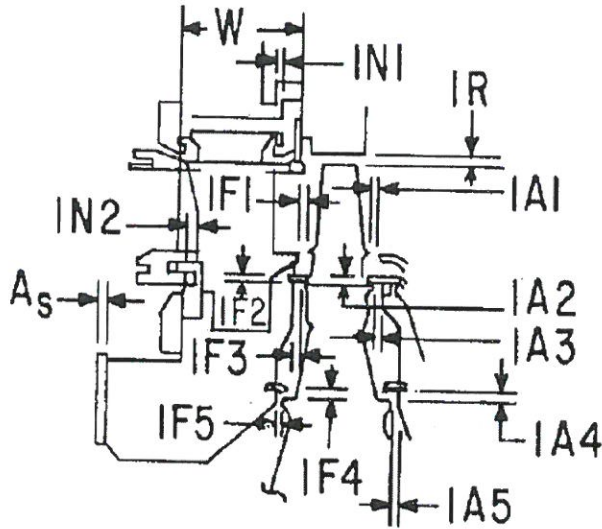
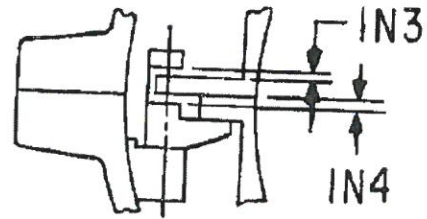
FIRST STAGE TURBINE

COMMENTS: - W & IN1 are a little off, but not of major concern
 - R it's a little tight, but there is no evidence of rubbing
 - IF4 is a little open, seal needs to be replaced

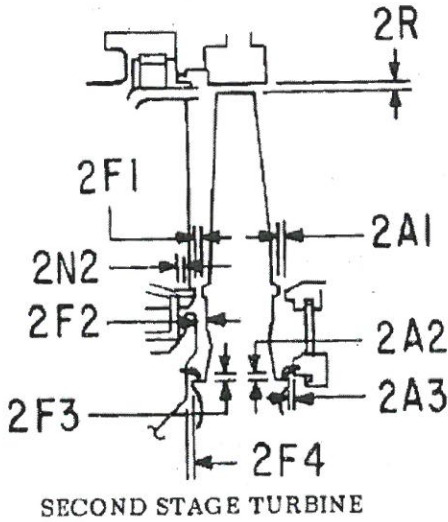
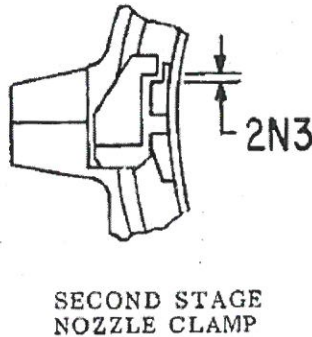
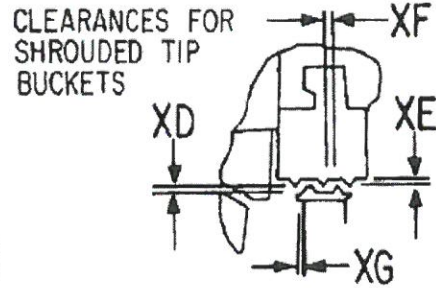
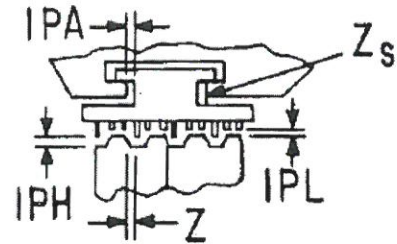
SECOND STAGE PACKING SEALS

COMMENTS: -2R is not applicable on this turbine
 -2F3 the seal has wear
 -2A2 the seal has wear
 -XD close but no evidence of rubbing
 -XF open but no evidence of rubbing

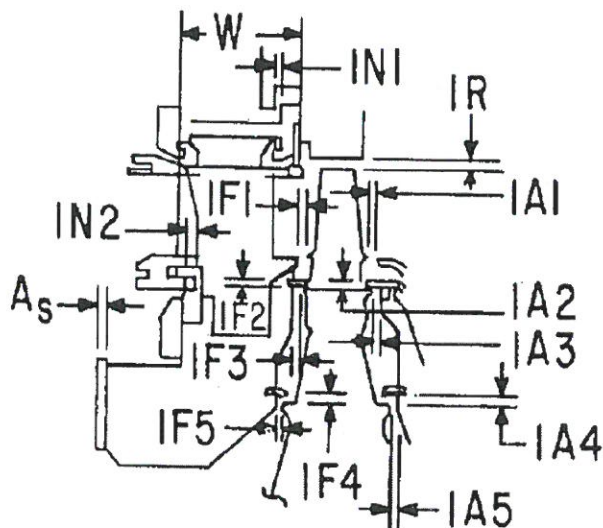
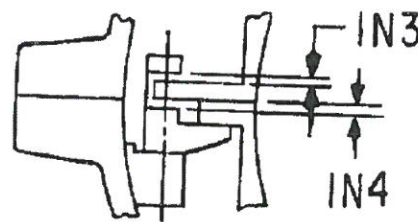
FIRST STAGE TURBINE

COMMENTS: *- R is a little tight, but there is no evidence of the 1st bucket rubbing*
- IF4 is open. The seal should be replaced as soon as feasible
Witnessed + Revised
Juan Castellanos 11/10/2016 GE

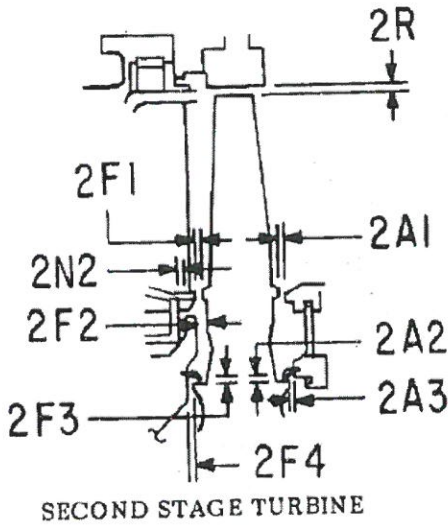
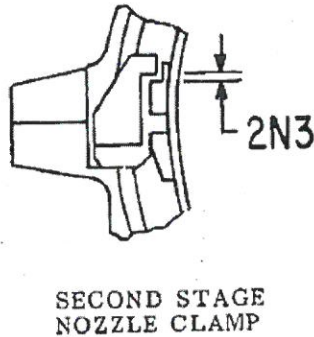
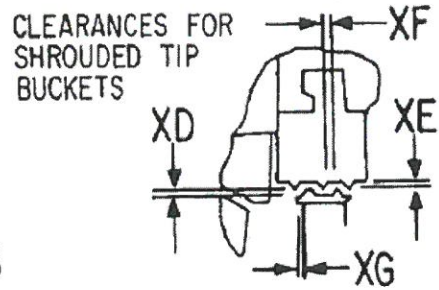
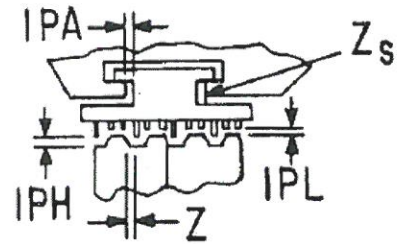
SECOND STAGE PACKING SEALS

COMMENTS: *2N2 - tight, no major concern*
2F3 & 2A2 - the seal has wear
Z, IPA + IPH - clearances are off, but
no major concern on this
XD - tight, but no evidence of rubbing

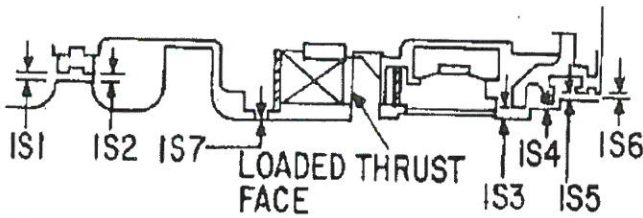
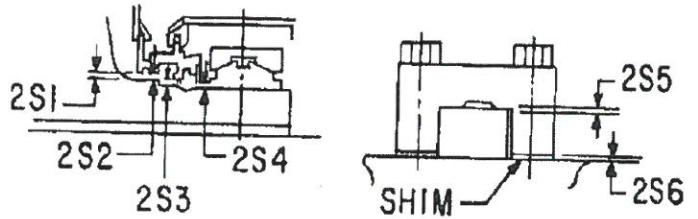
CLEARANCES		VISUAL INSPECTION		COMMENTS
	Left	Right	Condition	Disposition	
1S1	0.15	0.25			good
1S2	0.2	0.25			good
1S3	0.2	0.25			good
1S4	0.18	0.25			good
1S5	0.1	0.2			good
1S6	0.15	0.2			good
1S7	0.12	0.15			good
2S1	0.2	0.2			good
2S2	0.18	0.3			good
2S3	0.2	0.2			good
2S4	0.18	0.2			good
2S5	0	0			good
2S6	0	0			need shim thickness
