出國報告（出國類別：洽公）

5,000 噸級油品化學品輪(平運輸)建造採購案(A2910T001)，船廠進度追蹤及品質查核

服務機關：台灣中油股份有限公司

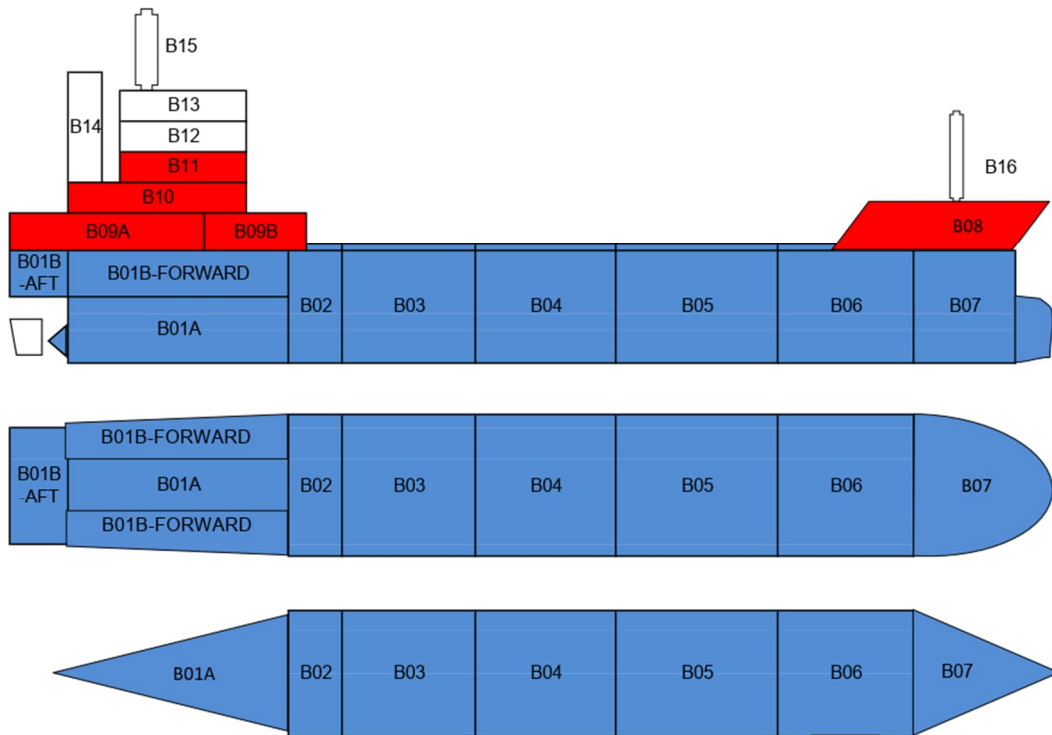
H1266 Block Construction Board

本公司新建環(離)島小油輪 5,000 DWT 油品化學品輪平運輸(Hull No. 1266) 平運輸係由新加坡 ASL Marine Holding Ltd 取得合約建造，目前船段於印尼 ASL 巴淡廠製作的部分已全部完成，最終將在新加坡 ASL 船廠做組裝，至 8 月底前組裝工作已大致剩下住艙及船艙甲板桅桿部分未完成。

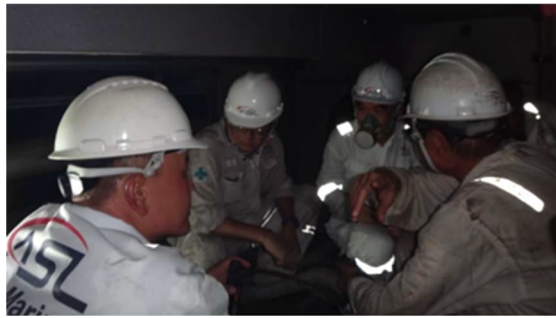
檢查完後之意見交流

在壓水艙檢查完成後，將相關人員集合於出口處討論檢查之結果，對於後續之工作進行會有相當之幫助，建議監工團隊與船廠品管人員應維持此方式之討論。
