# Debris Flow Disaster Management in Taiwan

Hsiao-Yu, Huang

Senior Engineer Debris Flow Disaster Prevention Center Soil and Water Conservation Bureau Council of Agriculture, Taiwan

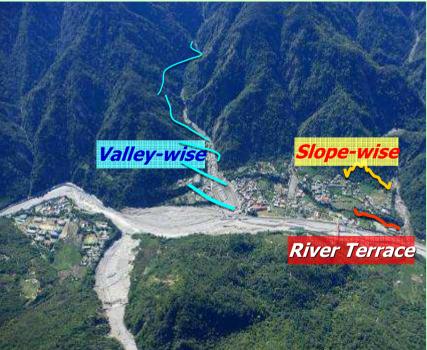
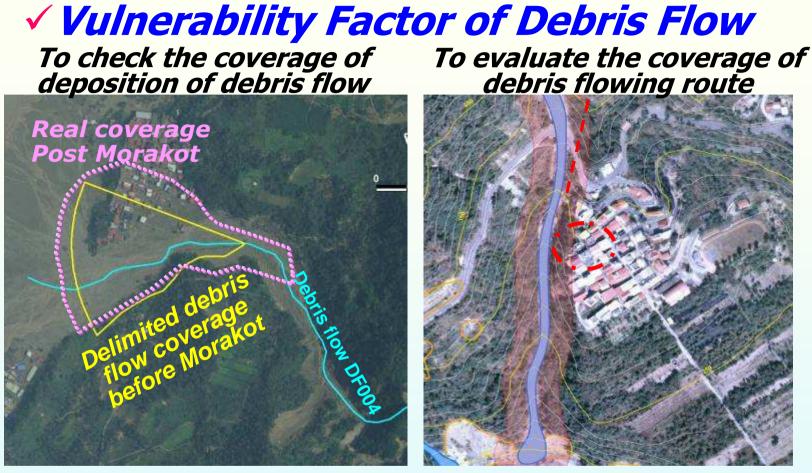
Influential Area Estimate

- Coverage Area of debris flow Disaster:
  - After Typh. Morakot: By satellite image processing, 49 additional debris flows (44 caused by Typh. Morakot) are identified and there will be 1,552 debris flows in total in Taiwan.
- Potential hazard area: determined by geology investigation and site reconnaissance.

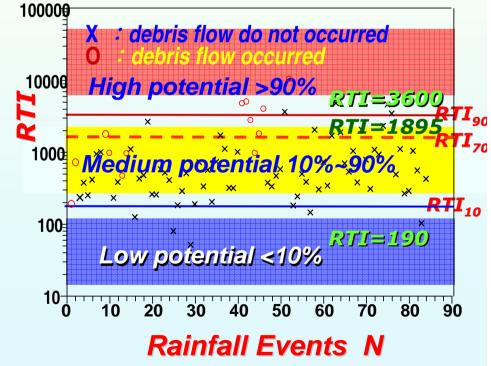
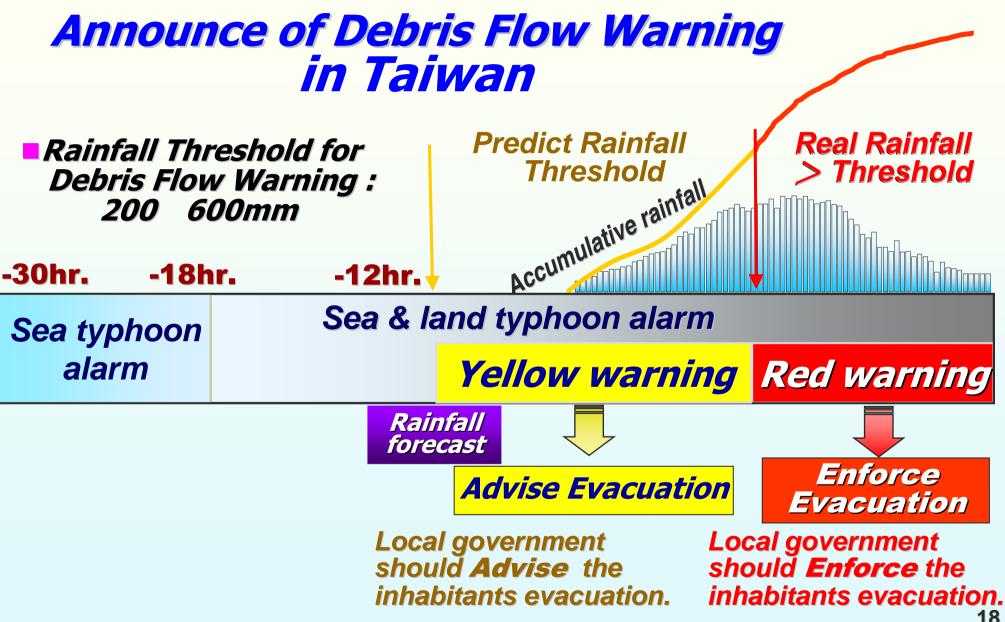
# *Localized Rainfall-based Debris-flow Warning Model* > *Rainfall Triggering Index (RTI)*

= Rainfall intensity × Effective accumulated rainfall

R<sub>t</sub> : Effective accumulated rainfall = Accumulated rainfall Preceding rainfall for 7 days

I : Rainfall intensity (mm/hr)

RTI<sub>70</sub> : RTI at 70% of probability that debris flow occurred

The critical accumulated rainfall for evacuation (Rc) is set for easier public understanding and local application

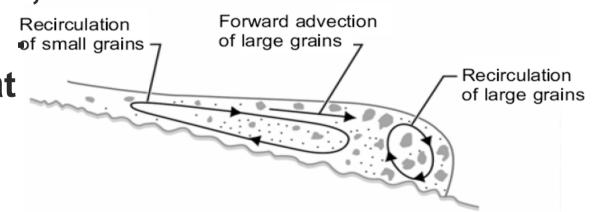
# **Characteristic of debris flow**

High velocity (2~20m/s), high impact force.

- Head with boulder front, followed by hyperconcentrated flow.
- Larger size at top, smaller size at bottom

Initiation area mostly at slope above 15~30, deposition area 3~6 of
 Alluvial fan formed at torrent exit, gentle slope area.

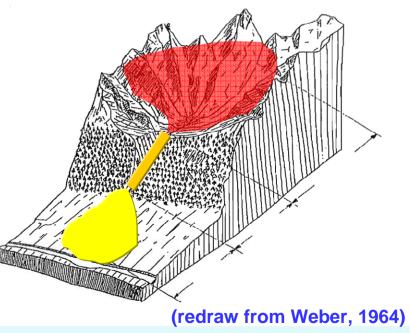
# Development of Debris Flow System

**Initiation zone:** Steep slope failure in the headwall or side slope of a gully or stream channel. Mostly forms a V-shape; the vegetation around often appear sparse, for a large amount of landslide fragments accumulate here.

✓ Transit zone: U-shape, usually located in the valley or the middle and lower reaches of the river, and there are debris that collapsed from both side of the valley on the riverbank.

Deposition zone: Once the flow reaches a flatter or less confined area, it will spread out, lose speed and deposit.

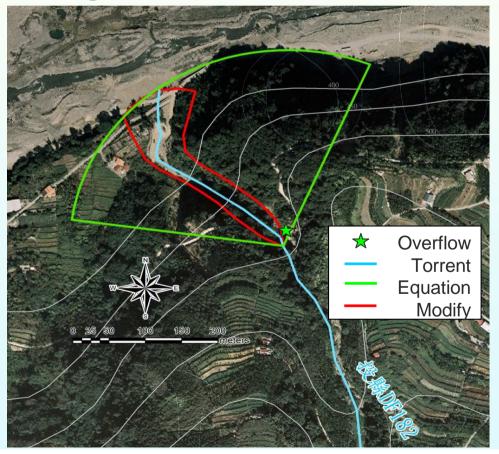
### Affected area zoning

- The apex of the affected area was selected at valley exit or overflew point with 105 degree fan area, the runout-distance (radius of the fan) was calculated by Takahashi equation.
- Eliminate the un-passable areas, for example if banks were 10~12m higher than channel.

#### **Hiroshi equation**

$Log(L) = 0.42 \ Log(V \ tan_{d}) + 0.935$

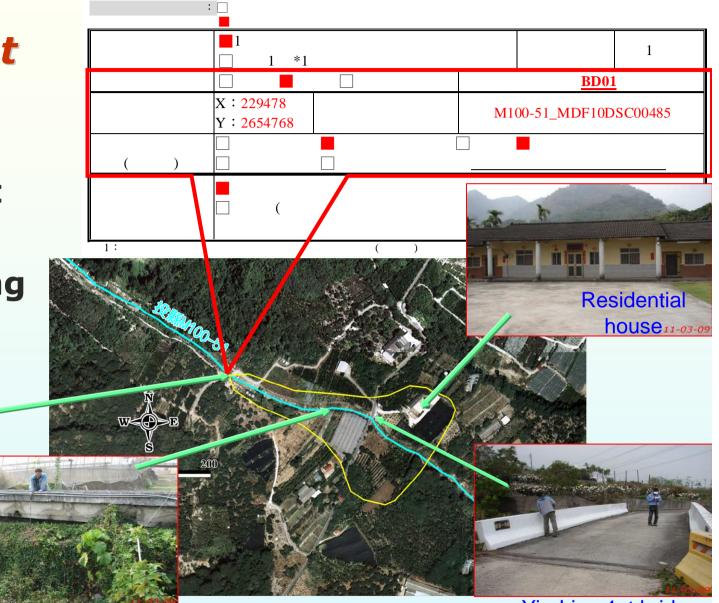
#### **Overflow point**

- Opening
- ✓ Obstacle
- Bending point
- Valley exit
- Slope changing

Overflow point at begin of opening

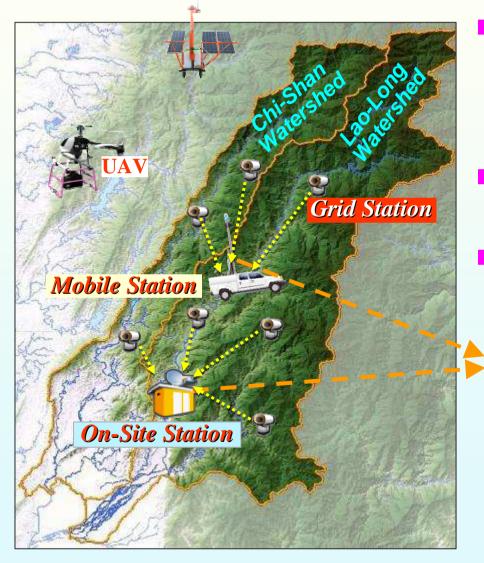
#### Watershed-oriented Monitoring Network

Point→Line→Plane: extended to upper stream and the source of debris, considering a whole watershed.

Combining on-site, mobile, and grid stations.

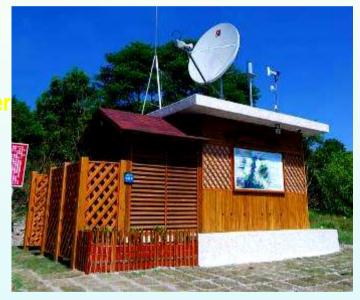
Instrumental cabin Data-processing Power-Supply

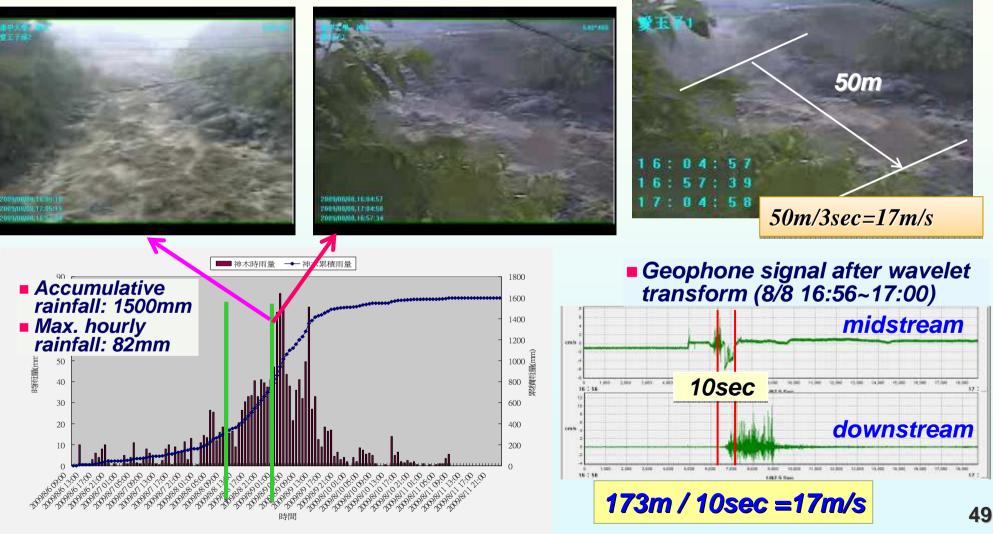
CCD image (front view) of Aiyuzi downstream

CCD image (sideview) of Aiyuzi upper stream

Velocity

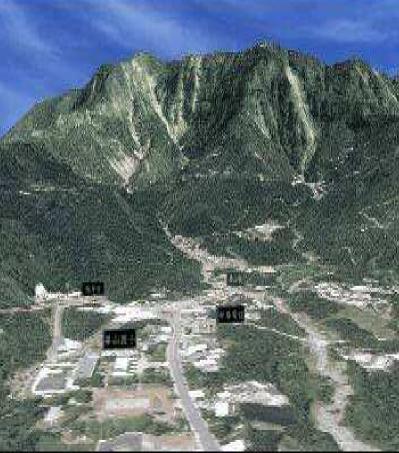
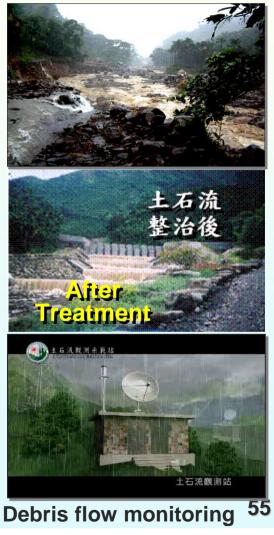
Soil and Water Conservation Bureau, Taiwan Integration of Debris Flow Disaster Mitigation & Rural Regeneration

in Hua-shan, Ku-keng, Yunlin A Debris flow outdoor classroom established after debris flow mitigation

Post Typhoon Nari, 2001

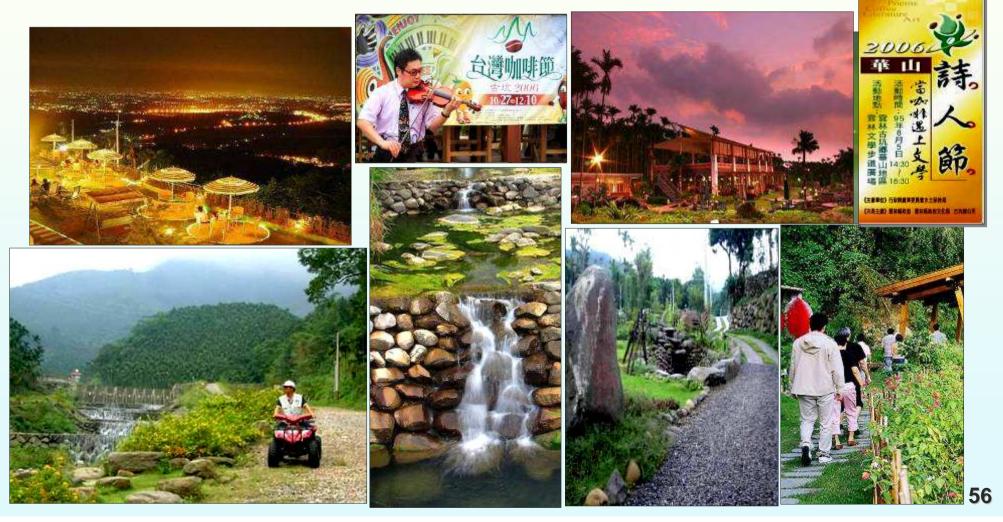
### Soil and Water Conservation Bureau, Taiwan Debris Flow Disaster Mitigation with **Integrated Rural Development**

#### in Hua-shan, Ku-keng, Yunlin
