Water System Overview

Taiwan Delegation
October 8, 2019

Simon Hsu
Water Resources Division

The Research of Repairing Method of Water Tank Leakage

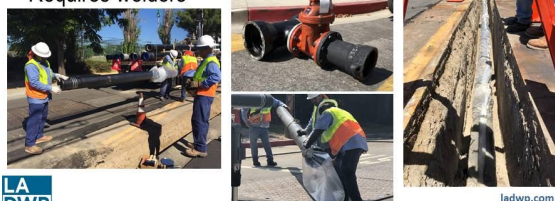
Construction

- Easy Installation
- S1, A, M2 (8-inch pipe)
- Compatible with existing materials
- Established material supply chain
- Requires welders

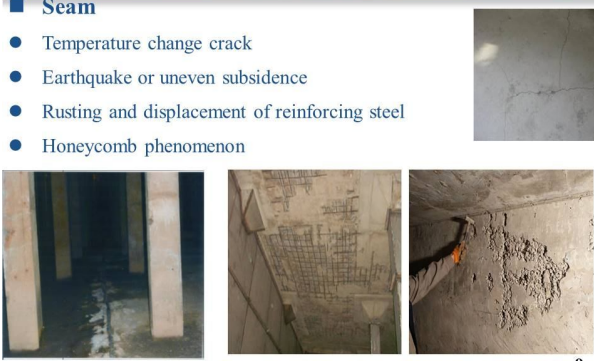
Seam

- Temperature change crack
- Earthquake or uneven subsidence
- Rusting and displacement of reinforcing steel
- Honeycomb phenomenon

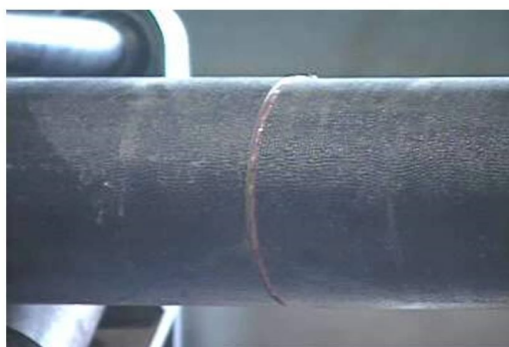
Dynamic tensile test – Base Hose by itself

Sample	Internal pressure (MPa)	Joint separation (mm)	Amplitude (mm)	Frequency (Hz)	Number of displacement cycles	Results
1	0.50	100	±50	1.0	30	No leakage
2		100	±10	3.0	90	
3		100	±20	3.0	90

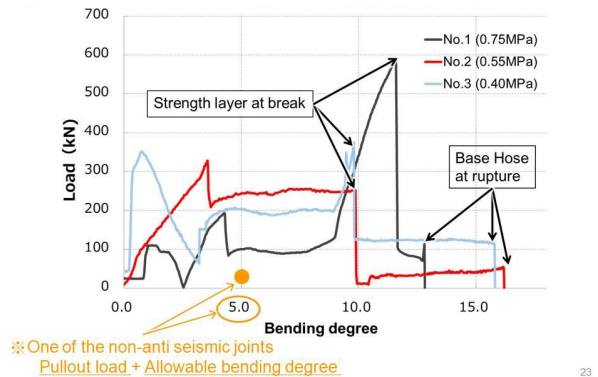
Bending test - fully structural CIPP with BH

Sample	Internal pressure (MPa)	Strengthening layer at break		Base Hose at rupture		Leakage
		Load (kN)	Bending angle	Load (kN)	Bending angle	
1	0.75	591	11.5	100	12.5	Yes
2	0.55	251	10.0	53	16.0	Yes
3	0.40	362	10.0	-	16.0	No*

*Test aborted at max bending of apparatus

Multi-layered CIPP maintained watertightness up to certain displacement after strength layer ruptured

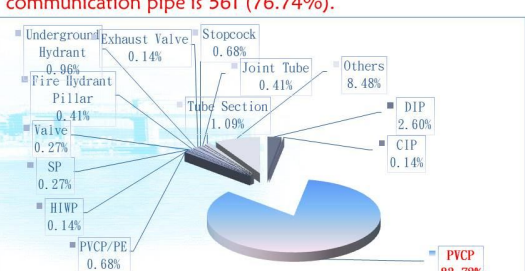
From Feb. 6 to 14, the number of leak items was 731. The leaks of **PVC/P** reached up to **83.72%**, of which the number of **communication pipe** is **561 (76.74%)**.

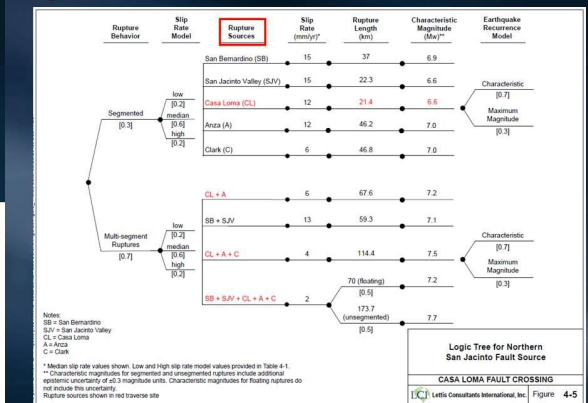
Logic Tree Example – Fault Source

- Logic Tree Approach
 - Capture uncertainties in primary parameters
 - Tree branches represent values of parameters
 - Weights define distribution of values
- Fault Displacement Parameters
 - Rupture sources ←
 - Slip rate
 - Rupture length
 - Earthquake magnitude & recurrence
 - Fault displacement prediction model

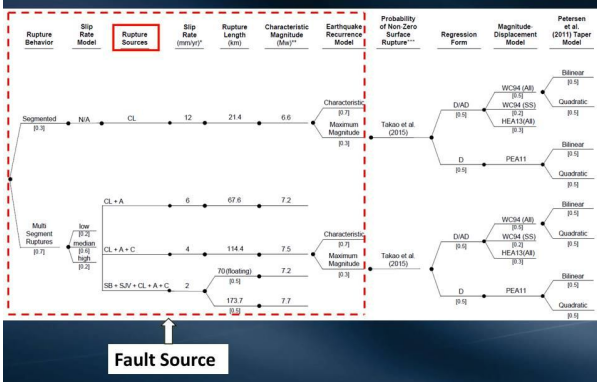
Logic Tree Example – Prob. Fault Displacement

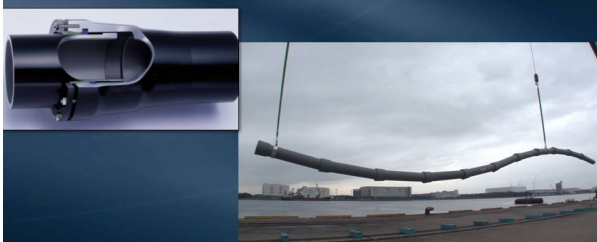
- Earthquake Resistant Ductile Iron Pipe (ERDIP)
 - Absorbs large displacements & allows pipeline to remain intact
 - Over 50 years of experience in Japan
 - Used in US and Canada since 2013

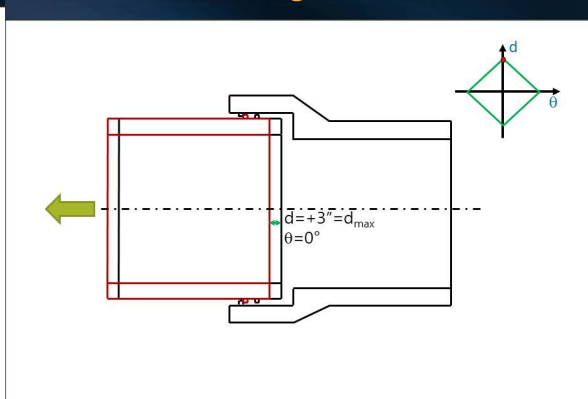
Joint behavior: Moving in tension

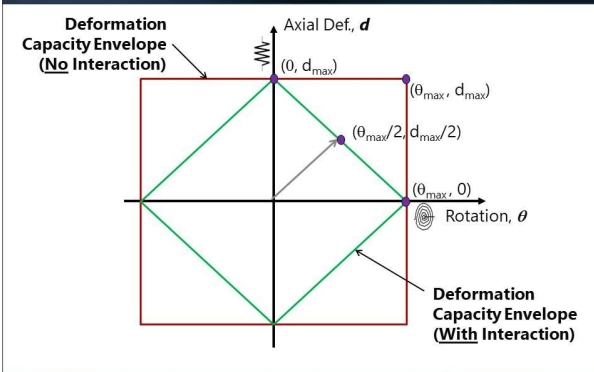
Axial/rotation joint capacity with and without interaction

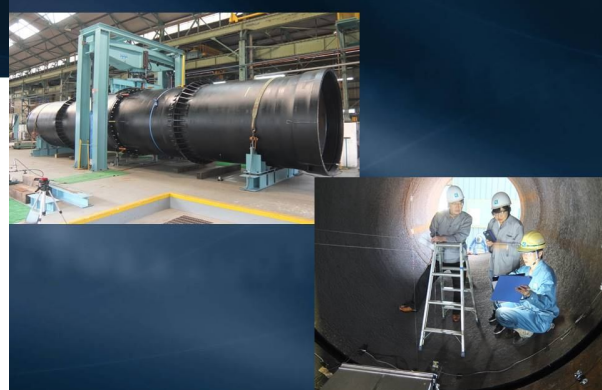
ERDIP Performance Testing

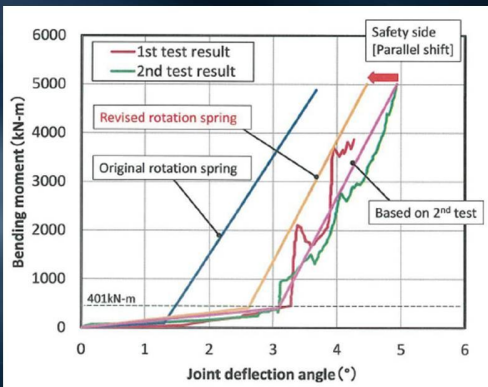
Revised Rotation Spring

- The displacement hazard would cause large stresses in a conventional continuous pipeline.
- ERDIP absorbs the displacement through axial movement and rotation within the joints.
- The pipeline system could be designed for large displacement with a combination of S-type joints, collar joints, and engineered backfill.
